INTRODUCTION

Engines need regular interval overhaul. All units of main engine and auxiliary engines needed to be overhauled while the vessel in Tuzla/Anchorage Area, Tuzla/Gemsan Dry Dock & Tuzla/Türkter Shipyard. Regarding to schedule, the added value of Teknomarin's expert diesel repair capabilities were put to the test.

SULZER RND 90 MAIN ENGINE OVERHAUL

Engine Room had some additional works to be done. Alternator rewinding, turbochargers overhauls, governors overhauls, daeration tank fabricating, cooling sea water pump, fuel oil burning pump, hydrophore pump and some other kinds of pumps overhauls, exhaust isolation jobs, inspection & recondition jobs and many others things to be done means that there is an *“engine room complete overhaul”* we can call it. This report includes all jobs to be done in M/V Almawashi.

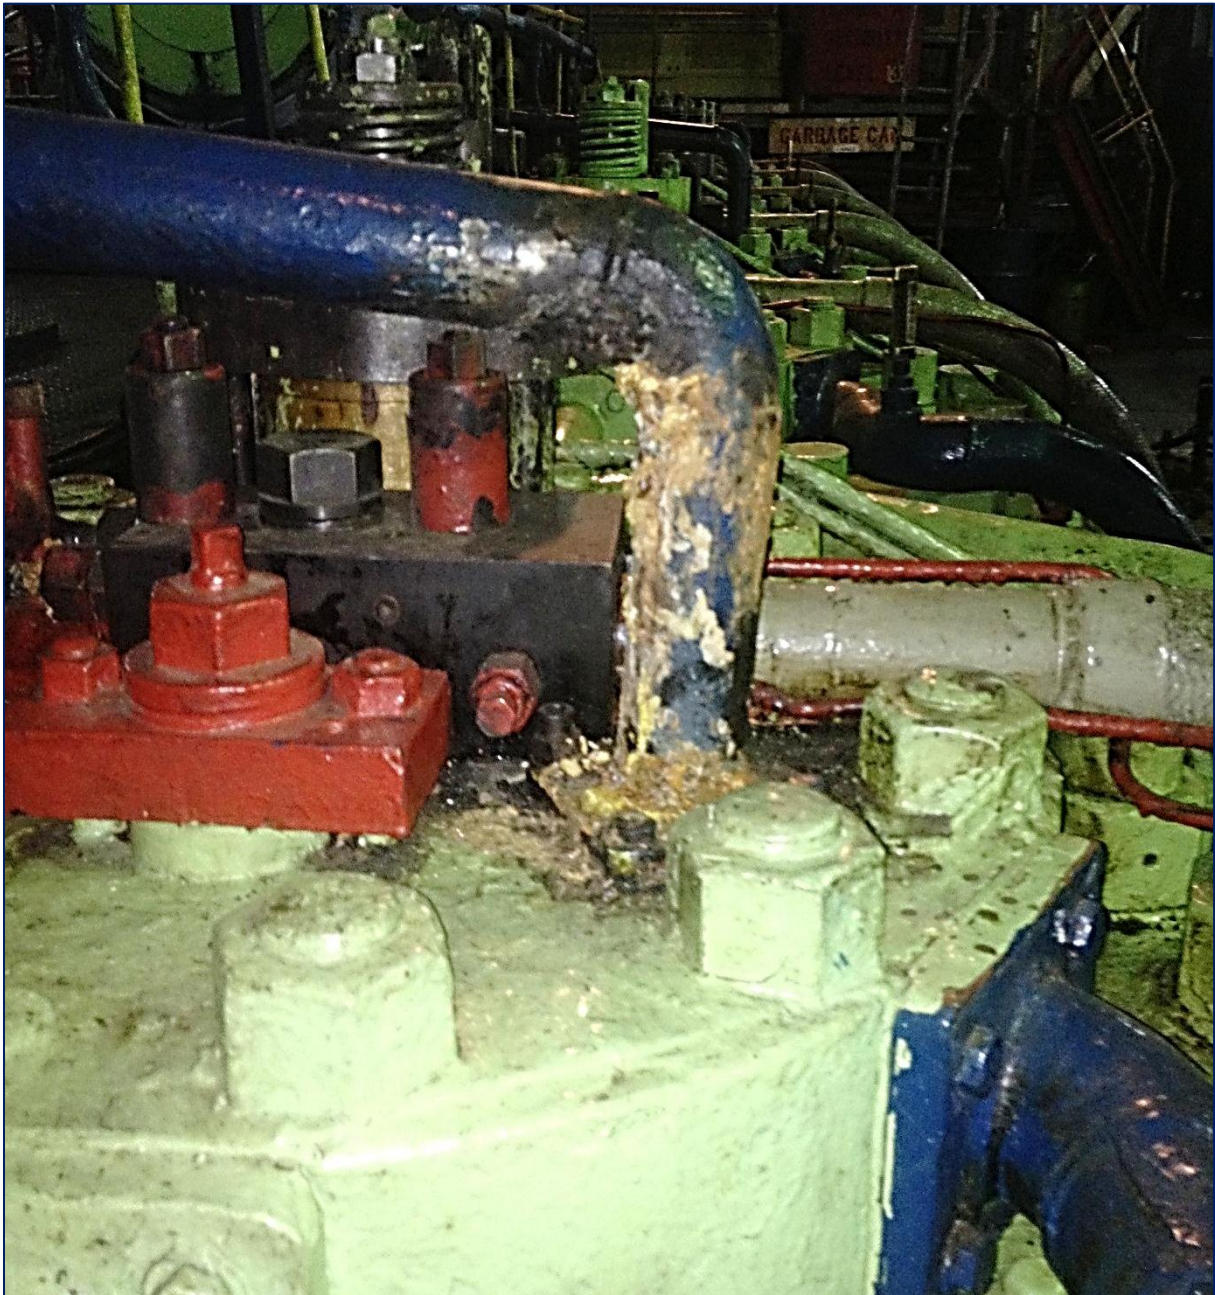
All cylinder heads dismantled and inspected on stu. Two of them transferred to the TEKNOMARIN's workshop cause of the condition themselves. All safety valves, starting valves and Indicator valves overhauled and tested. Indicator cocks overhauled and tested. Cylinder covers water side cleaned by chemically and hydrostatic pressure tested. Cylinder heads mounted on stu.

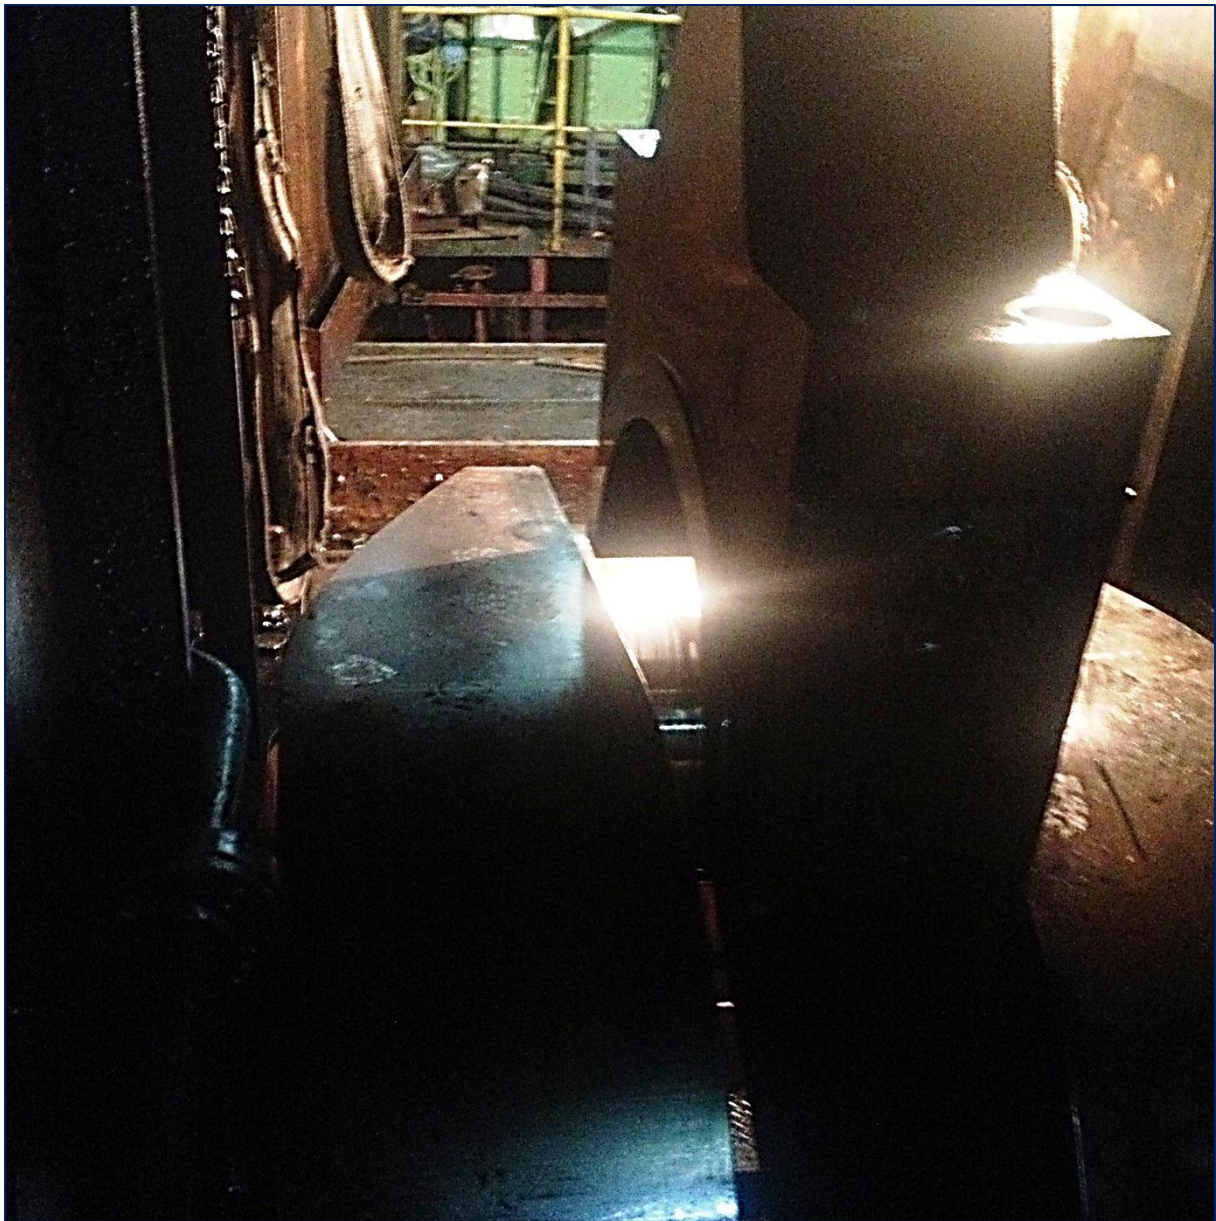
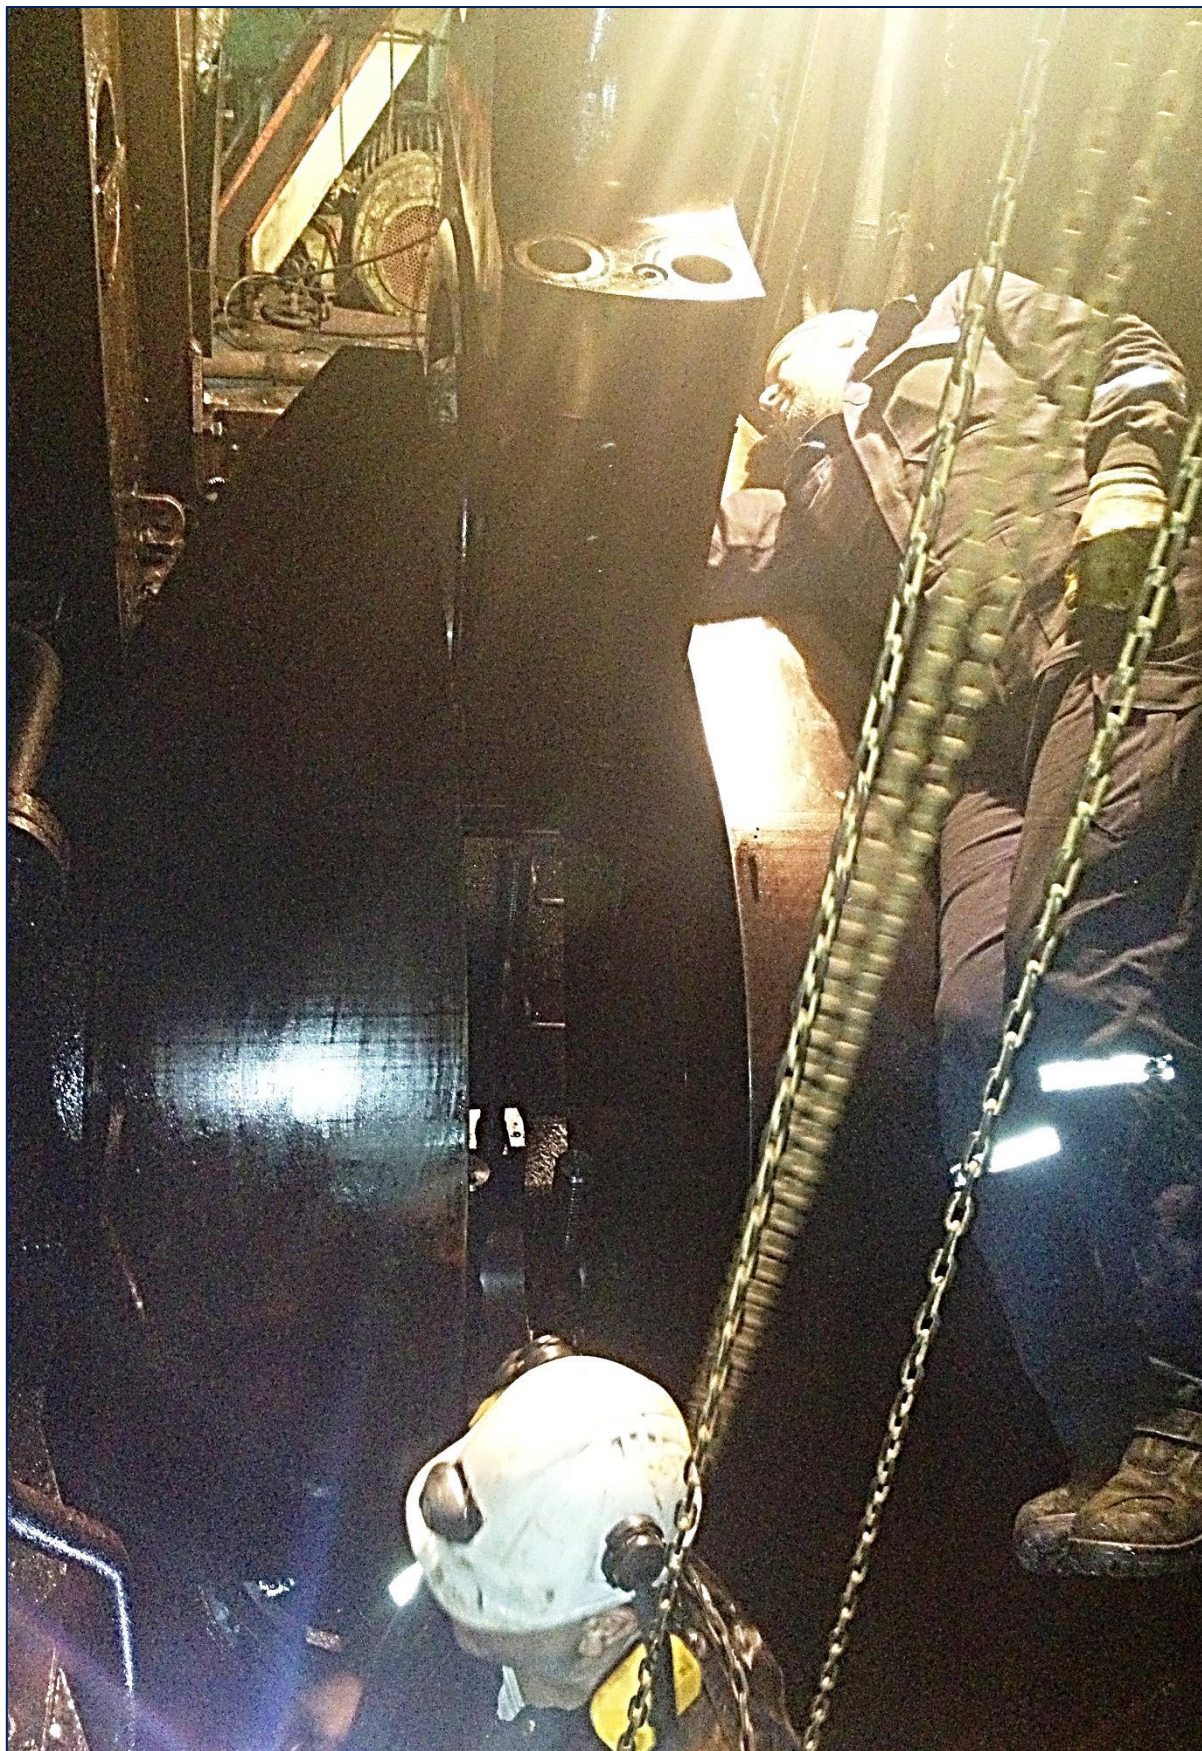
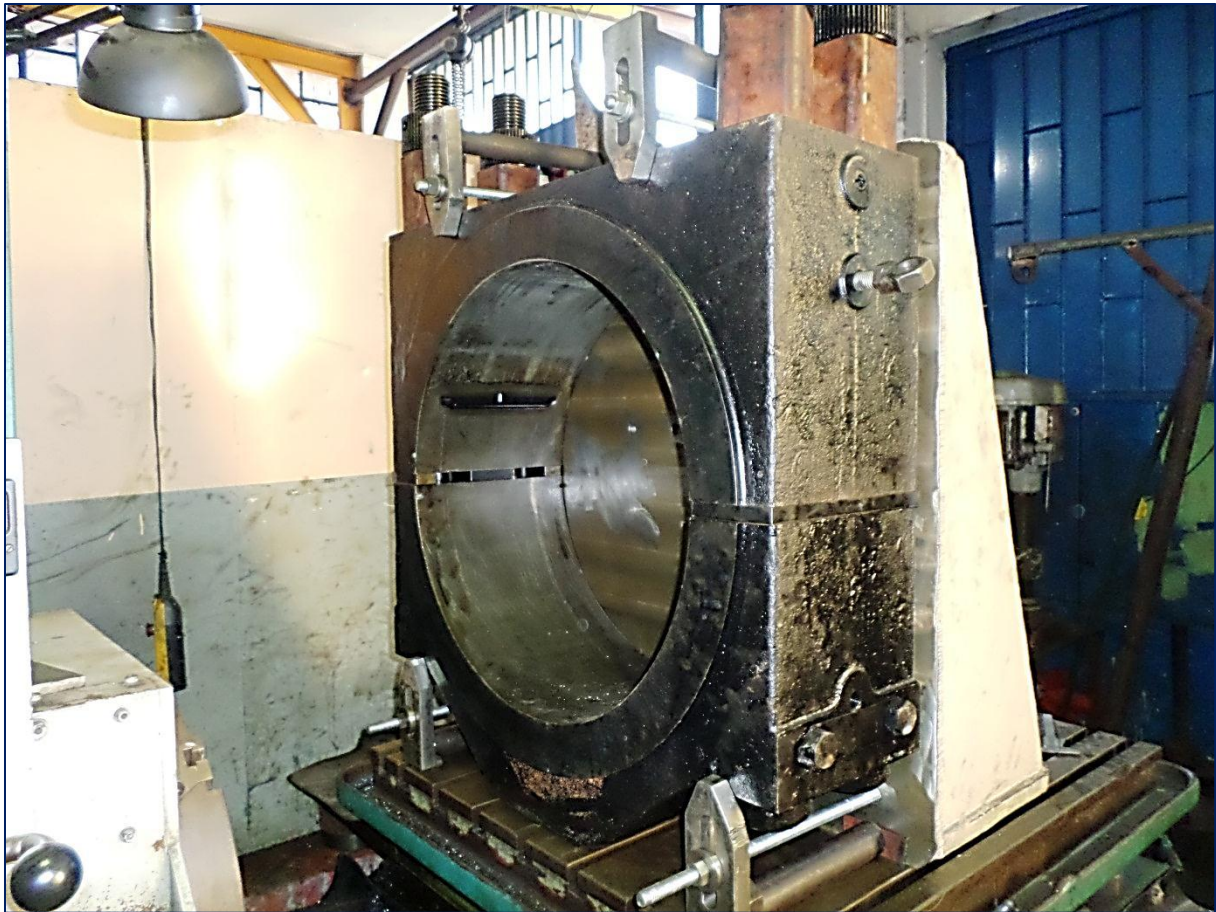
All piston bolts dismounted. All pistons disassembled. All con.rod bearings and main bearings has opened & inspected. Some of big end bearing spotted as damaged toughly. Damaged big end bearings dismounted & transferred to the workshop. Bearing cap housing ovality controlled. Piston ring groove clearence controlled. Connectin Rods bush bearings controlled. After recondition its transferred to the vessel and mounted immediately. Meanwhile security lock for big end bearing studs manufactured and supplied to the vessel. Mounted on stu.

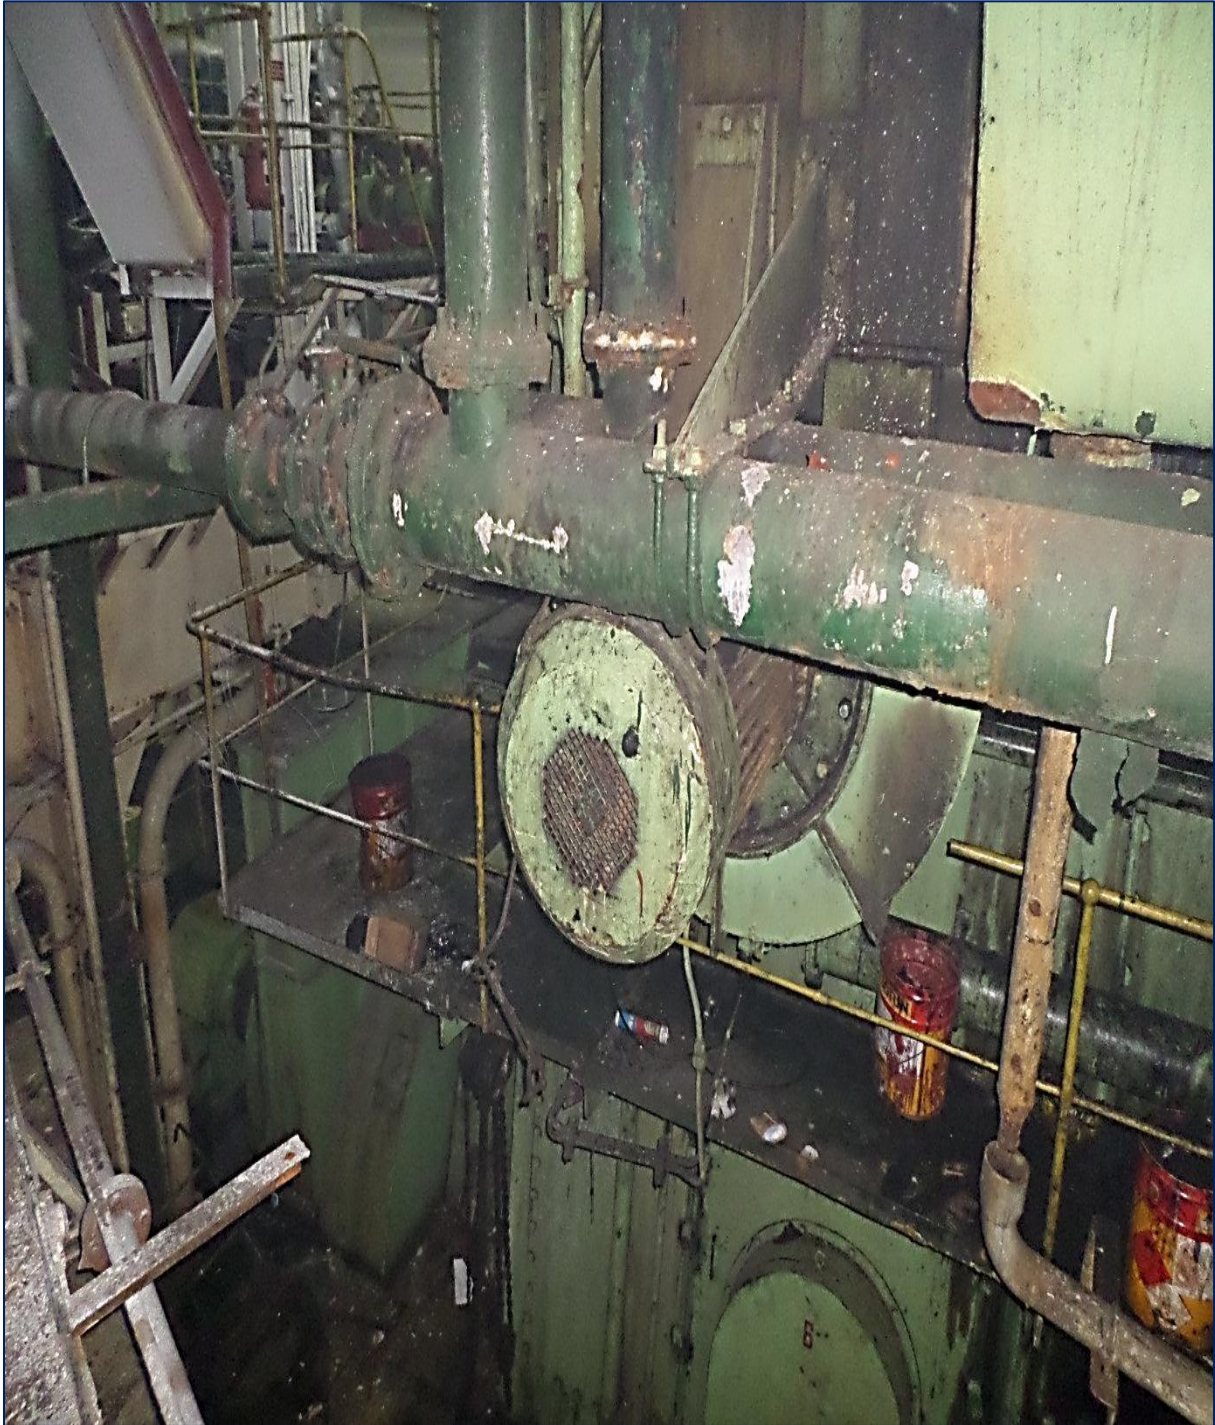
M/E Aux. Blower has dismantled & transferred to the workshop. Blower disassembled & inspected. Roller bearings has renewed & inside and outside of blower cleaned. Later by Blower balast tested. After that transferred to the vessel & mounted on stu.

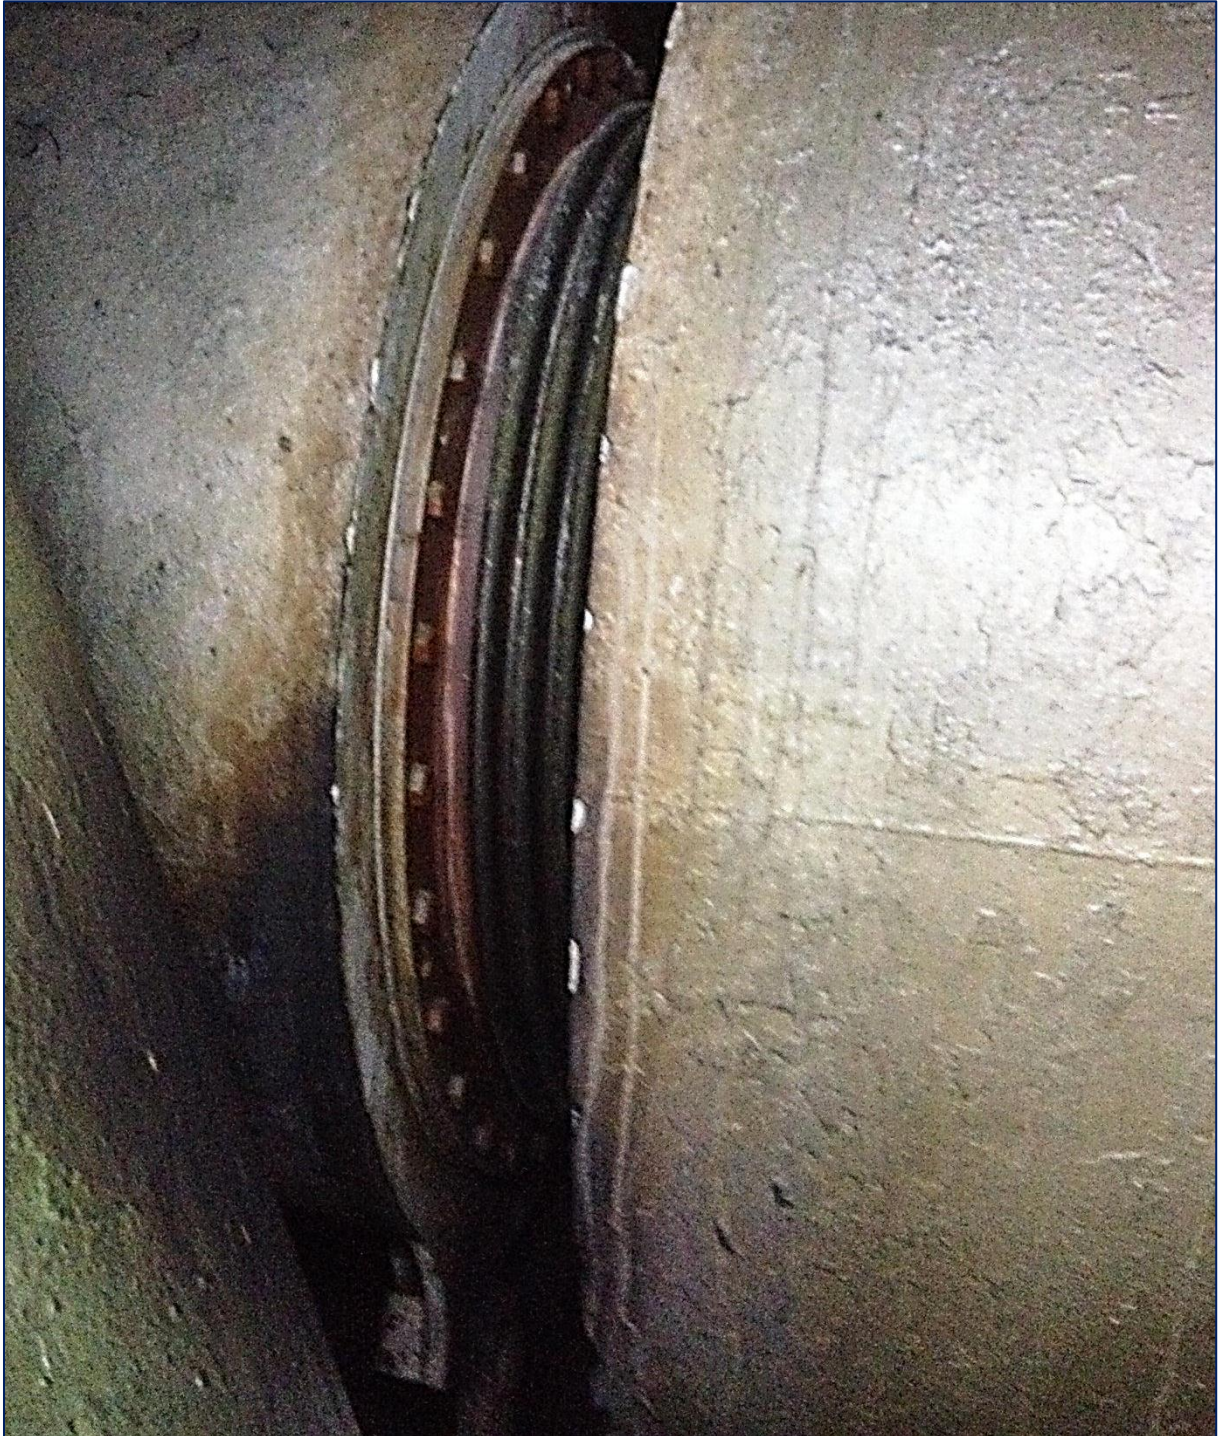
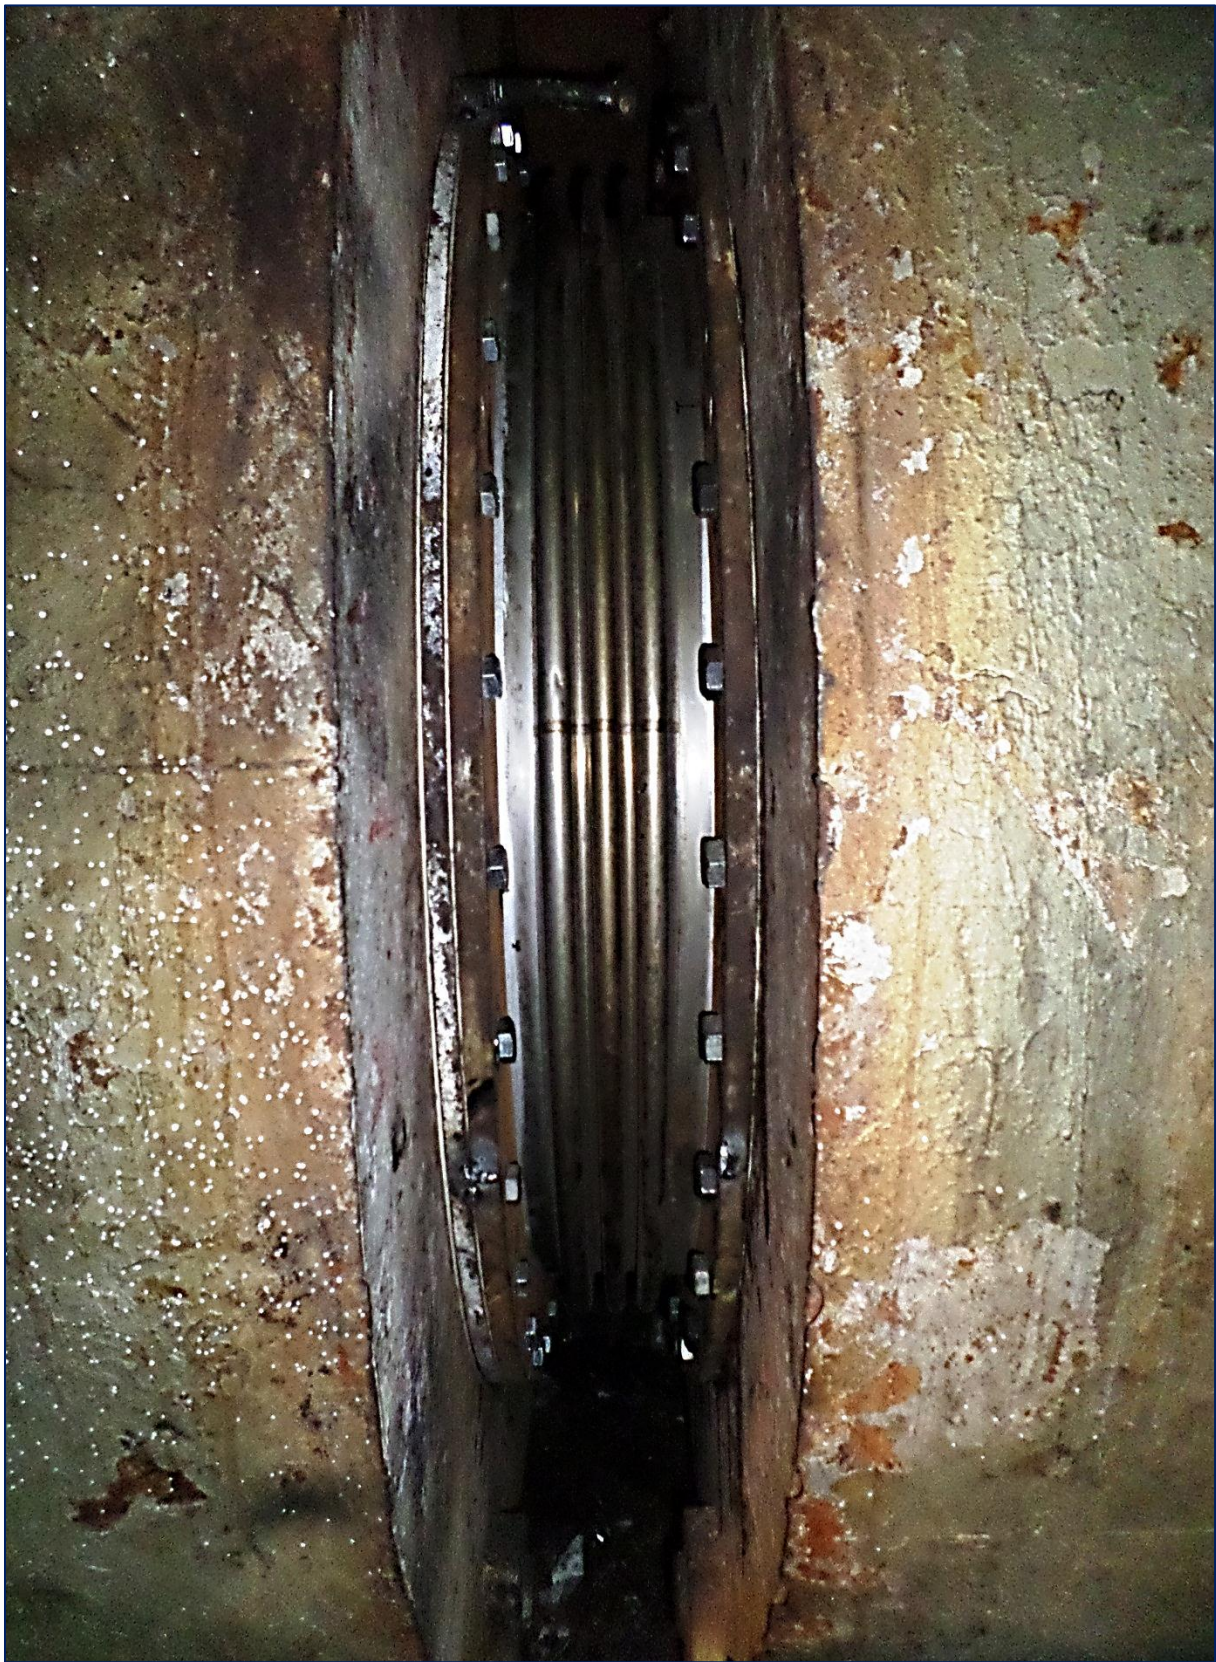
MAIN ENGINE EXHAUST EXPANSION REPAIR & OVERHAUL;

All exhaust expansions belongs to Main Engine, inspected. Two of them spotted as damaged toughly from welding lines. These expansions dismantled & transferred to the workshop. Meanwhile spare expansions mounted on stu. Later by reconditioned expansions transferred to the vessel and kept as spare.

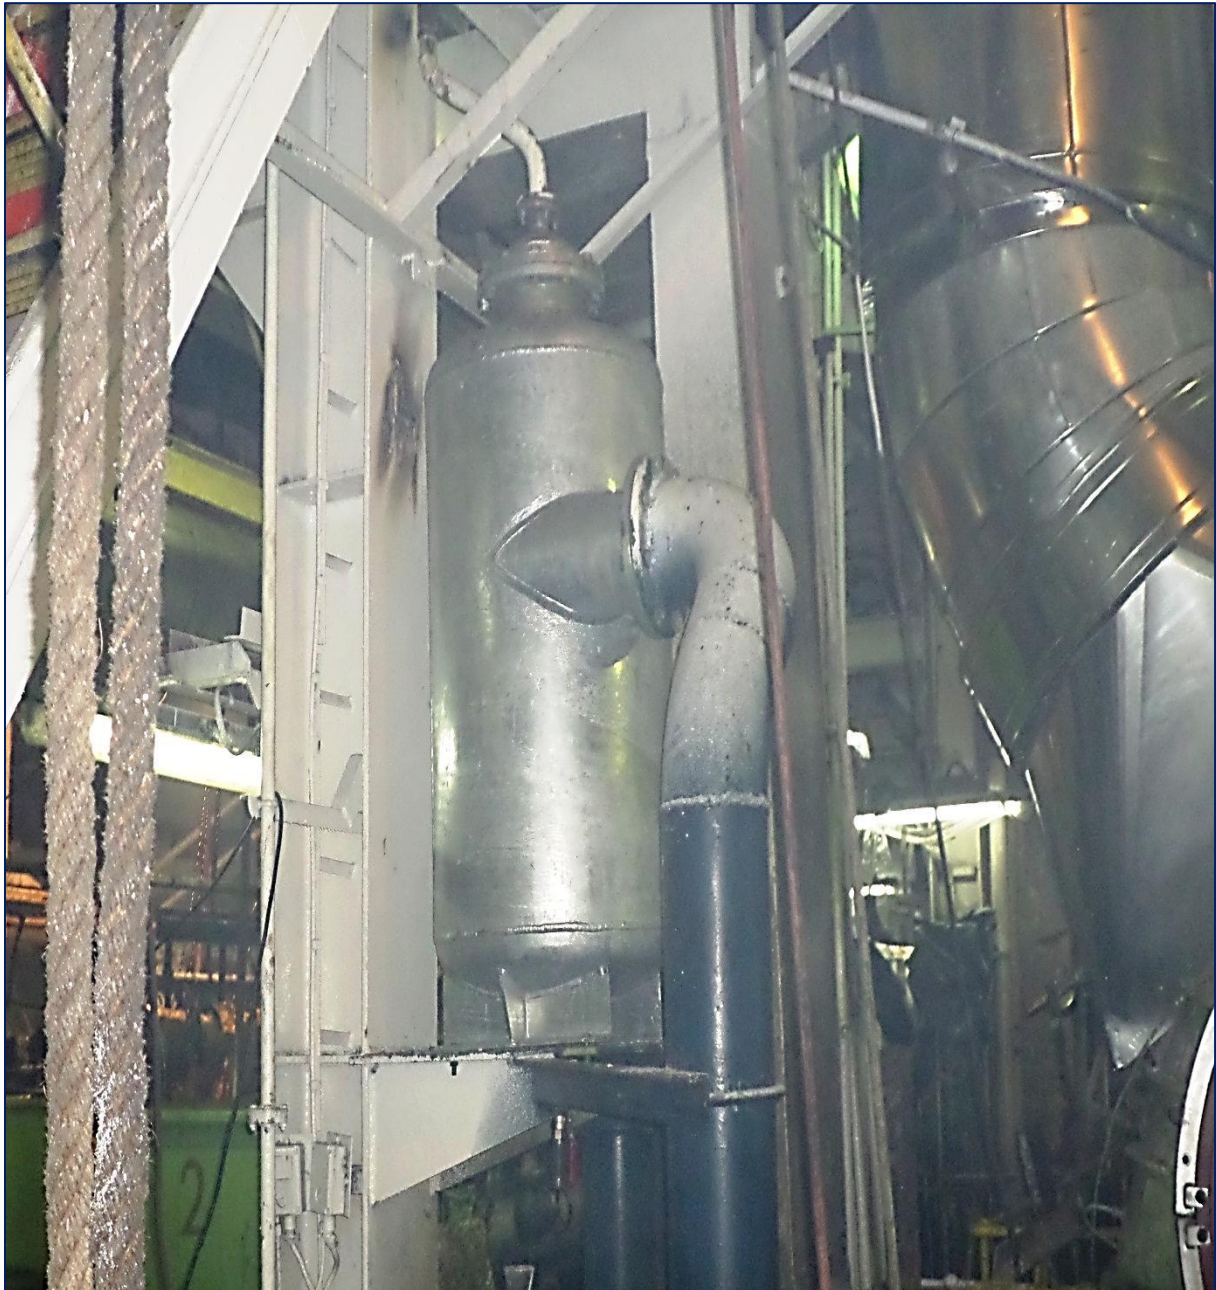
MAIN ENGINE FRESH WATER DAERATION TANK;

Regarding to our inspect main engine fresh water daeration tank has leakage in some parts and stuffed completely. In the light of this inspection, we dismantled the tank as sample and fabricated new one same as old. With new drain valve, gaskets, bolts & nuts, foundation fitting and pipes fitting, new fresh water daeration tank is ready for order.

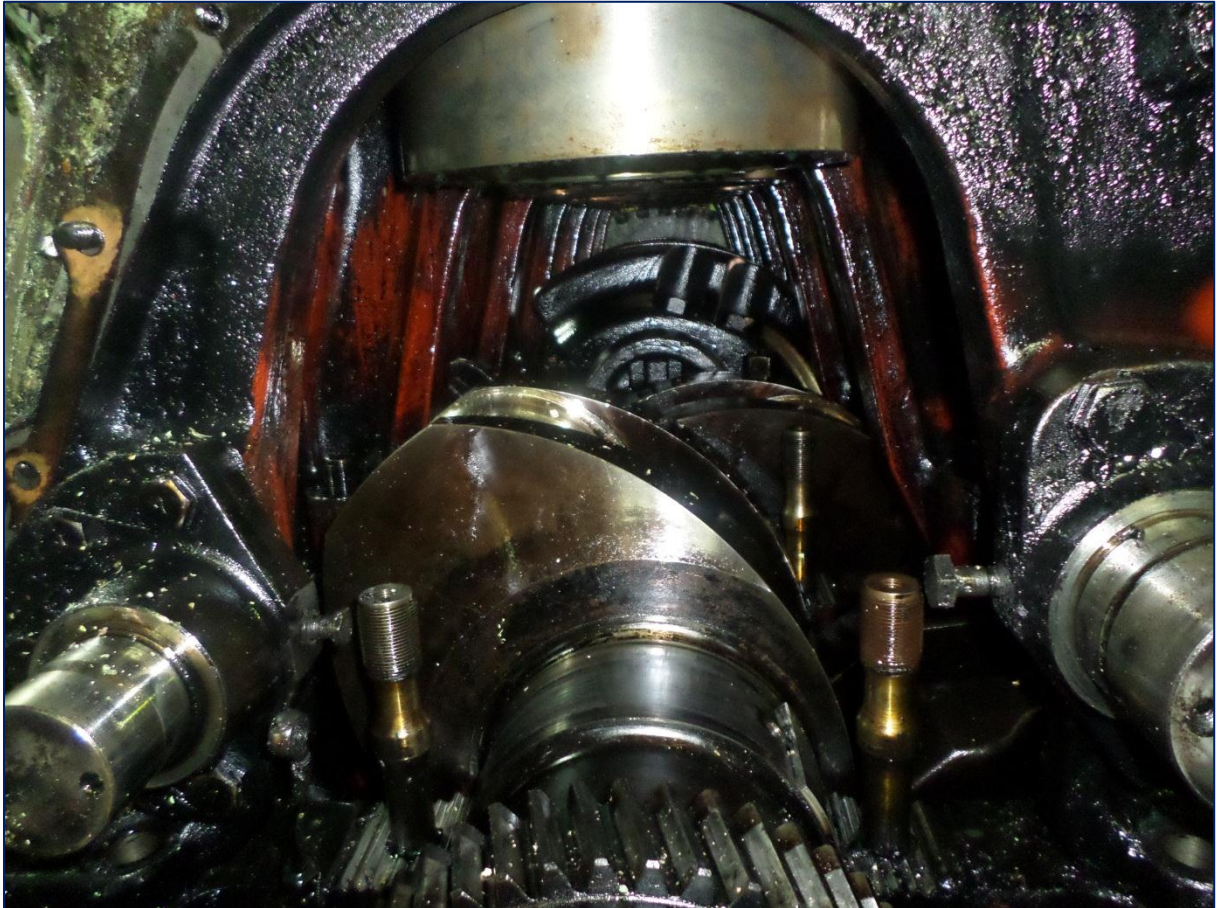
Regarding to our inspection with Generator Engine No:4 Crankshaft, we noticed that the crankshaft non-flywheel sides bushes has broken & there was some bending on crankshaft & should be boring. After the dismantling of crankshaft, it has transferred to the workshop & main bearing, crankshaft boring job has already started.

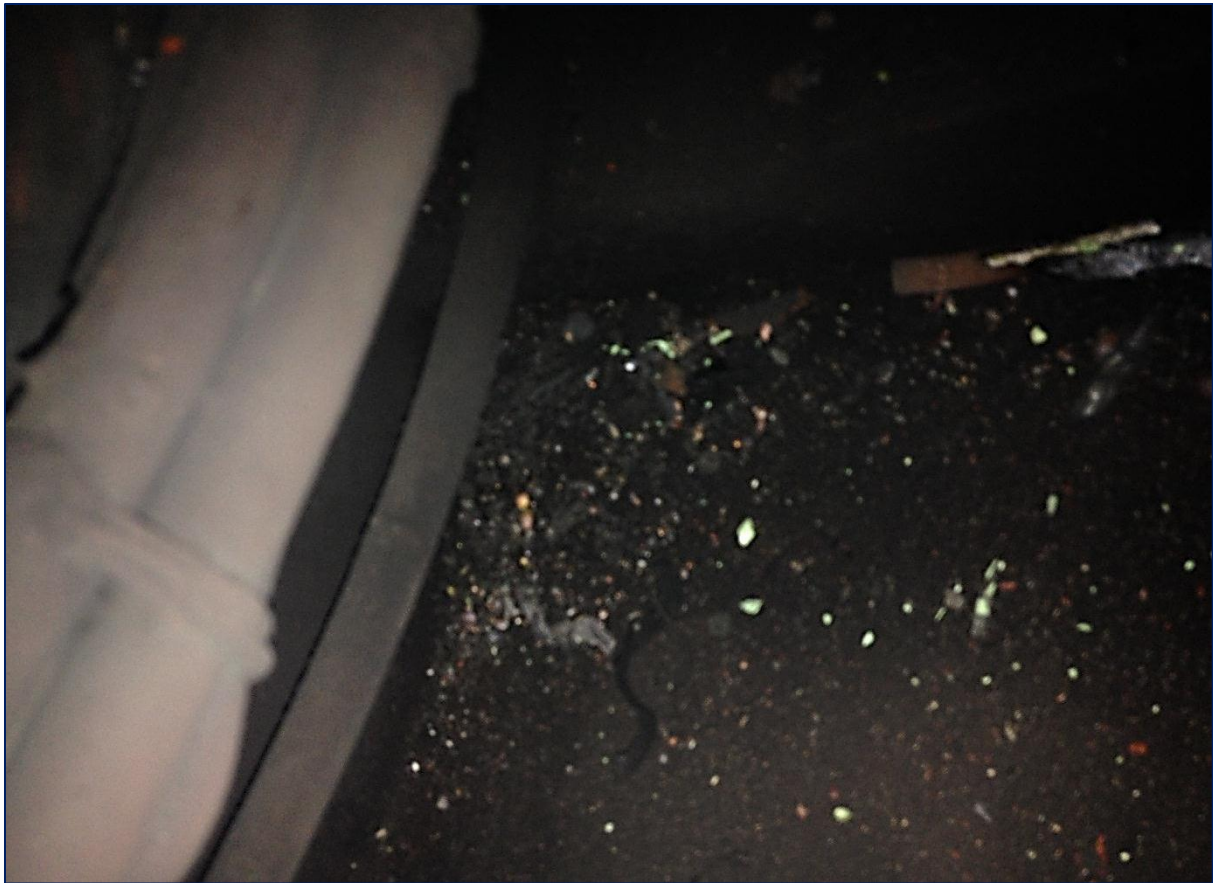
G/E NO:4 ALTERNATOR REWINDING;

Regarding to our inspection with Generator Engine No:4 Alternator, we noticed that the alternator was burned & should be rewind. Cause of the place & terms, rewind must to be on stu. After the measurements & continuos inspection, alternator has disassembled & rotor has been taken out. Alternator rewinding started immediately, after the completion of rewinding, mounted on stu & tested. **Operative.**

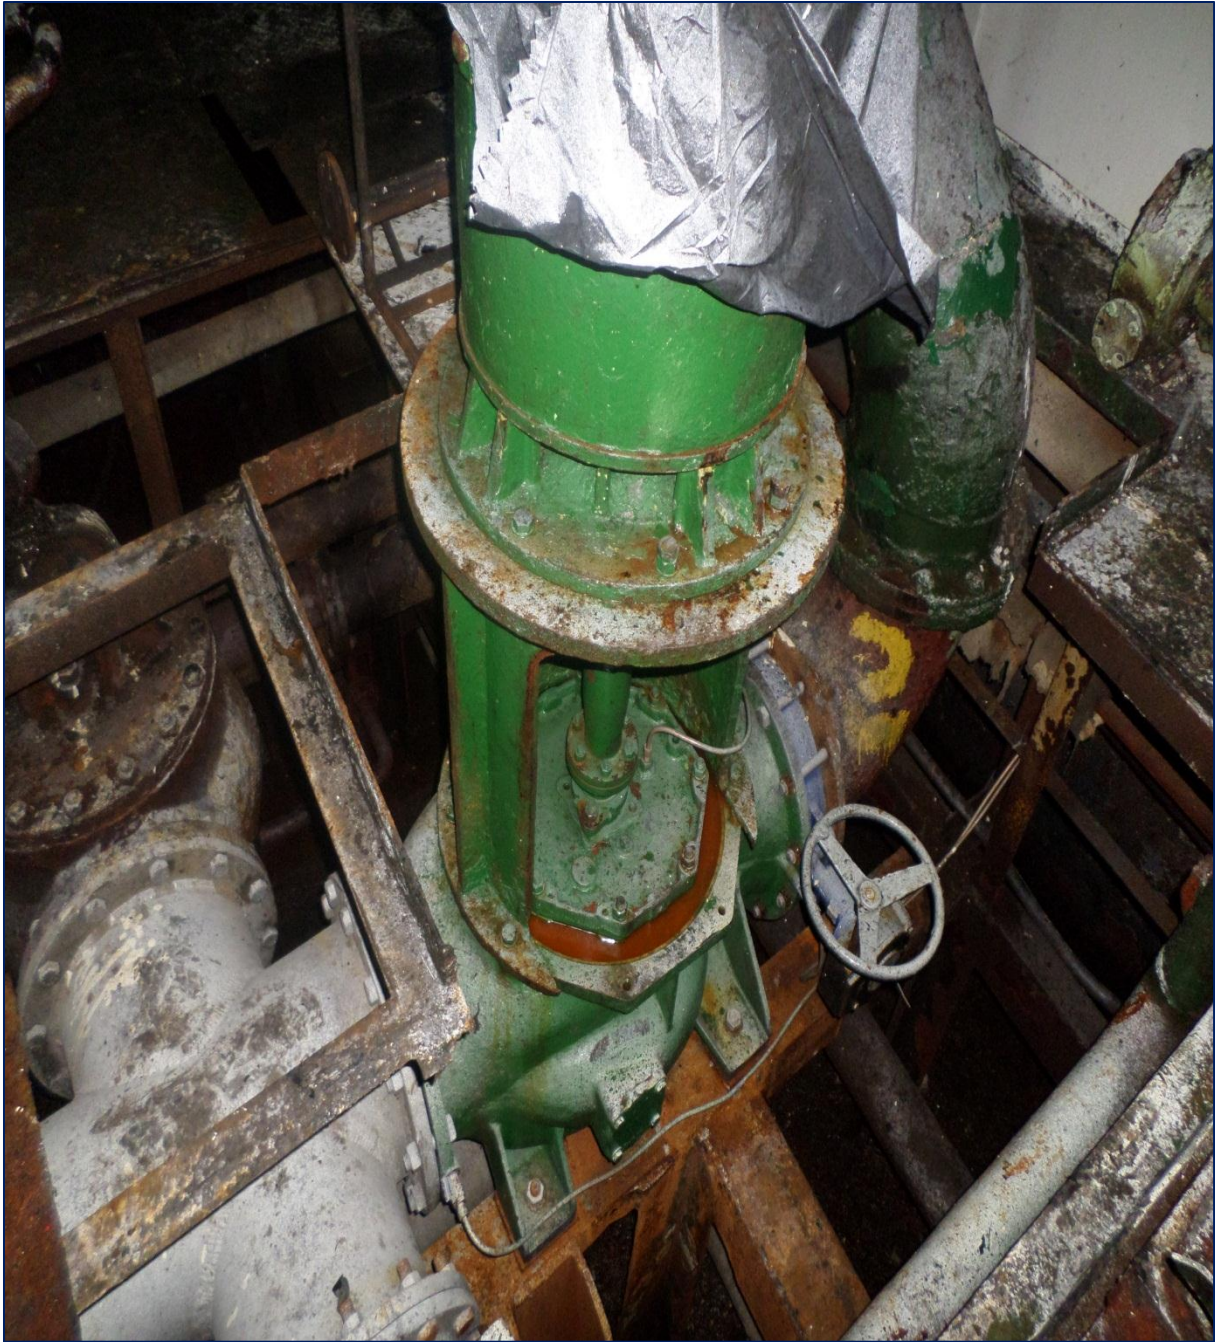
SANITARY PUMP OVERHAUL;

Sanitary Pump has dismounted from foundation. Transferred to the workshop & opened for inspection. According to our inspection, we started to overhaul. But cause of the material condition, it was not possible. All surface of the pump was broken or corroded. In the lights of this inspection, sanitary pump completely destroyed & seperated as scrap.

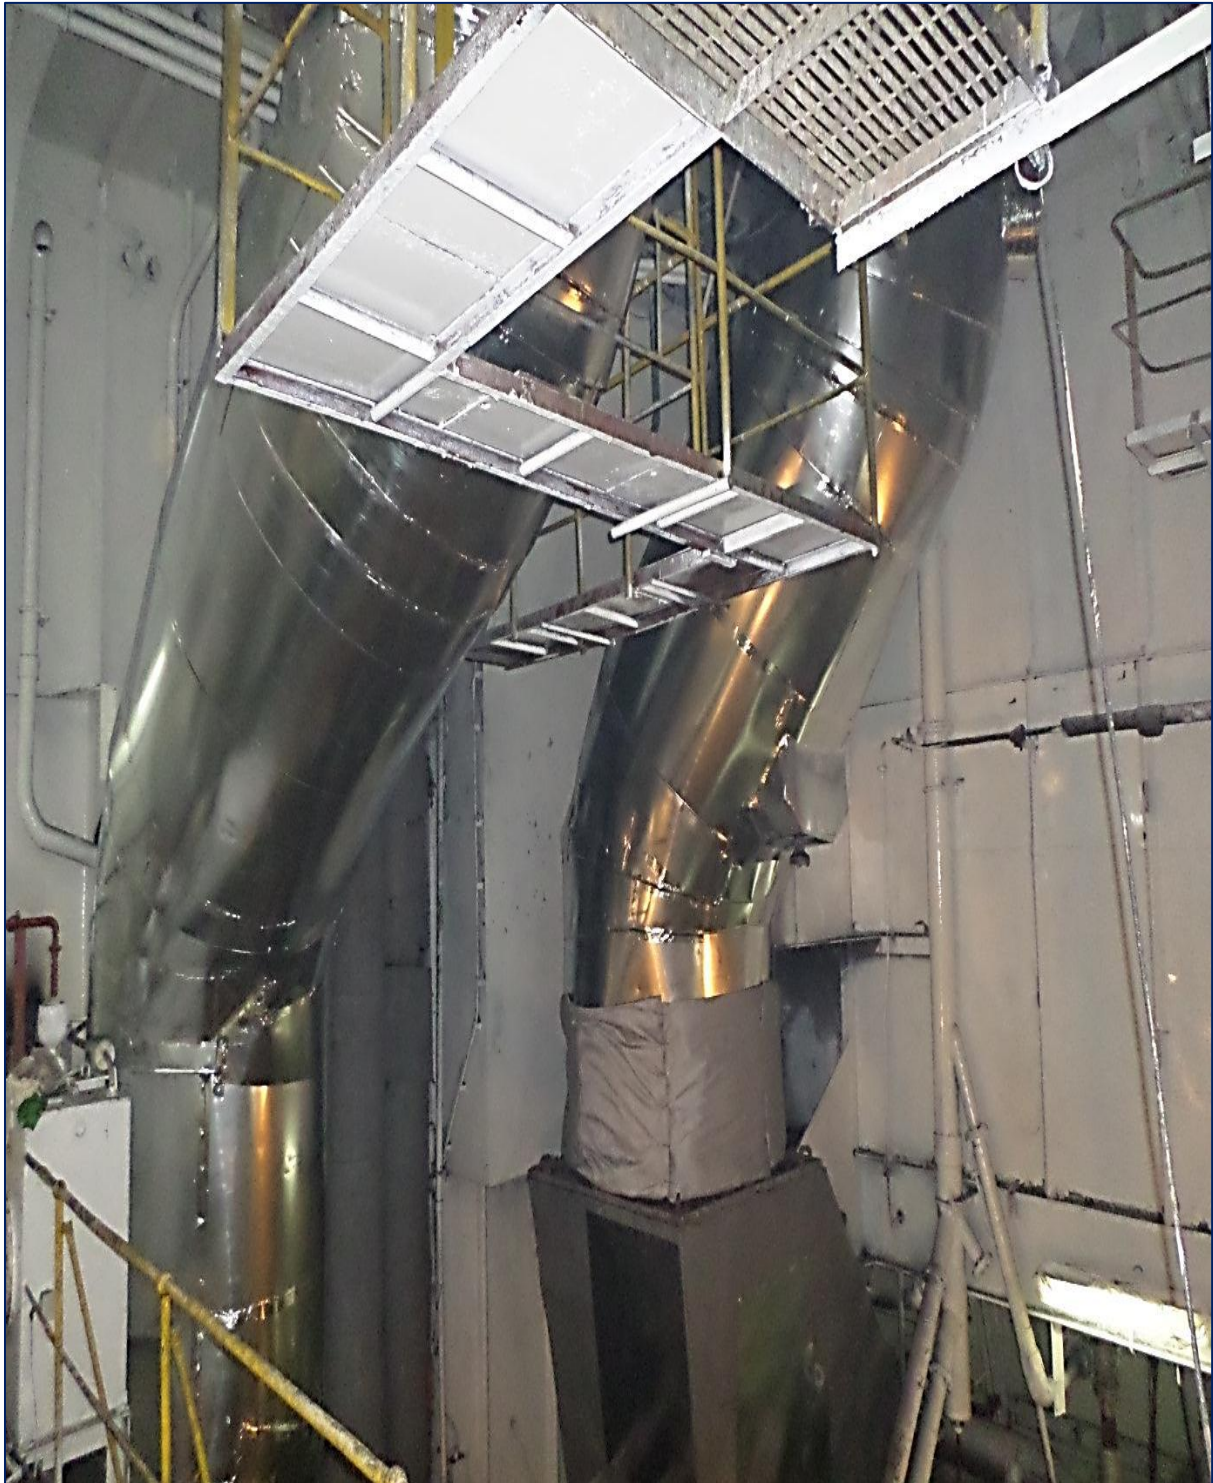
Due to our inspection, Boiler exhaust's isolation has corroded & damaged. Regarding to our taken measures, isolation plates has renewed & replaced.

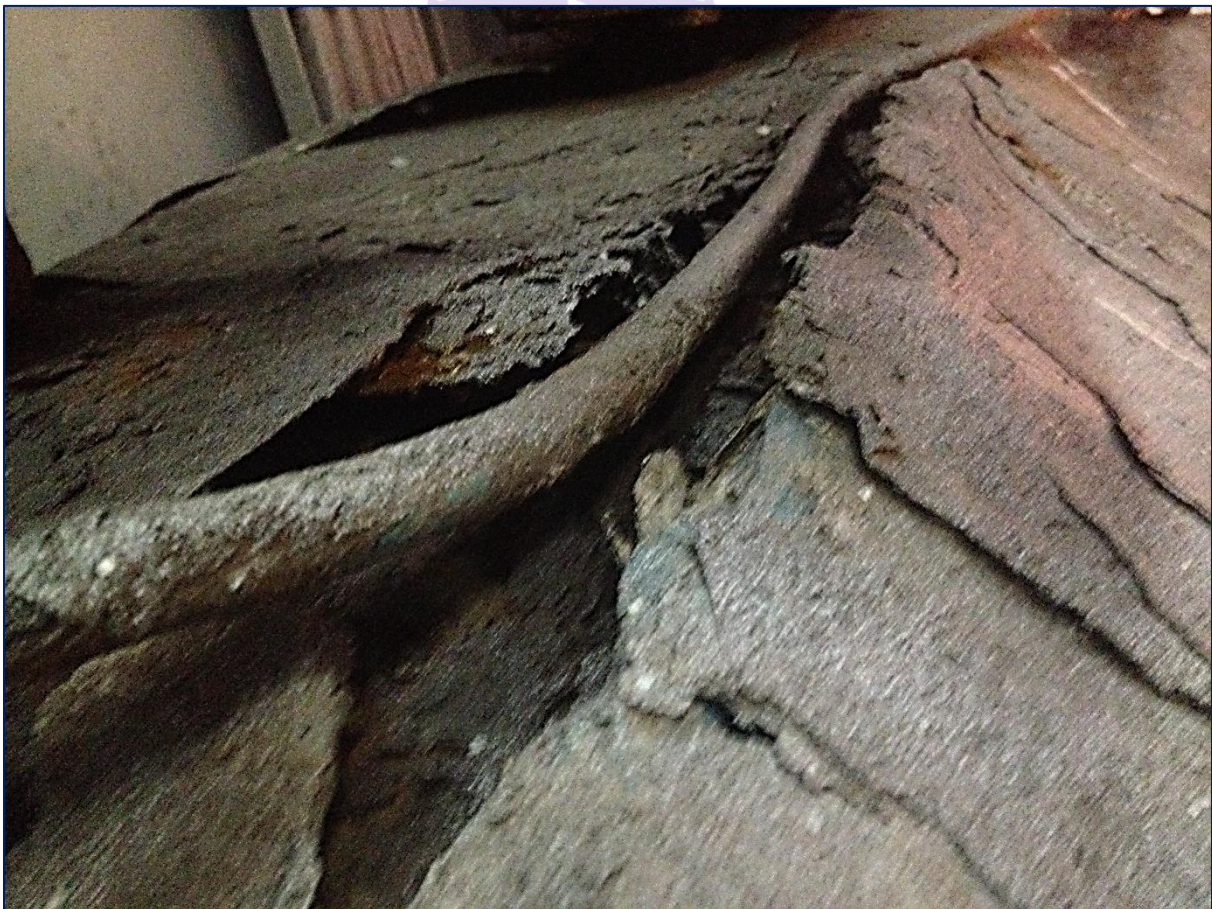
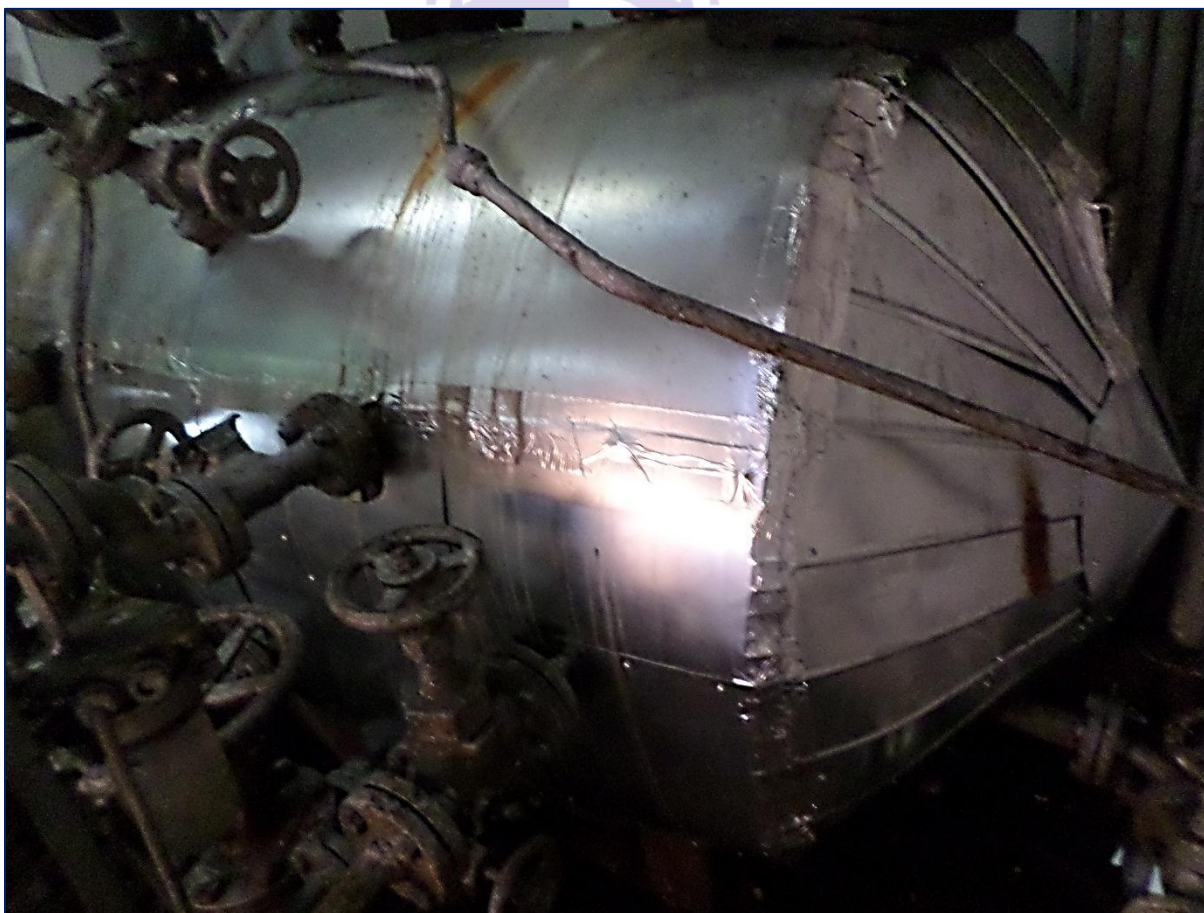
STEAM TANK ISOLATION;

Due to our inspection, steam tank isolation has corroded & damaged.
Regarding to our taken measures, isolation plates has renewed & replaced.
