INTRODUCTION

Engines need regular interval overhaul. All units of main engine and auxiliary engines needed to be overhauled while the vessel in Tuzla/Anchorage Area, Tuzla/Gemsan Dry Dock & Tuzla/Türkter Shipyard. Regarding to schedule, the added value of Teknomarin's expert diesel repair capabilities were put to the test.

SULZER RND 90 MAIN ENGINE OVERHAUL

Engine Room had some additional works to be done. Alternator rewinding, turbochargers overhauls, governors overhauls, daeration tank fabricating, cooling sea water pump, fuel oil burning pump, hydrophore pump and some other kinds of pumps overhauls, exhaust isolation jobs, inspection & recondition jobs and many others things to be done means that there is an *“engine room complete overhaul”* we can call it. This report includes all jobs to be done in M/V Almawashi.

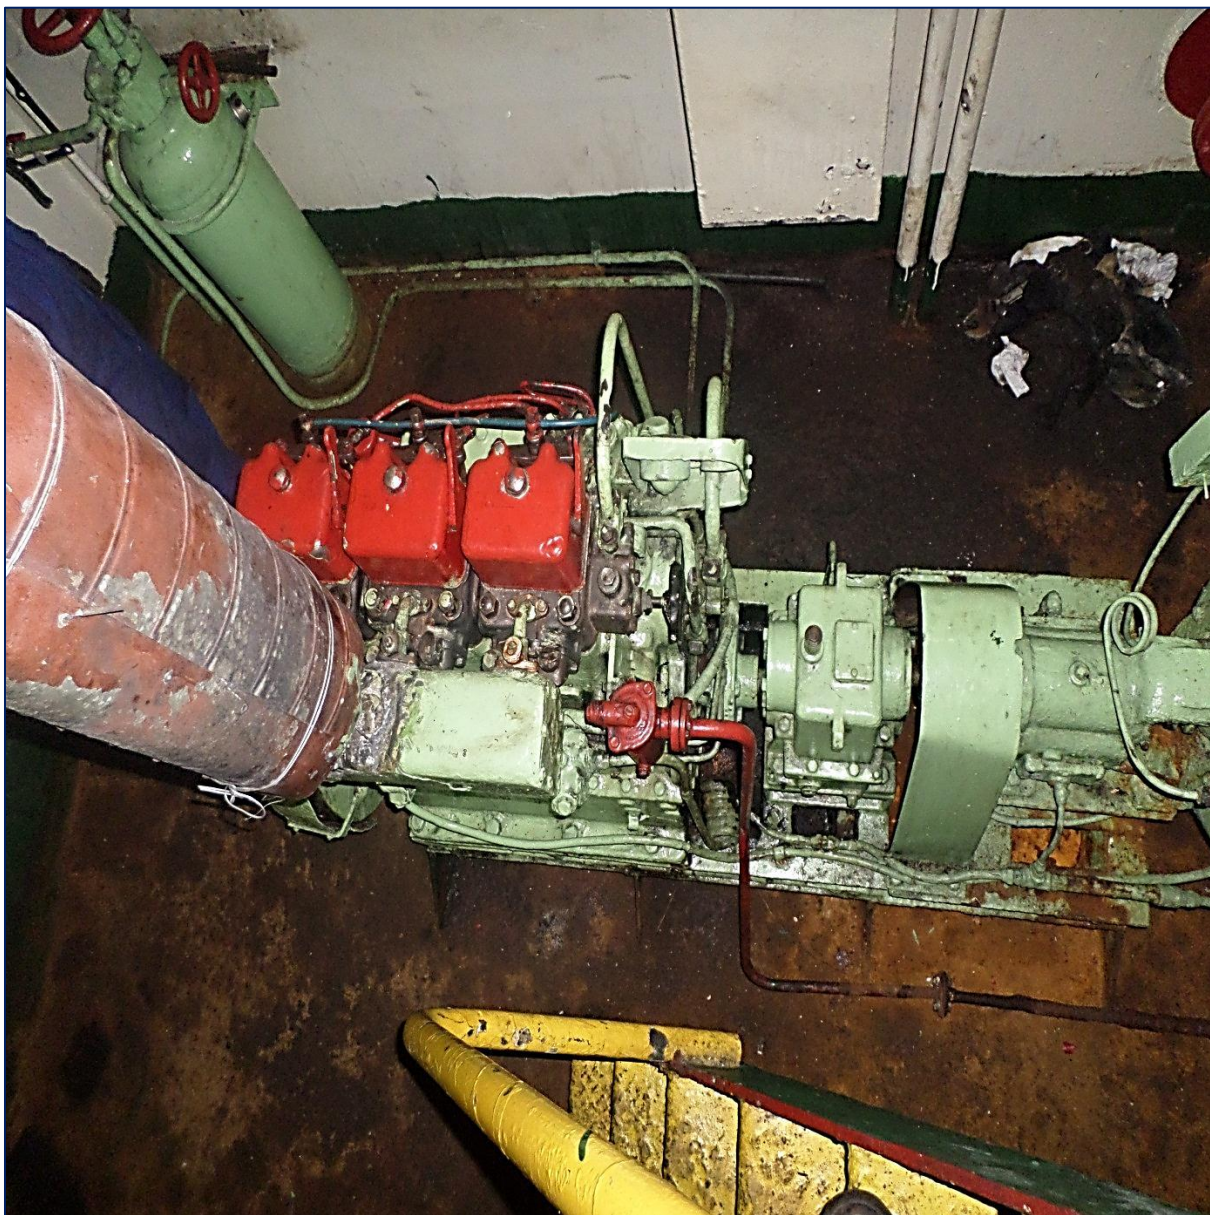
All connections of cylinder heads dismantled. All cylinder heads dismantled & transferred to the workshop. All piston bolts dismantled. All pistons disassembled & transferred to the workshop. All liners disassembled & transferred to the workshop. Block checked for possibly cracks. After inspection and measurements, liners mounted, pistons assembled. Cylinder heads assembled & valves timed. According to this maintenance we started the emergency fire pump engine with the pump, pressure checked, engine checked. All is well, **Operative.**

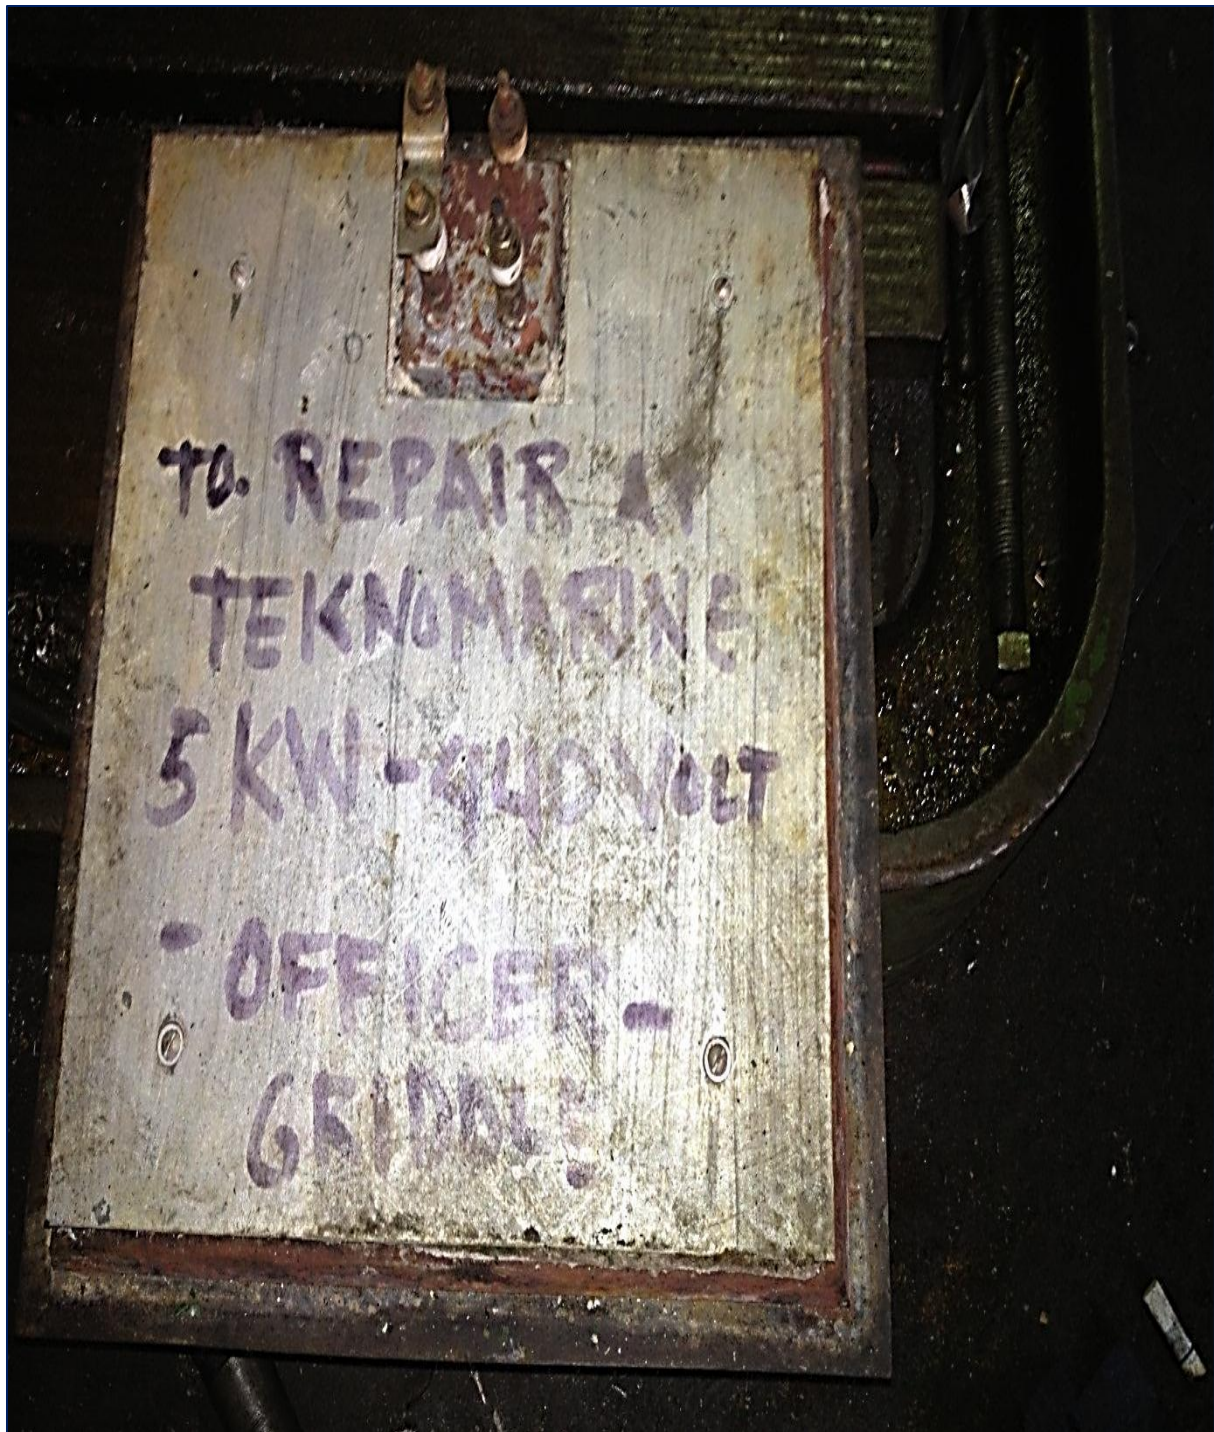
GALLEY HEATER RECONDITION;

Two units of galley heater has dismantled cause of the heating problem. As we inspected, these items must be recondition. Some of the resistances has dismantled as sample & renewed, replaced. Meanwhile cover also controlled. Later by transferred to the vessel & delivered.
