TSB 02-157-14R

Surface Treatment Change To Oil Control Piston Rings

2013-2014 Subaru Legacy and Outback Models with 2.5L FB Engine

2011-2014 Subaru Forester Models with 2.5L FB Engines

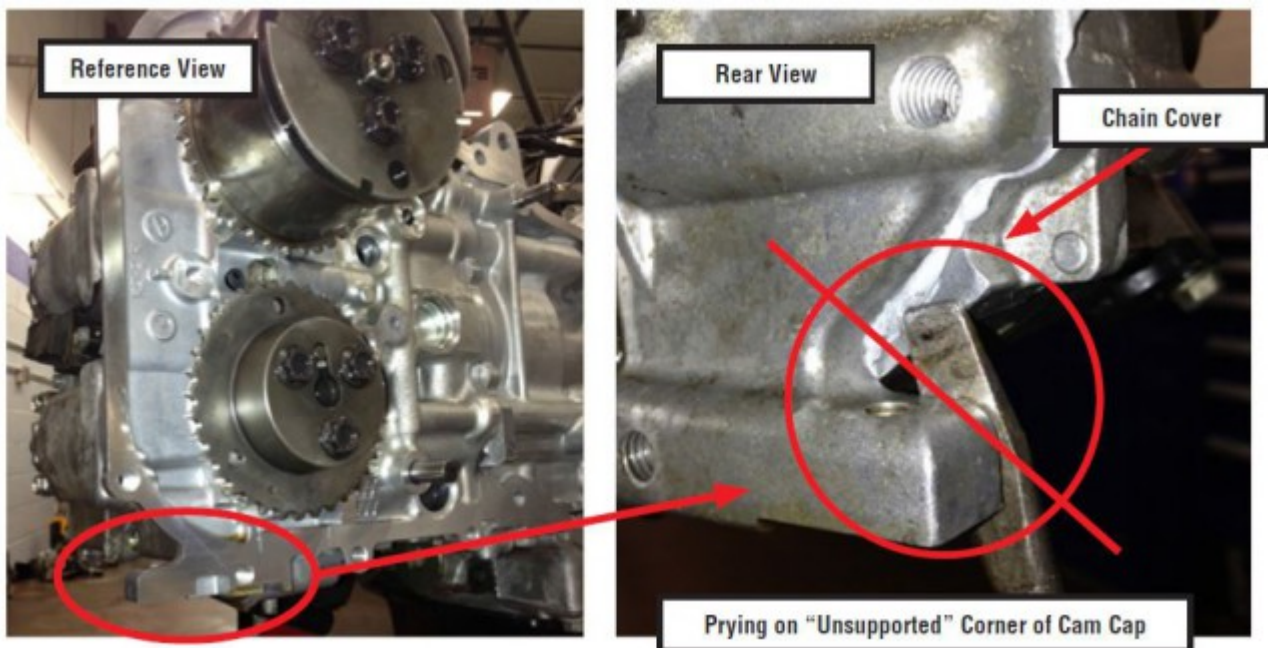
- There is no need to remove the oil dipstick tube or the original oil filter from the front chain cover. While the cover is removed, store it face (front side) down to minimize the chances of damaging the machined sealing surface on the block / head side. Also, don't use it as a tray to store other removed parts.
- **IMPORTANT:** After all 32 bolts securing the chain cover are removed, be **EXTREMELY** careful where you pry and what you pry on to break the silicone sealant's bond. The photos below show an example of where **NOT** to pry. In this case, the cam cap became cracked requiring a complete cam carrier replacement. Patience is the key!

cam cap became cracked
requiring a complete cam carrier replacement

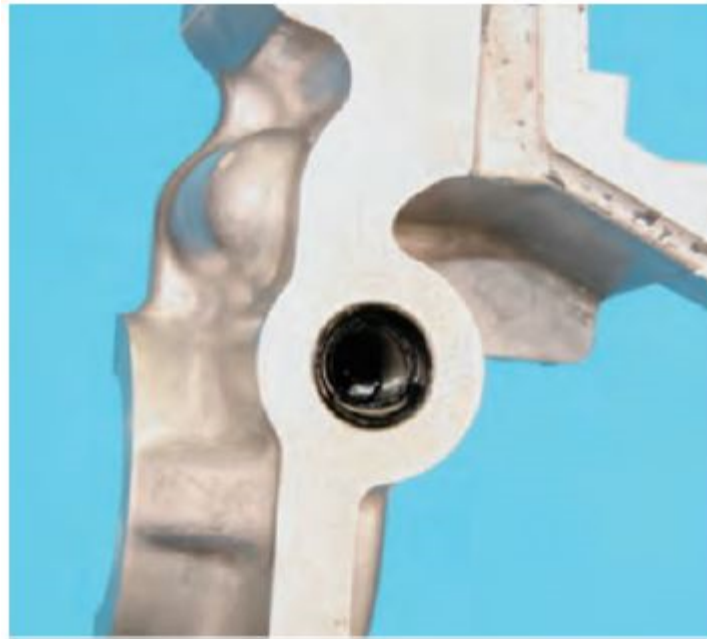
AVCS filter screen

• **IMPORTANT:** If by chance the AVCS filter screens in the cam carriers have come loose or fallen out during disassembly, they are directional and **MUST** be reinstalled in their original position. There is an oil passage in the cam case which **MUST** align with a hole on the outside diameter of the filter screen tube otherwise, oil flow to the AVCS will be restricted or blocked resulting in engine damage.

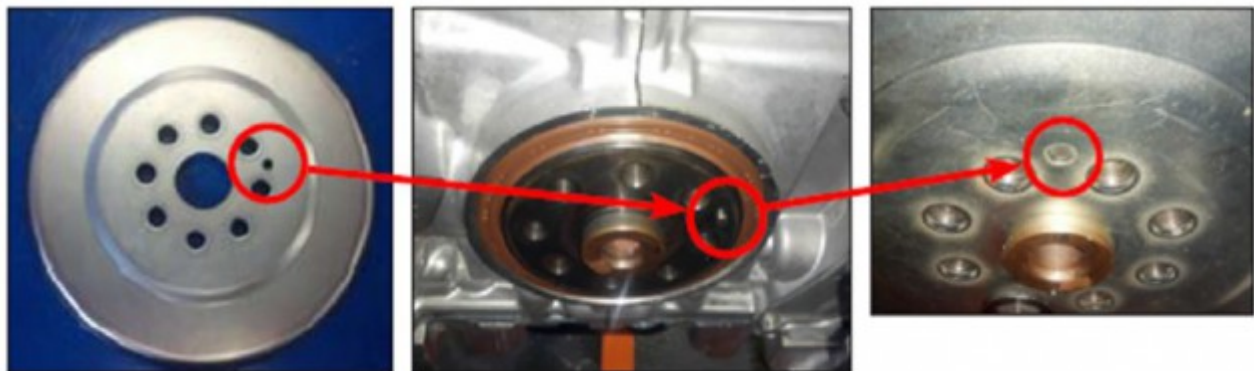
• **REMINDER:** When replacing the short block, in addition to transferring the crankshaft position sensor, be sure to index the reluctor properly onto the crankshaft as shown in the photos below. The reluctor is indexed by a dowel pin in the rear crankshaft flange which aligns with a corresponding hole in the reluctor. It is possible to install the reluctor without indexing it correctly. Failure to index the reluctor correctly will result in a no-start condition due to an out of time crank position signal to the ECM.
