# HOME REPORT

34 Braidholm Road  
Giffnock, Glasgow  
G46 6HS

# **Structural Inspection Report**

The purpose of the Inspection was to comment on wall cracking picked up in a recent Surveyors Report.

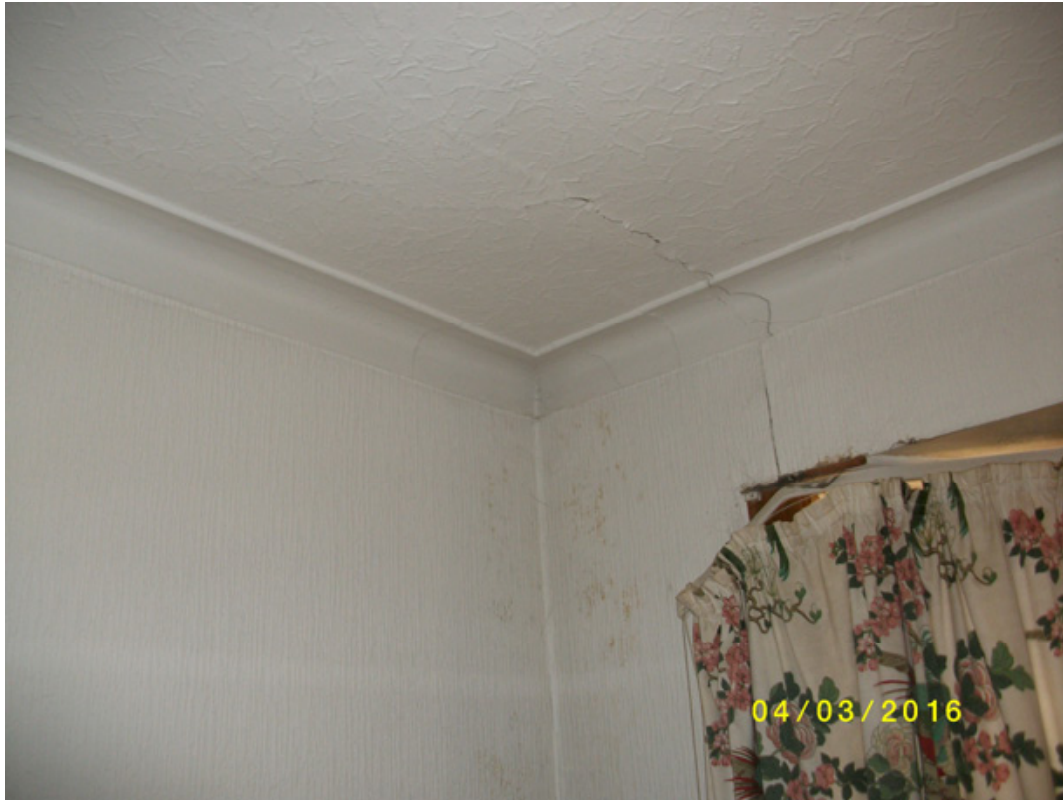
Internal Crack at front right hand corner of house

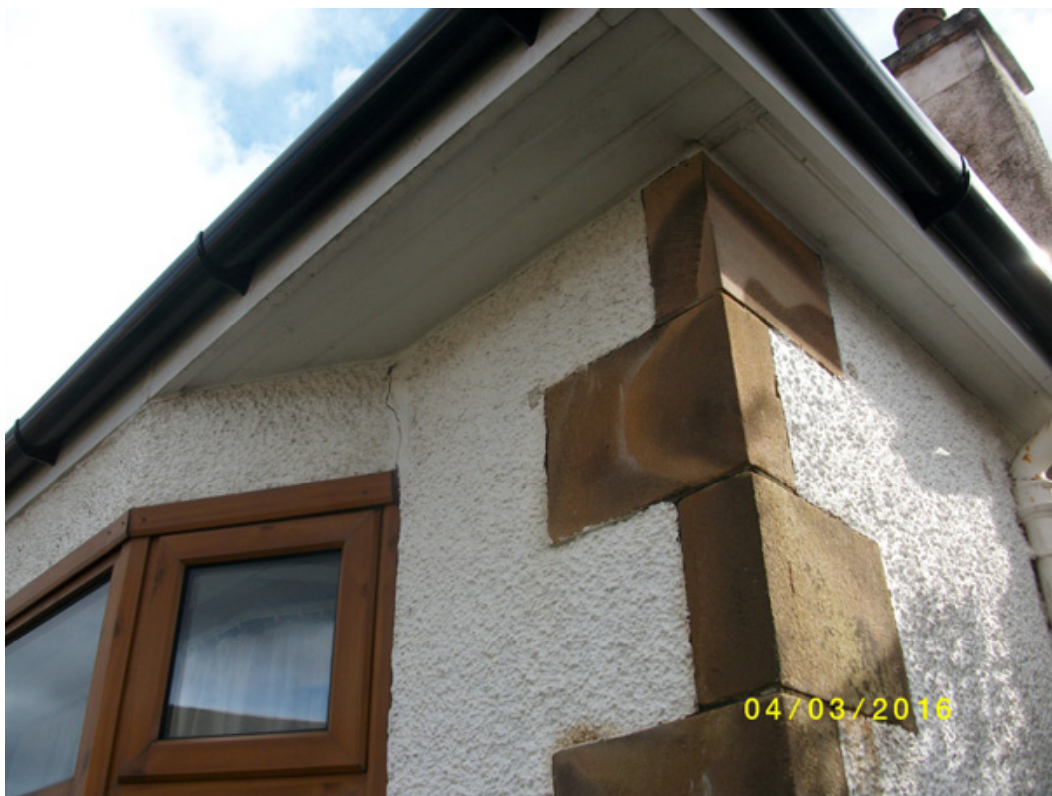
External Crack above bay window
