YEAR
1997

MODEL
3.0 CL

BULLETIN NO.
97-011

MIL Stays On After Starting

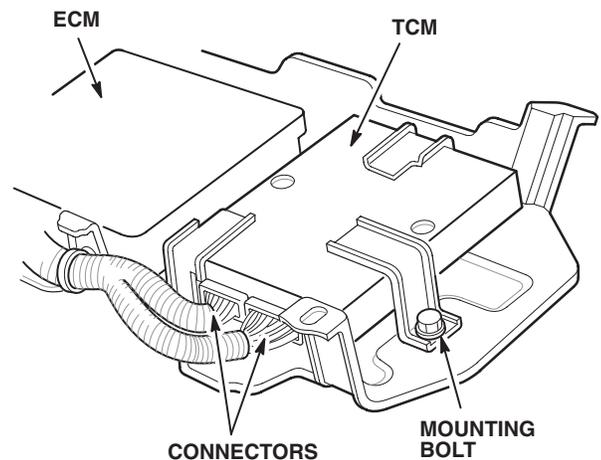
Electrical spikes from the ignition switch affect the TCM.

Replace the Transmission Control Module (TCM).

4. Remove the TCM by disconnecting the two connectors and removing the three mounting bolts.
