2015 September 17

National Institute of National Consumer Affairs Center

Folding bicycle frame was broken during travel

- Import agency has implemented the collection and free exchange of frame -

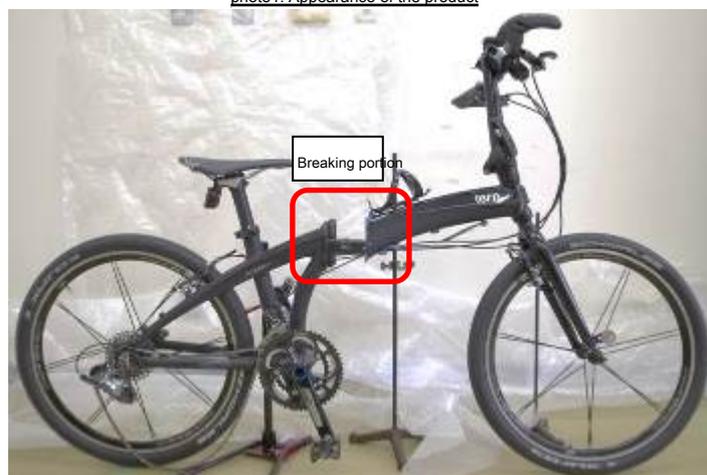
photo1. Appearance of the product

Currently, carried out a import agency Co., Ltd. Akibou is the exchange and recovery of frame for the six models, including the products (photo 1) (Tern · Verge X20 · Verge X10 · Verge X30h · Verge S11i · Eclipse X20 · Eclipse S11i) you have. The above models consumer you have a bicycle, please check Co., Ltd. Akibou.

Import agency, (see Note 1), including those past import agency imported, we are exchange and recovery of frame for the car model. If you have the appropriate folding bike discontinue use immediately, please contact:.

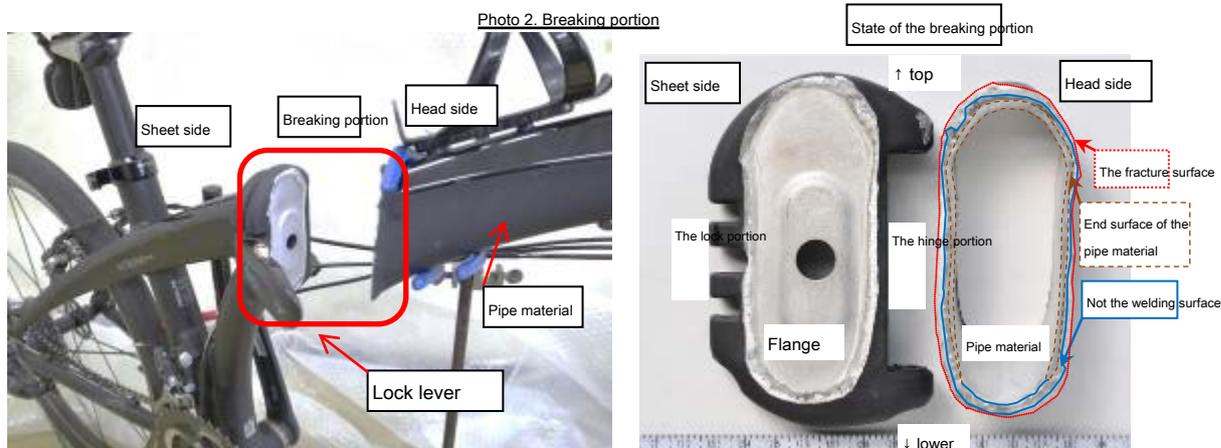
Rupture of the article in the folds of the aluminum frame was thrust Awa was welded portion of the pipe member and the flange (flange) (hereinafter, "sheet side breaks" the sheet side of the rupture portion, a front wheel handle side referred to as "heads side breaks." photo 2). It should be noted, such as deformation in the pipe material was not seen.

Head side breaks were observed end face of the pipe outside the bottom. Since the fracture surface is observed in the outer periphery of the weld metal, incomplete fusion (the state in which the weld metal and the base metal is not fully melted together) in the weld is considered that there was no, the inner periphery has a non-welded surface, it was considered to have been insufficient welding strength.

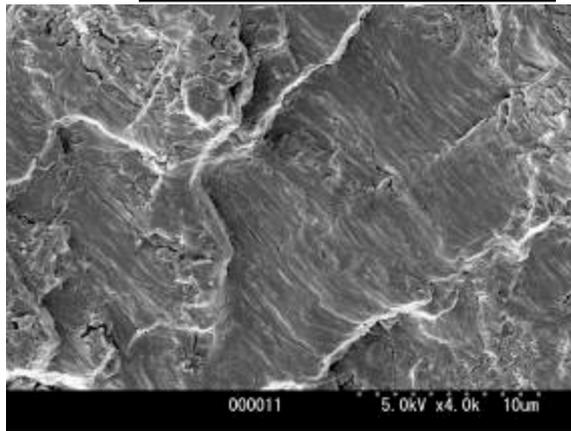
Hinge (hinge) side of the crack has been progress from the inside to the outside of the weld, the problem such that the direct cause of the destruction to the welding unit that crack has occurred could not be seen. The lower side of the crack of the broken part had to progress from the hinge side. One of the striations cane down pattern, which is also formed by the repeated stress on the fracture surface was observed (Photo 3), form of destruction was considered to have been a fatigue fracture.

Photo 3. Striation pattern of the fracture surface

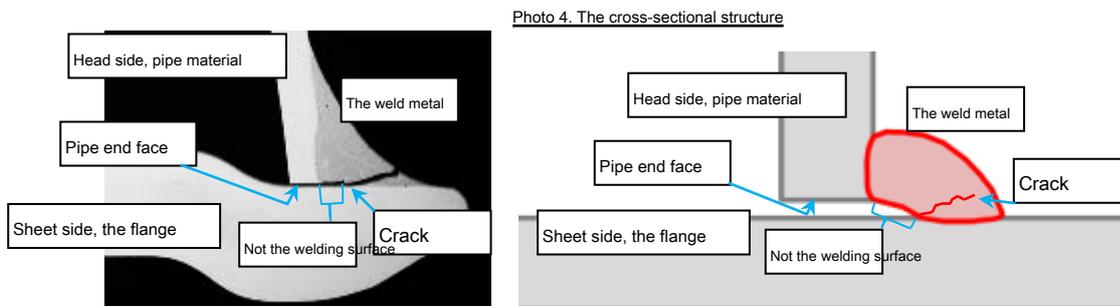
In the welding of the hinge side that would crack portion was subjected to cross-sectional structure observation, such as a direct cause of fracture in the weld metal bug but was not seen, the weld has unwelded surfaces, crack had occurred from the end of the non-welded surface (photo 4).

These results, the products have the welding of the pipe and the flange is not appropriate, the previous end of the non-welded surface becomes a starting point, the fatigue crack progressed reduces the bonding area, Setsu withstand load applied to the folded portion It has been considered to have broken without.
