### June 3rd - Arrival

Our project car arrives at Porsche Cardiff, looking rather tired and in need of some well deserved attention. Our first task was to assess how much work was involved, having been in storage for six years items for immediate replacement were fuel and brake lines accompanied by many suspension items. As time went on the list of items that required replacement grew ever longer.

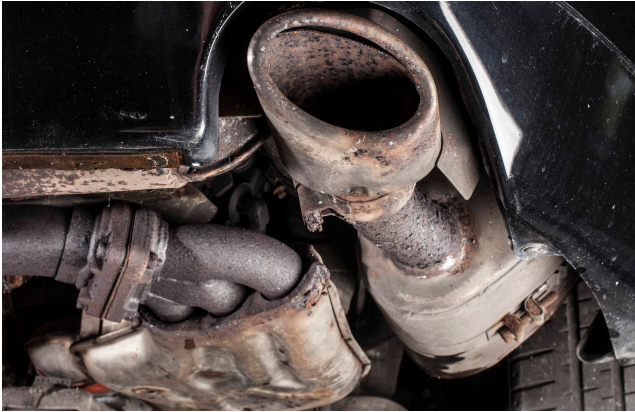
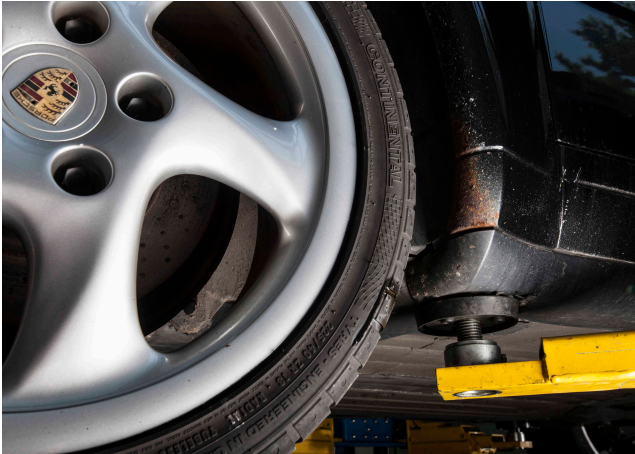
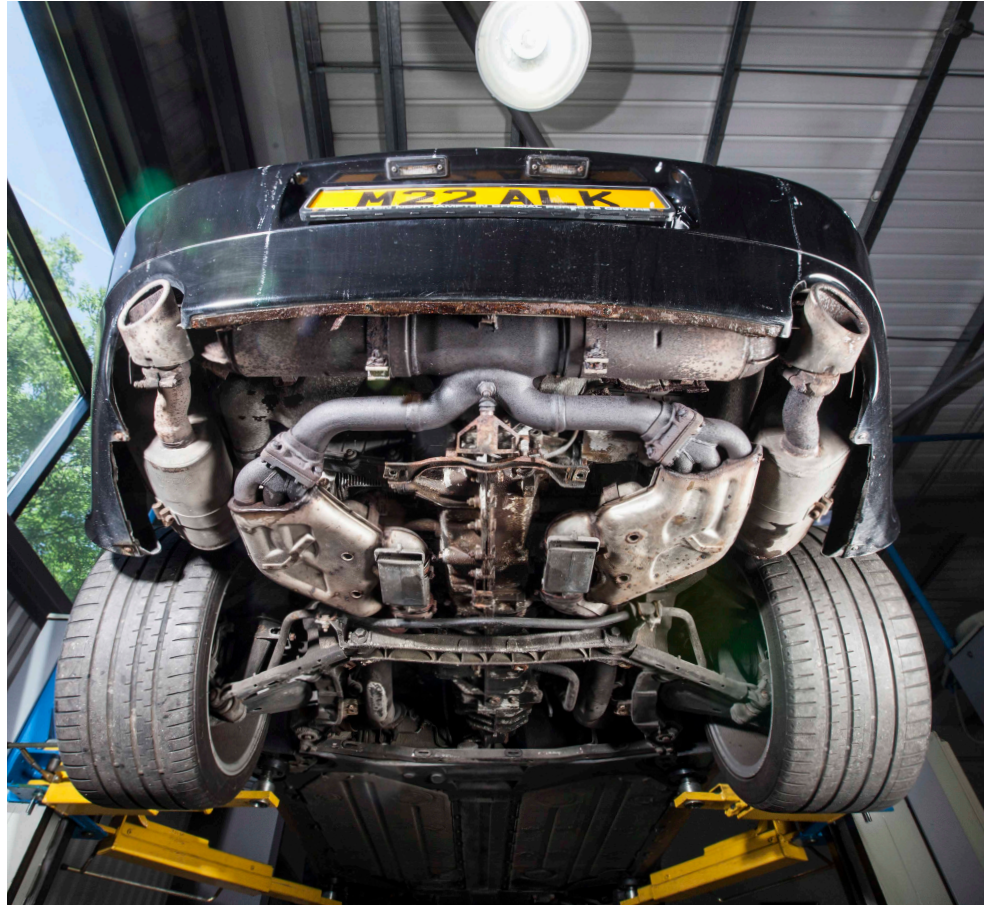
**Clockwise from left:** Exhaust heat shield missing, tired looking undeneath, corrosion on front wings

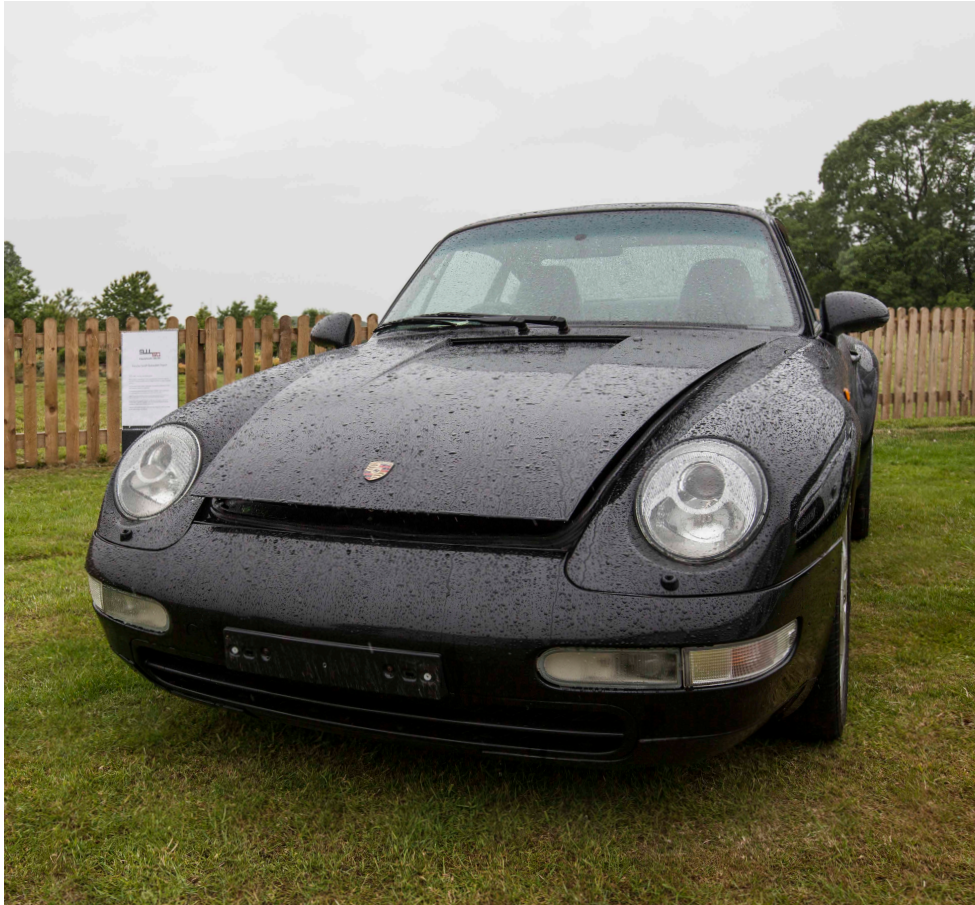
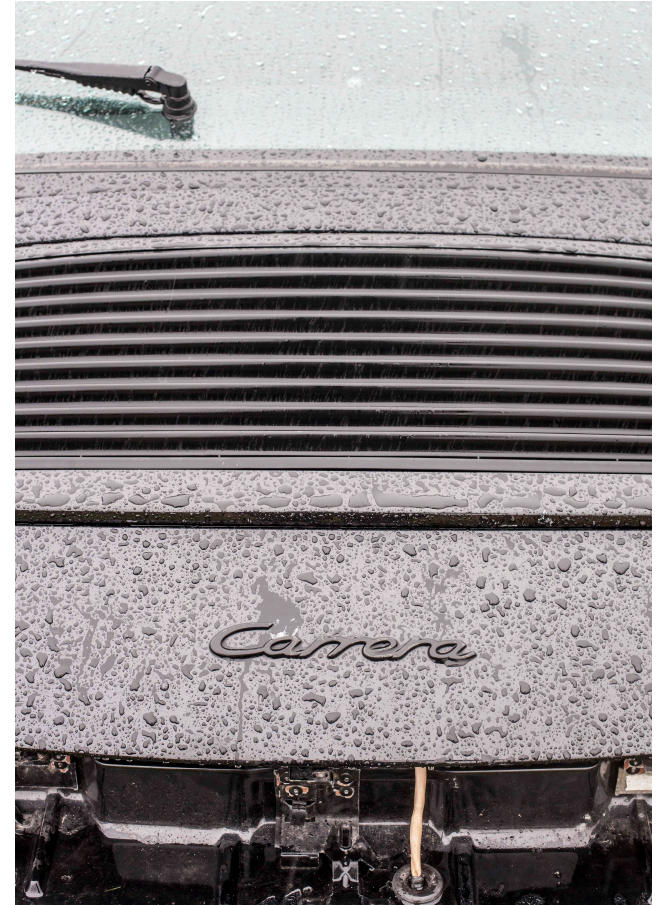
### June 10th - Engine Removal

Upon removal of the engine and gearbox it became apparent that all existing tin work around the engine had corroded. After so many years of sitting idle the exhaust fittings had corroded to almost nothing.

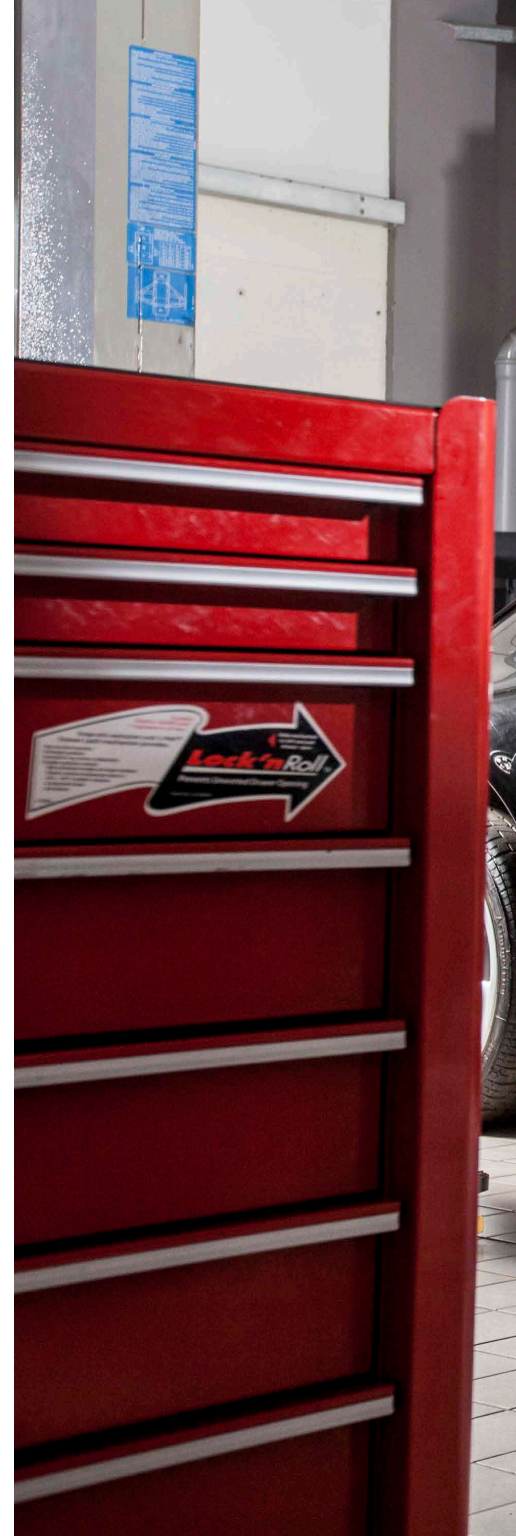
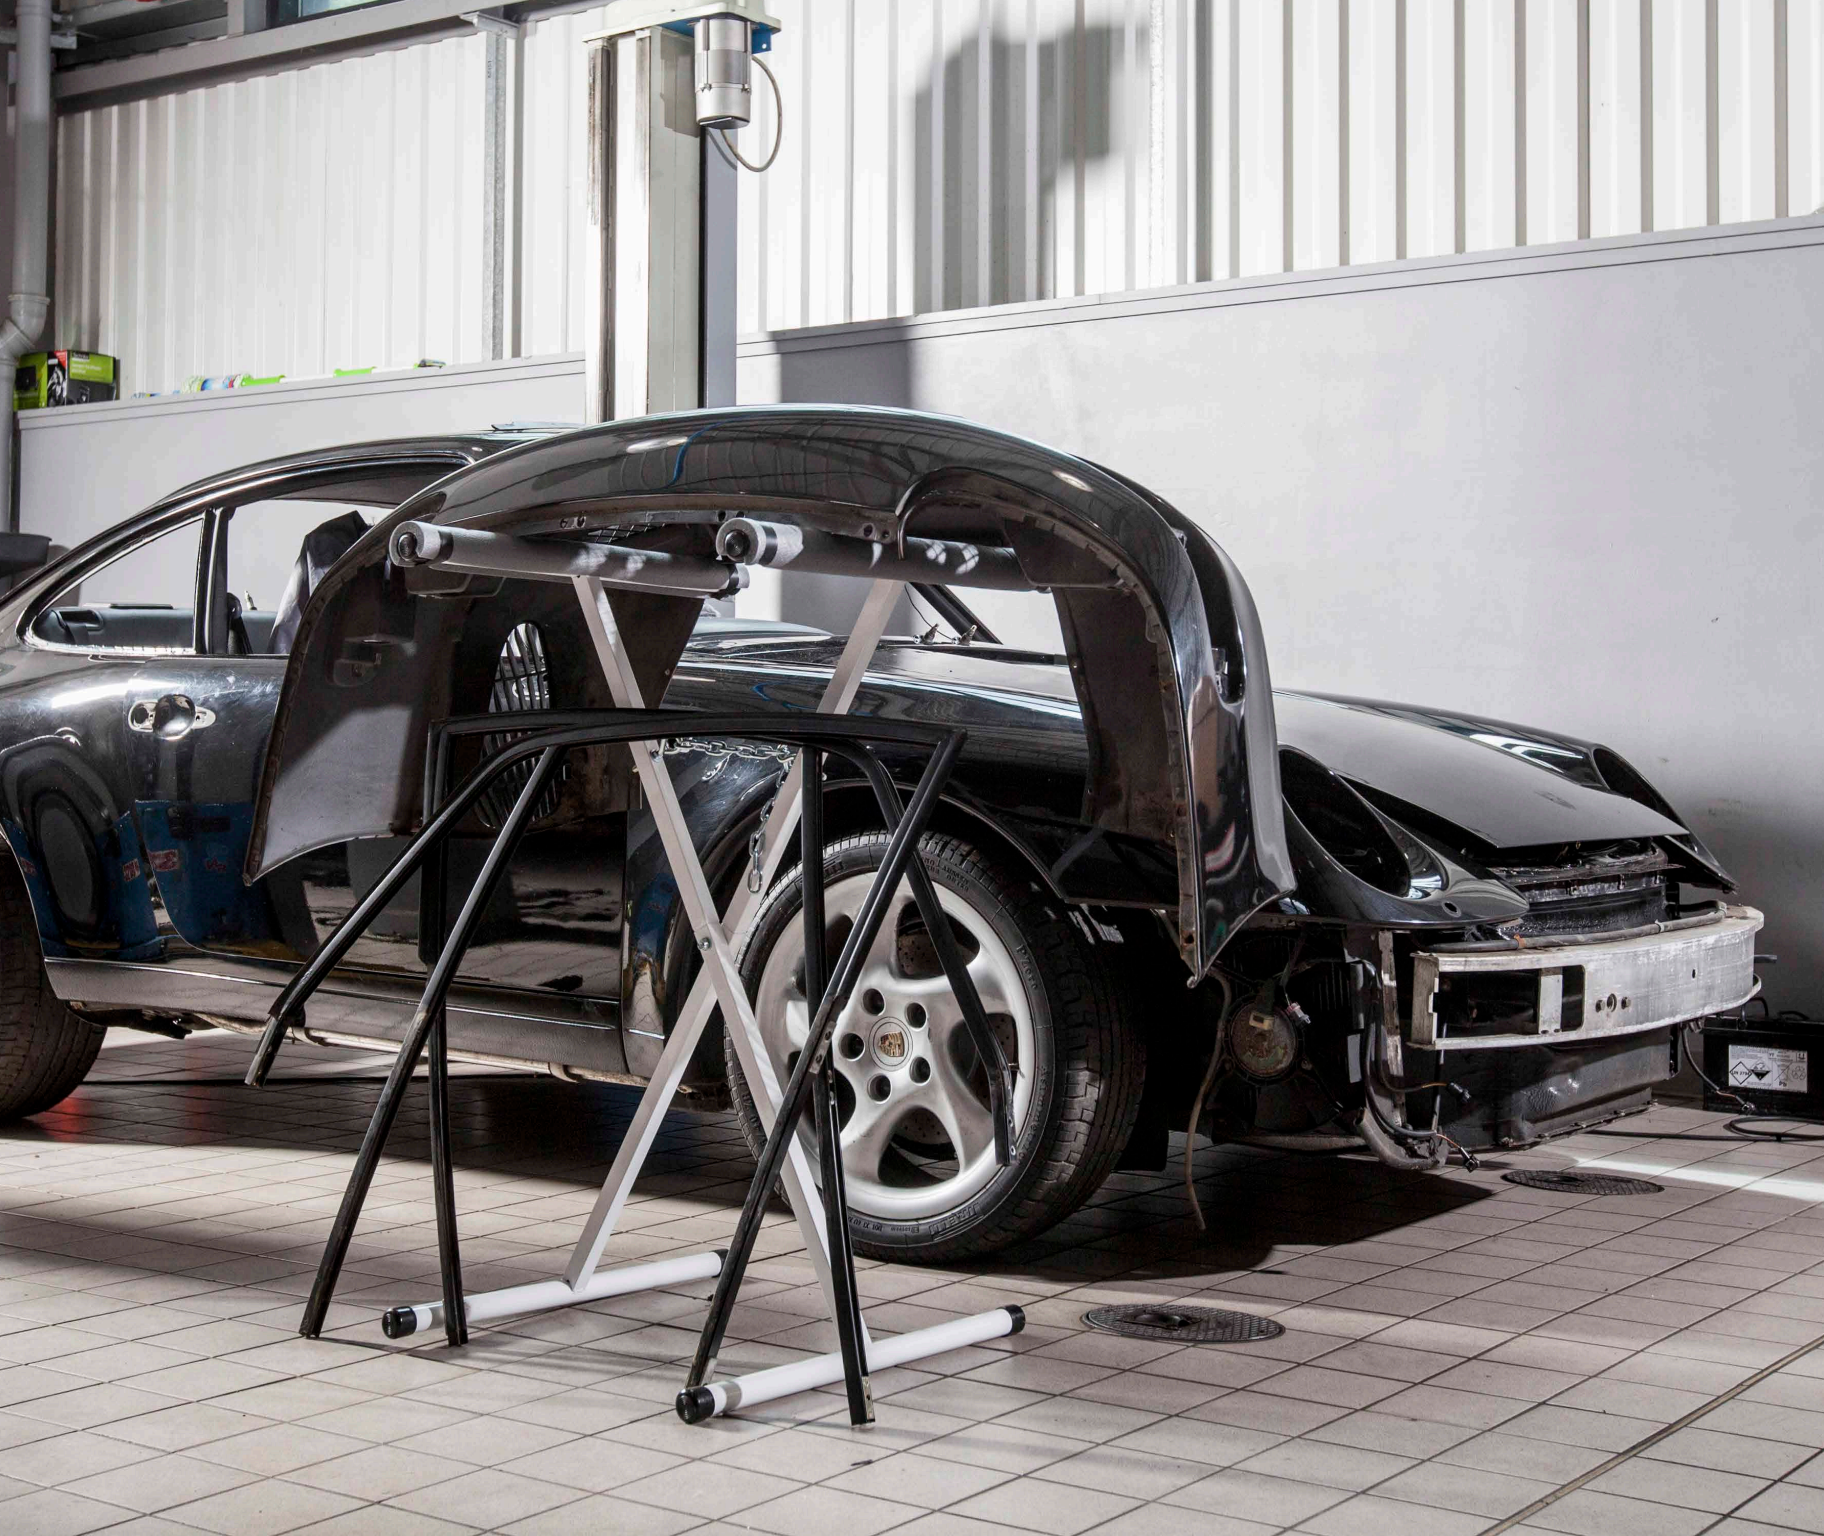
### June 22nd - Strip Down

Back to the workshop, the big strip. Windscreens are removed not one piece of trim was permitted to stay on the 993 looking rather disheveled Motorvation arrived with their transporter to take our project away.

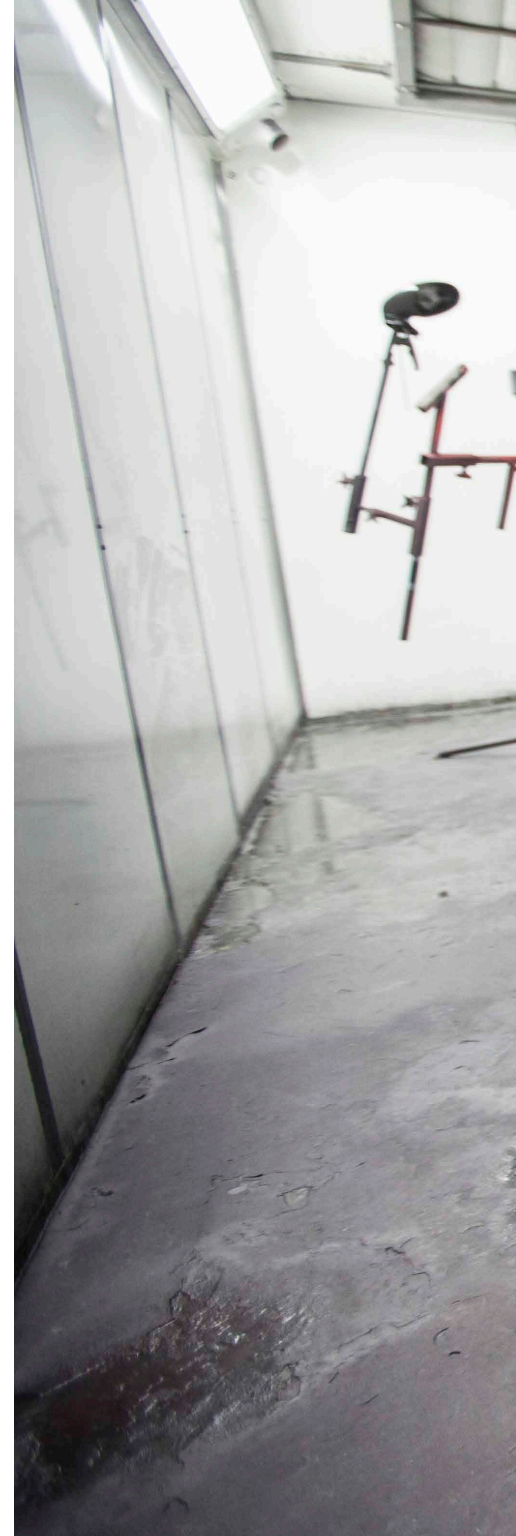
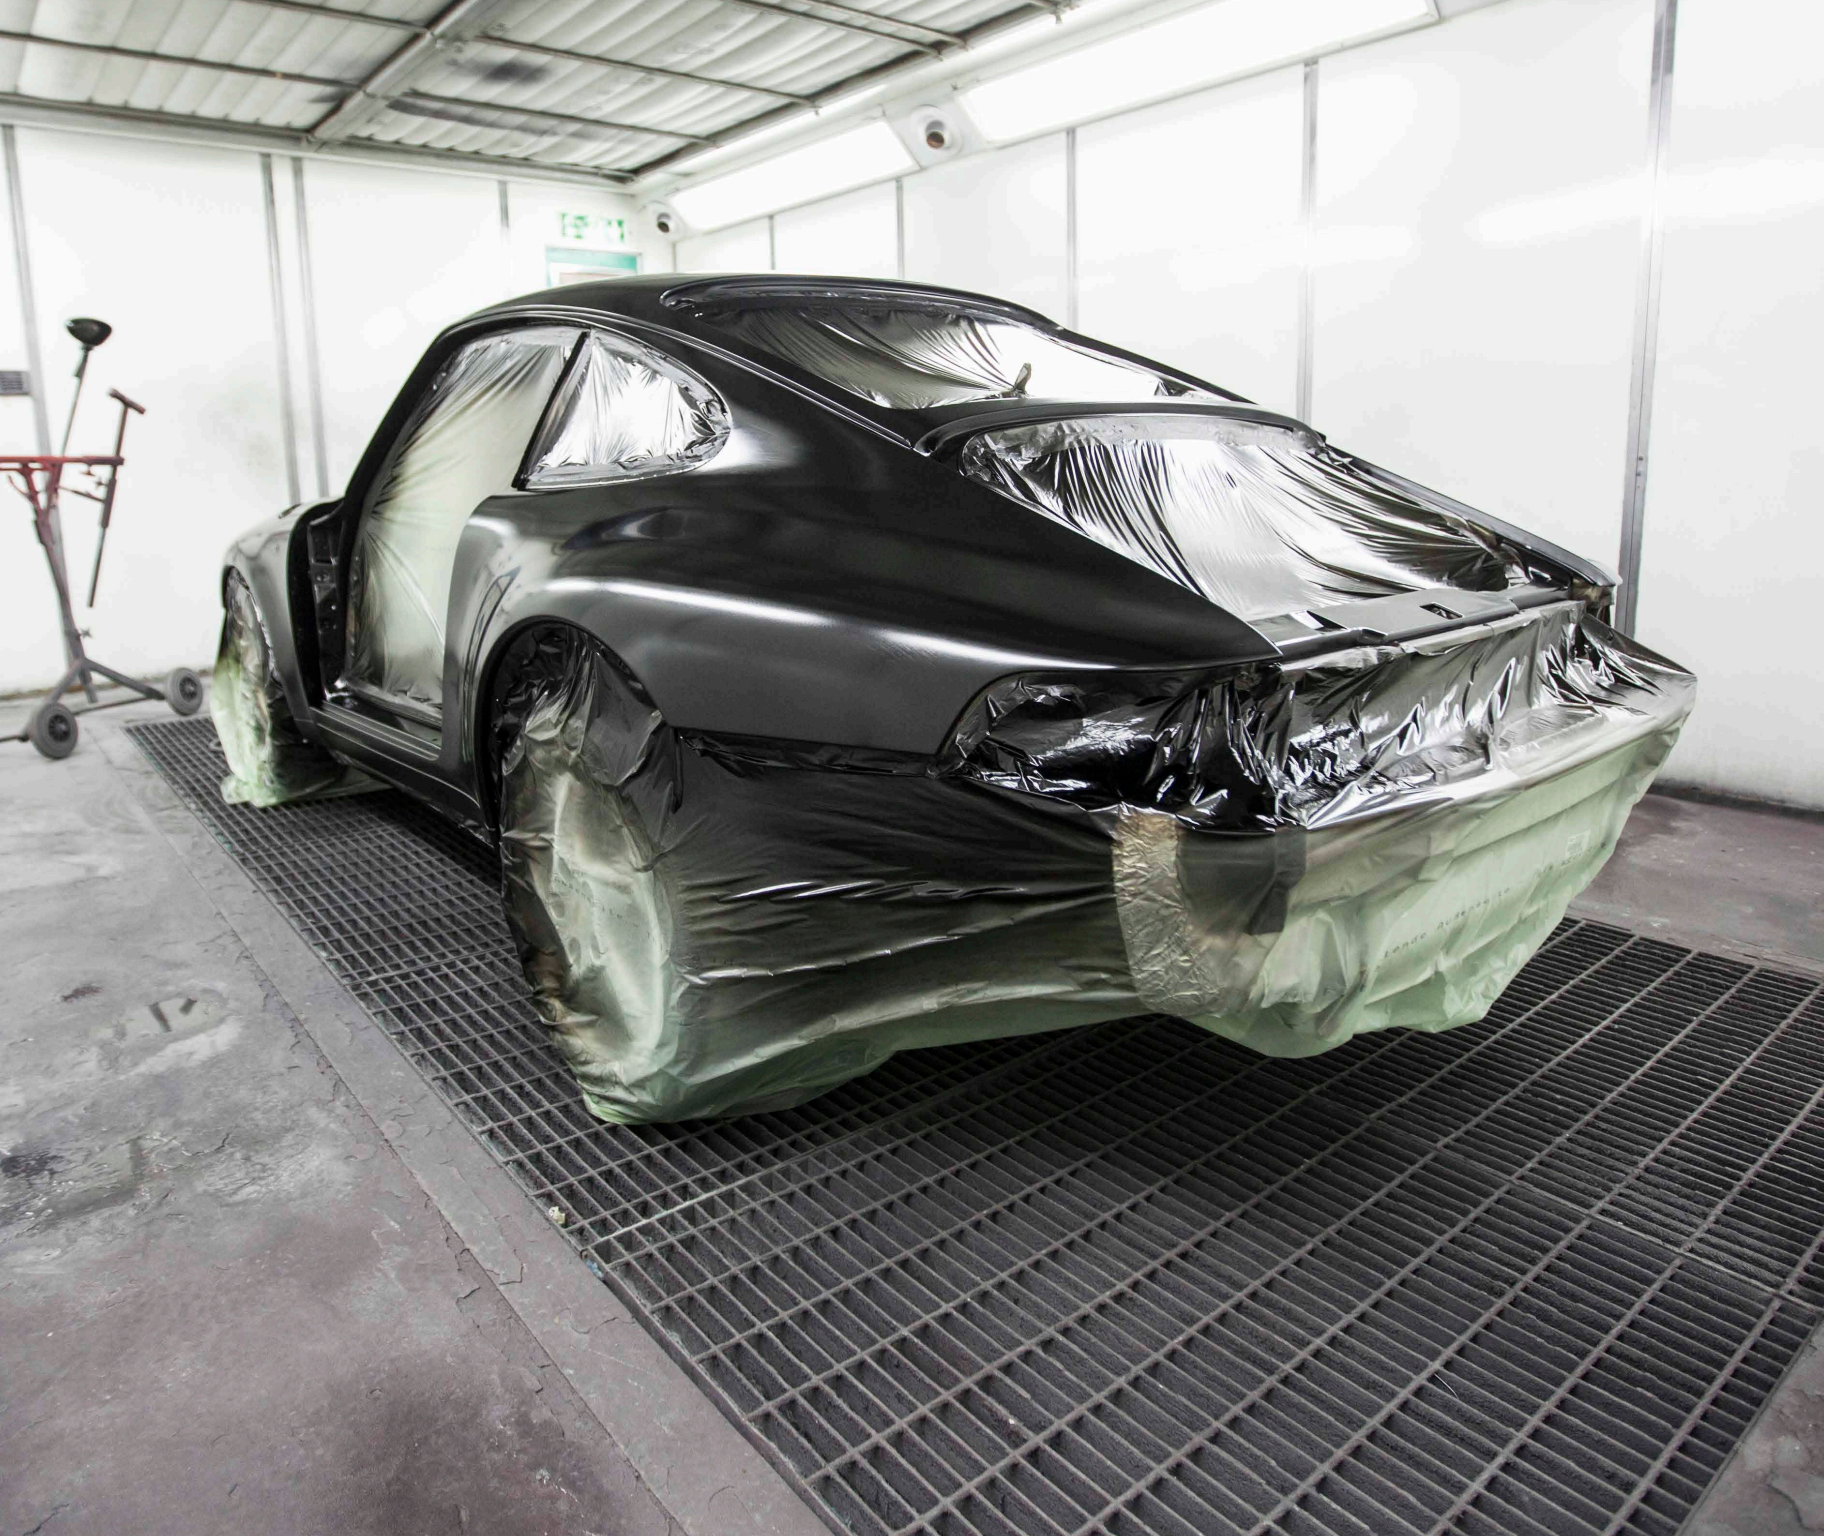
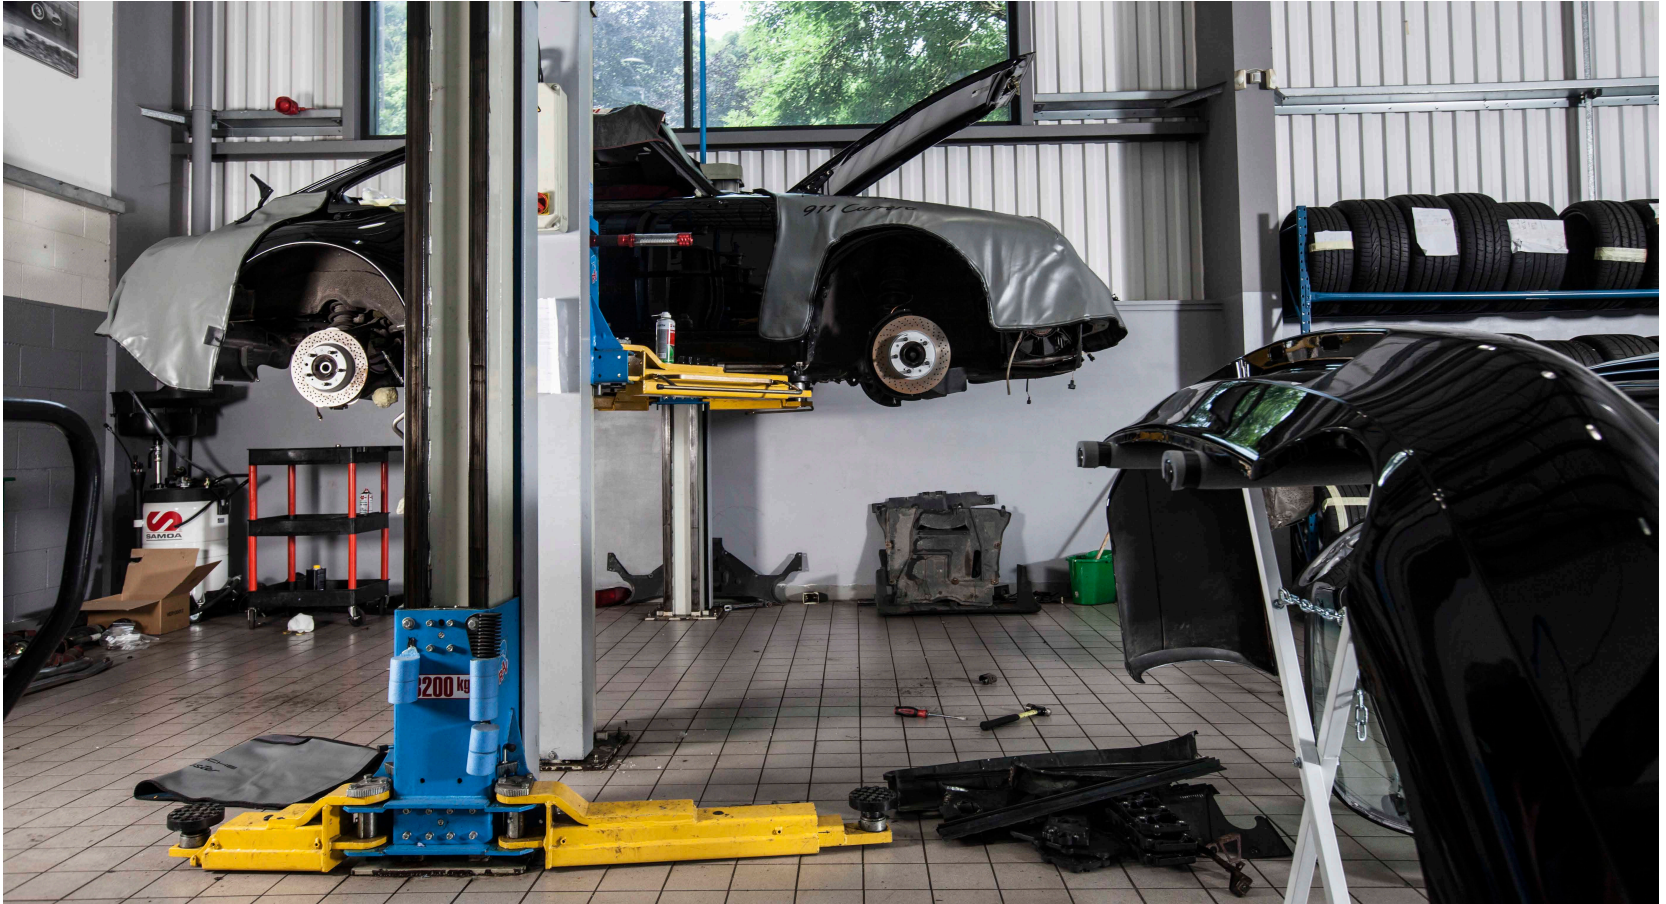
### July 8th - Respray

Julian Allen at Motorvation starts to undertake the massive task of bring this once stunning car back to its original condition. Removal of the doors, bumpers, engine cover and sunroof. Preparation was as ever with Julian meticulous to the last detail. Layer upon layer of glossy black paint was applied to give an absolutely stunning mirror black finish a full body paint was the only way to guarantee a finish that Julian was going to be happy with and one that our 993 deserved.

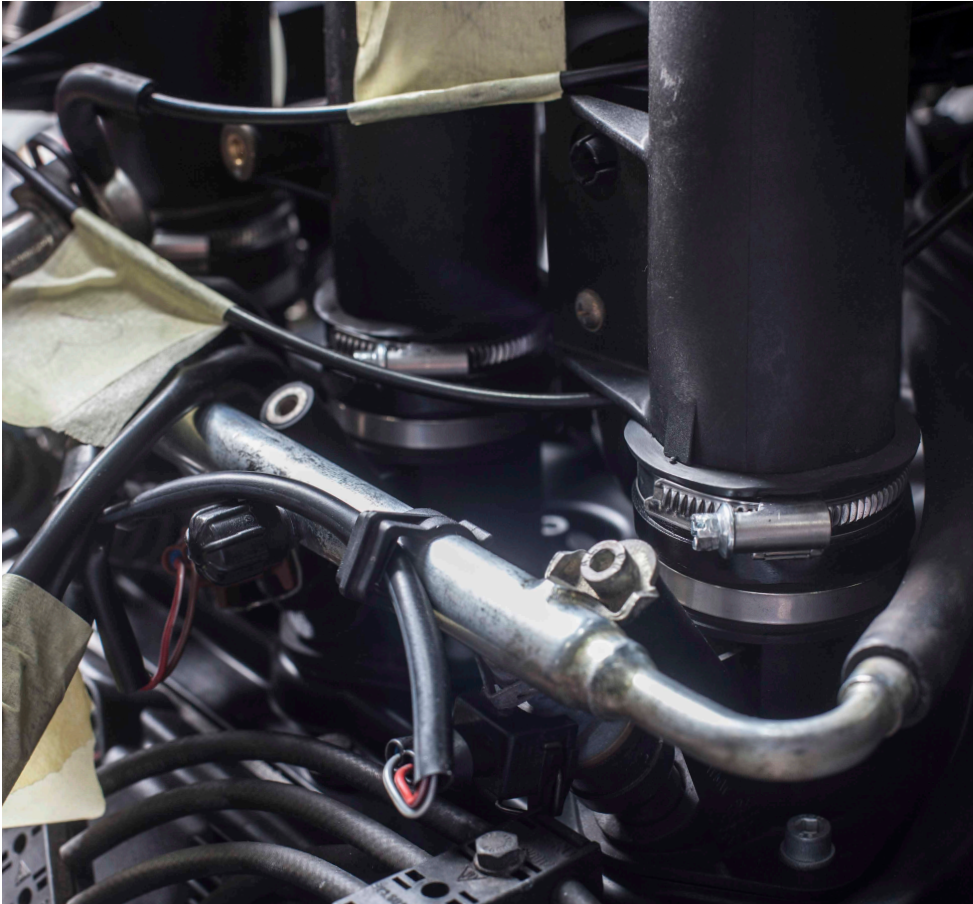
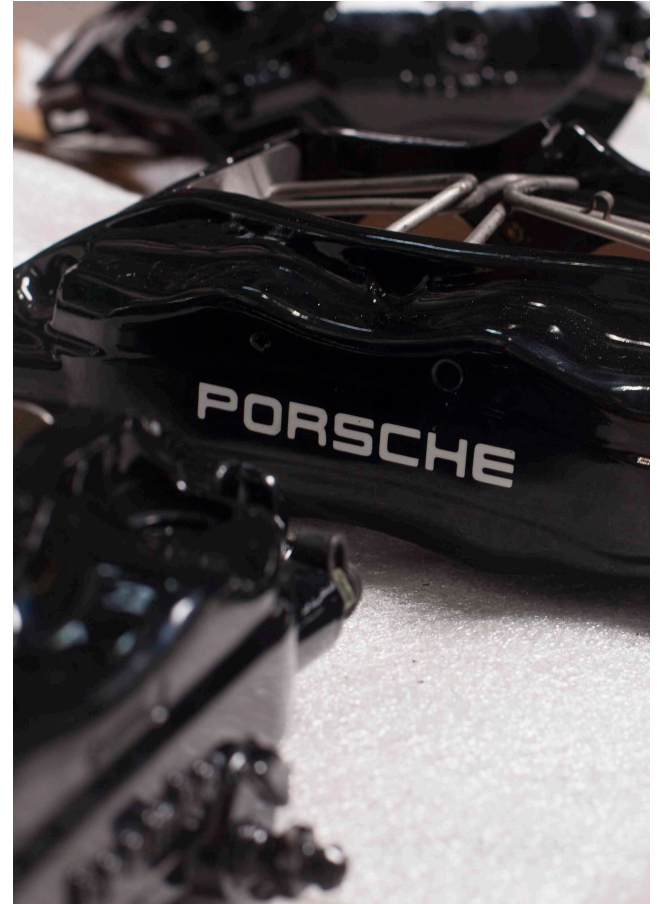
### July 15th - Rebuild

Our 993 returns...greeted back into the workshop ready for the refit. Brake calipers arrived from being rebuilt and coated. Many hours are spent rebuilding polishing and fettling.

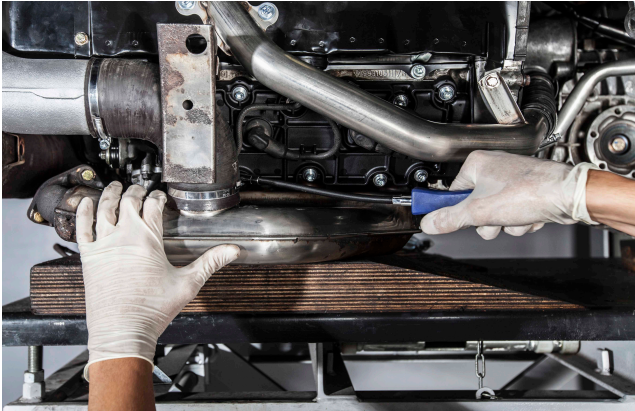
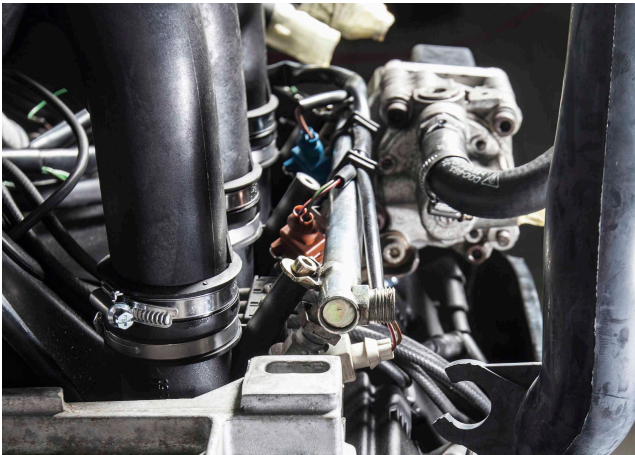
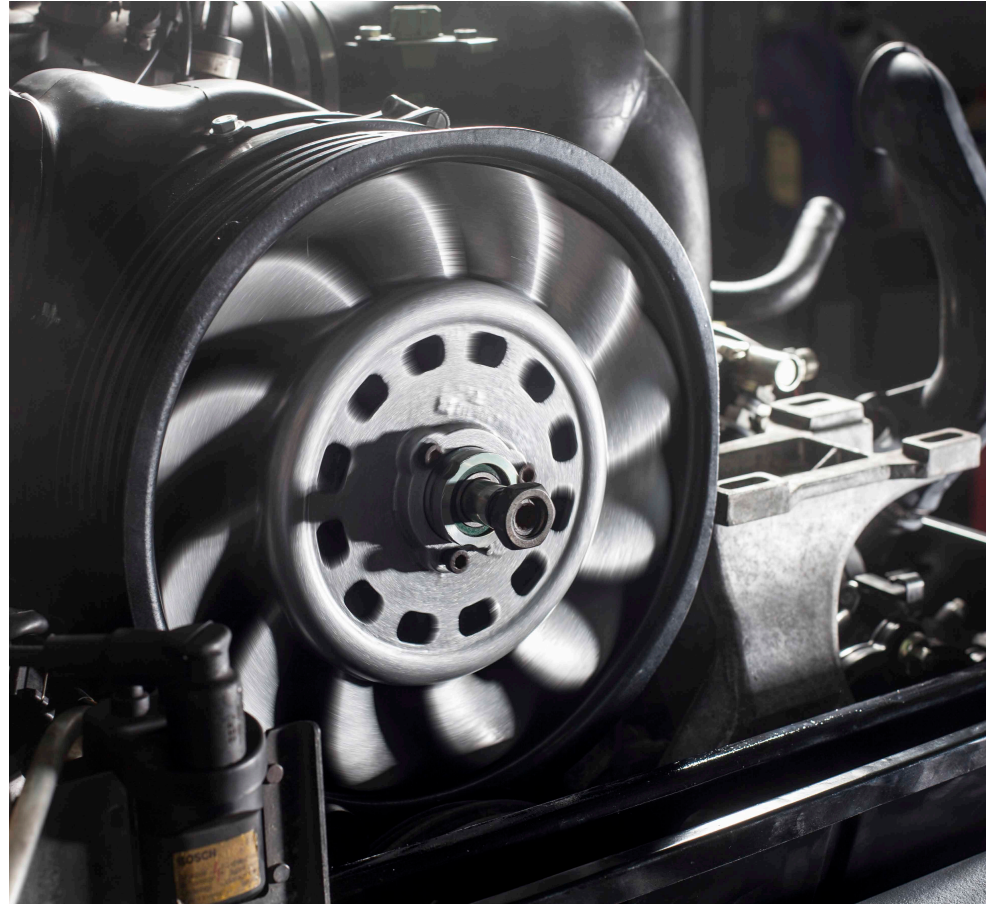
We return to the engine bay, with all air cooled 911's the first thing to appear when lifting the engine lid is a cooling fan and housing, this was removed and sent for a specialist coating. All timing and valve covers were replaced and fitted with new polished fixings the effect is stunning! Of course, when you start replacing new for old, other parts start to look dated. So again a decision was made to replace all fixings in the engine bay, for aesthetic purposes only.

***Clockwise from left:*** Replacing old bolts with new, freshly coated fan, cleaned up fuel rail and new fixings

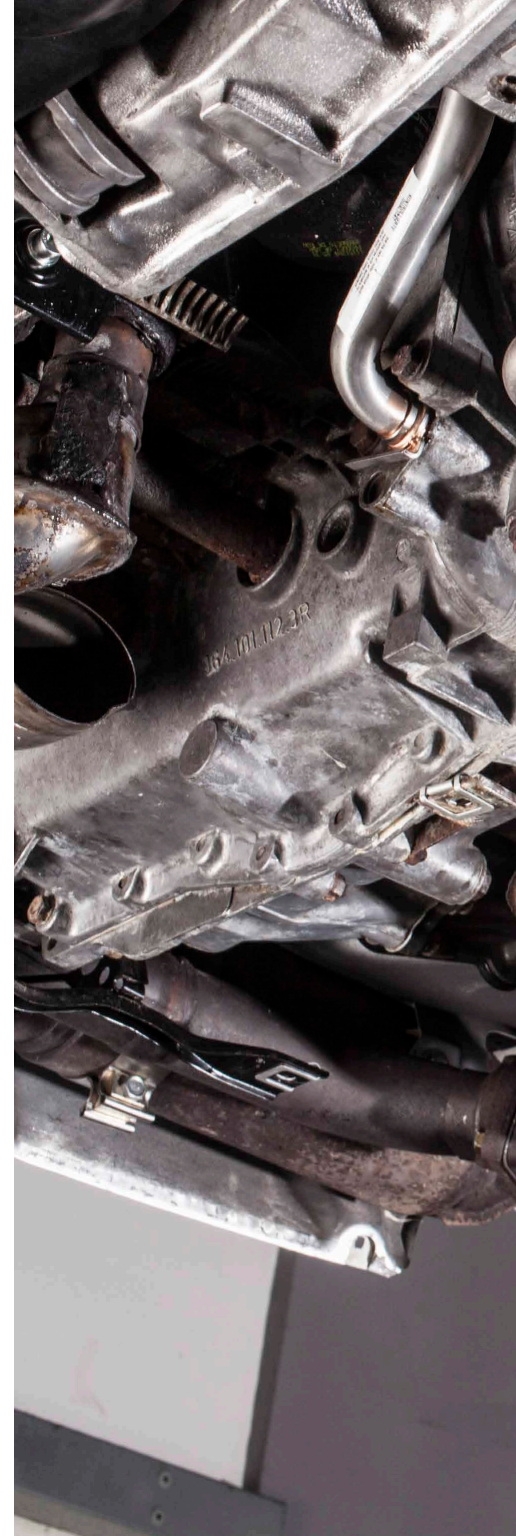
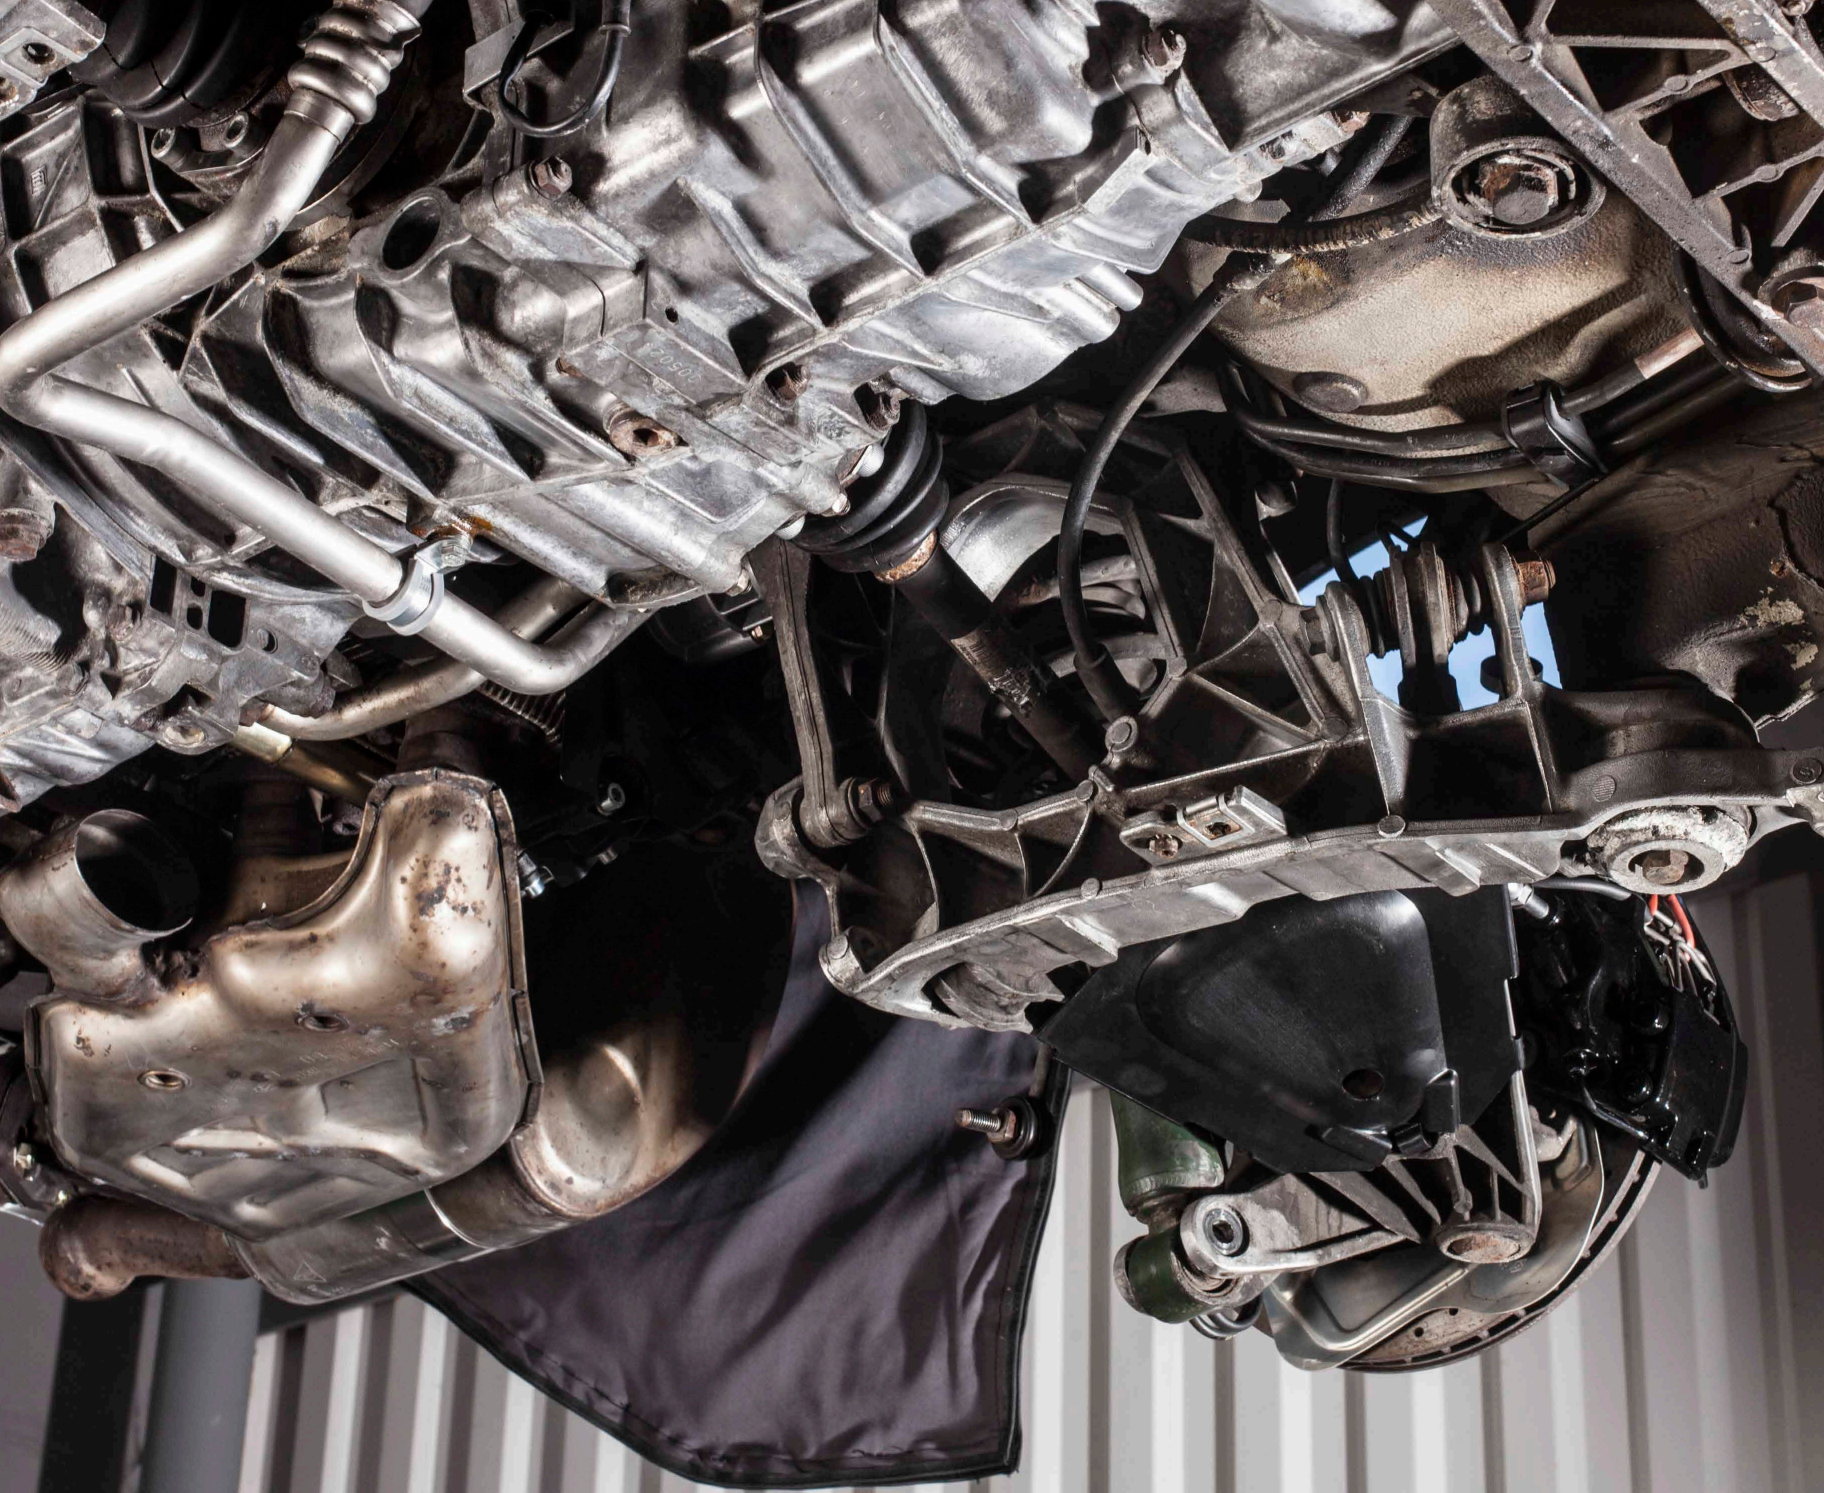
### August 2nd - First Start

After countless amounts of hours our 993 breathes, an unmistakable burble of that glorious 3.6 litre flat six. From every angle our air cooled transformation is taking shape with some momentum. Wheels are refurbished, undertrays and arch trims are refitted again anything that like its showing its age is replaced.
