SealXpert Products

Leak Repair Application Note 2

Pipe Material: Carbon Steel Pipe SCH40
Pipe Medium: Natural Gas
Pipe Size: 10"
Pipe Pressure: 150 psig
Temperature: 30°C
Leak Location: Straight and Tee-junction

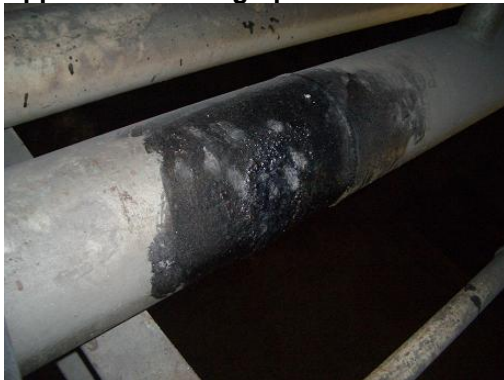
Severe corrosion and leaks on pipe surface

Seal Stic™ steel epoxy was first applied onto the pipe to seal off major pipe leak locations. Thereafter Wrap Seal PLUS™ standard resin and activator is applied onto the pipe surface to stop corrosion and seal off pinhole leaks. Wrap Seal™ fiberglass tape was then applied onto the pipe surface to reinforce the repaired location.

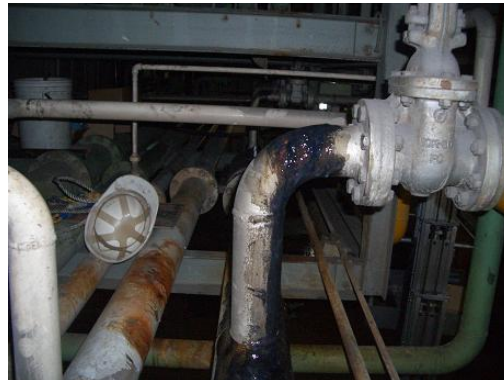
Severe corrosion and leaks on pipe elbow

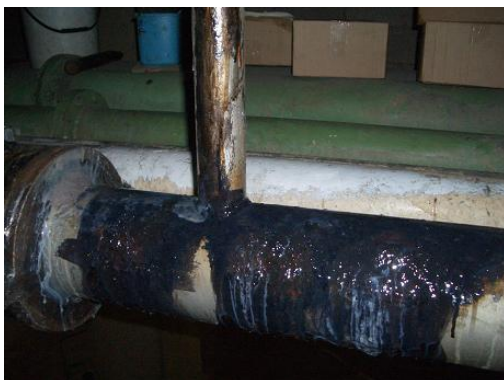
Applying pipe wrap Seal PLUSresin & activator

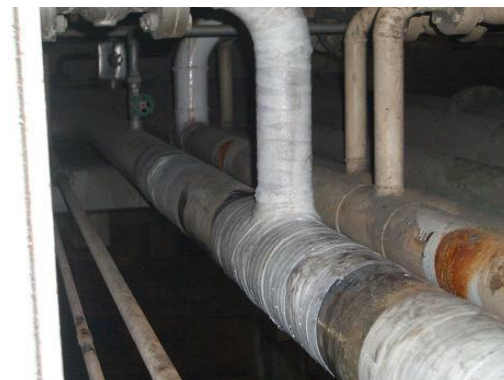
Applying Wrap Seal™ fiberglass tapes
