INTRODUCTION

Engines need regular interval overhaul. All units of main engine and auxiliary engines needed to be overhauled while the vessel in Tuzla/Anchorage Area, Tuzla/Gemsan Dry Dock & Tuzla/Türkter Shipyard. Regarding to schedule, the added value of Teknomarin's expert diesel repair capabilities were put to the test.

SULZER RND 90 MAIN ENGINE OVERHAUL

Engine Room had some additional works to be done. Alternator rewinding, turbochargers overhauls, governors overhauls, daeration tank fabricating, cooling sea water pump, fuel oil burning pump, hydrophore pump and some other kinds of pumps overhauls, exhaust isolation jobs, inspection & recondition jobs and many others things to be done means that there is an *“engine room complete overhaul”* we can call it. This report includes all jobs to be done in M/V Almawashi.

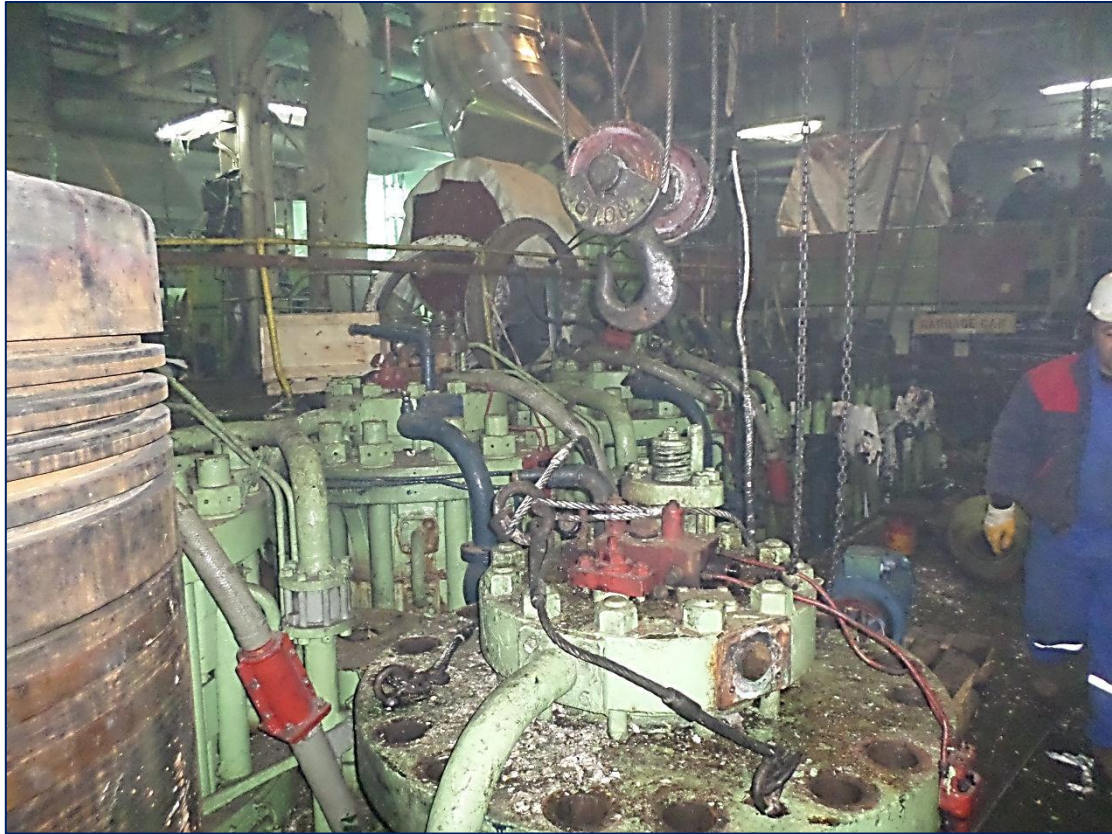
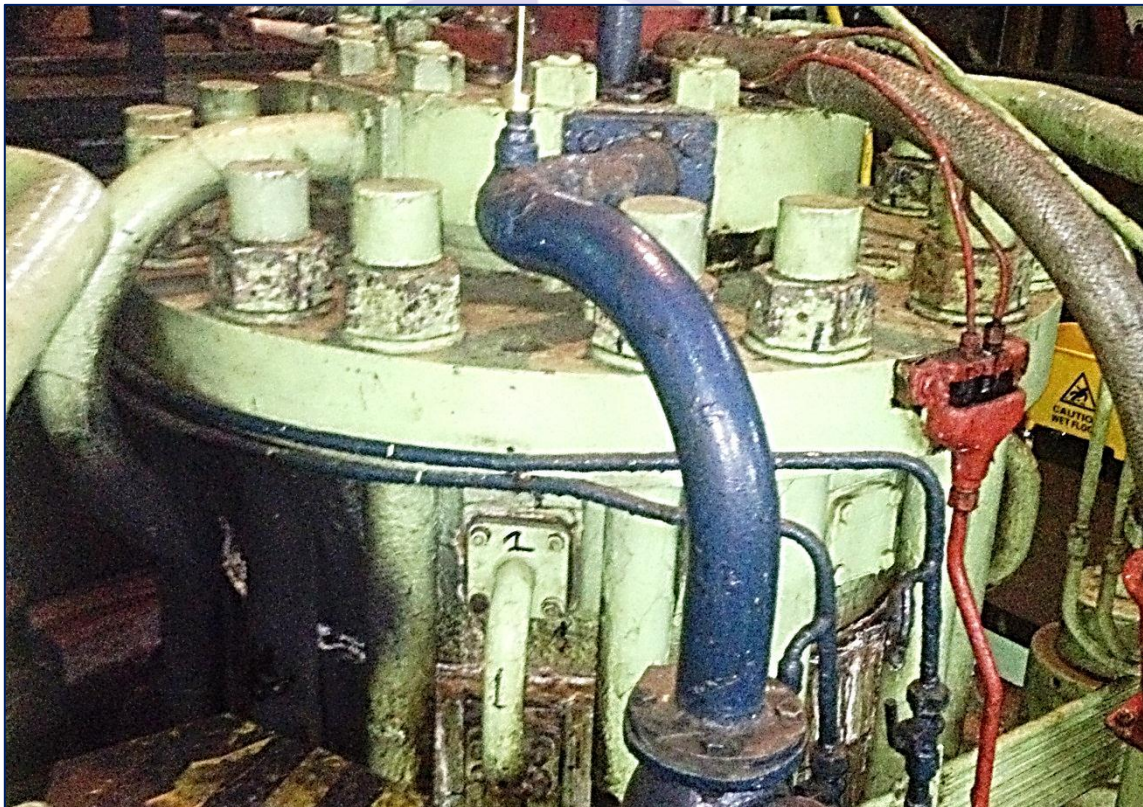
All cylinder heads dismantled and inspected on stu. Two of them transferred to the TEKNOMARIN's workshop cause of the condition themselves. All safety valves, starting valves and Indicator valves overhauled and tested. Indicator cocks overhauled and tested. Cylinder covers water side cleaned by chemically and hydrostatic pressure tested. Cylinder heads mounted on stu.

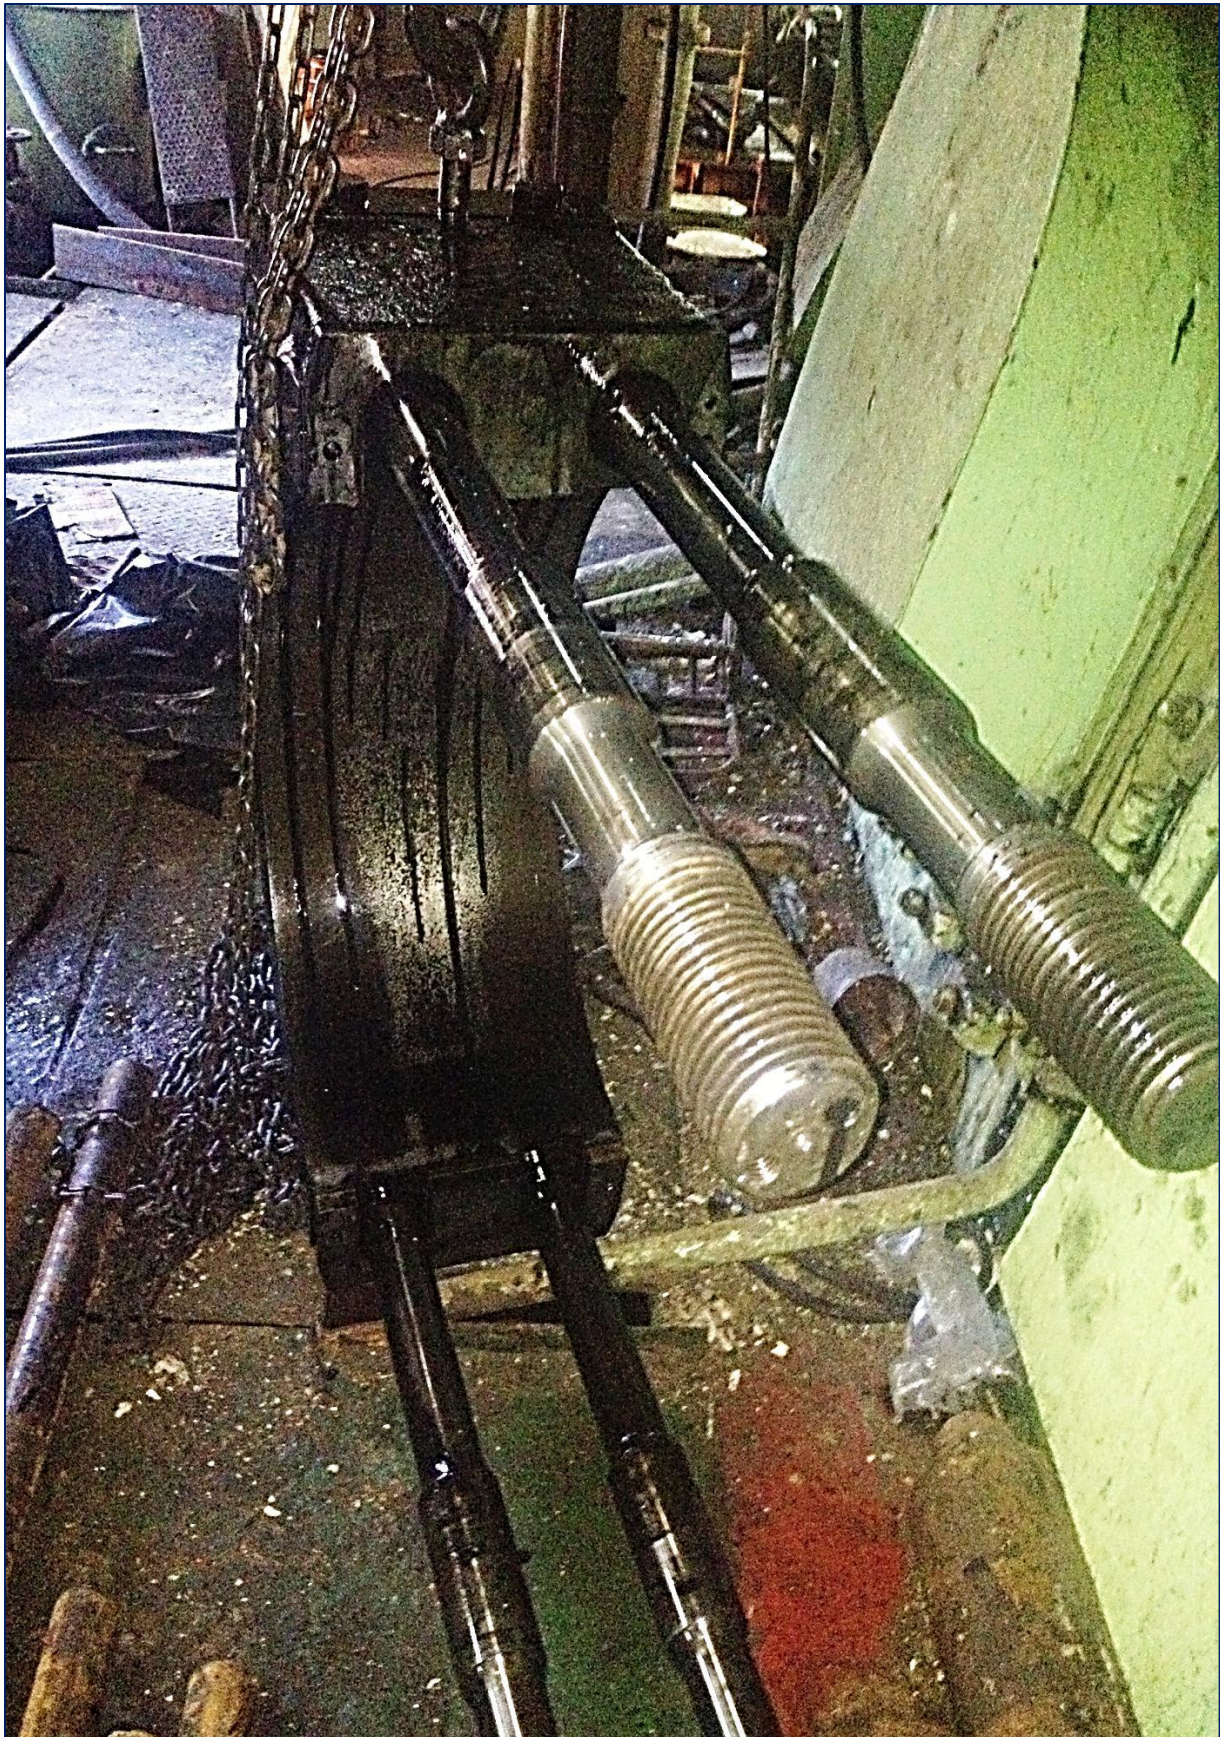
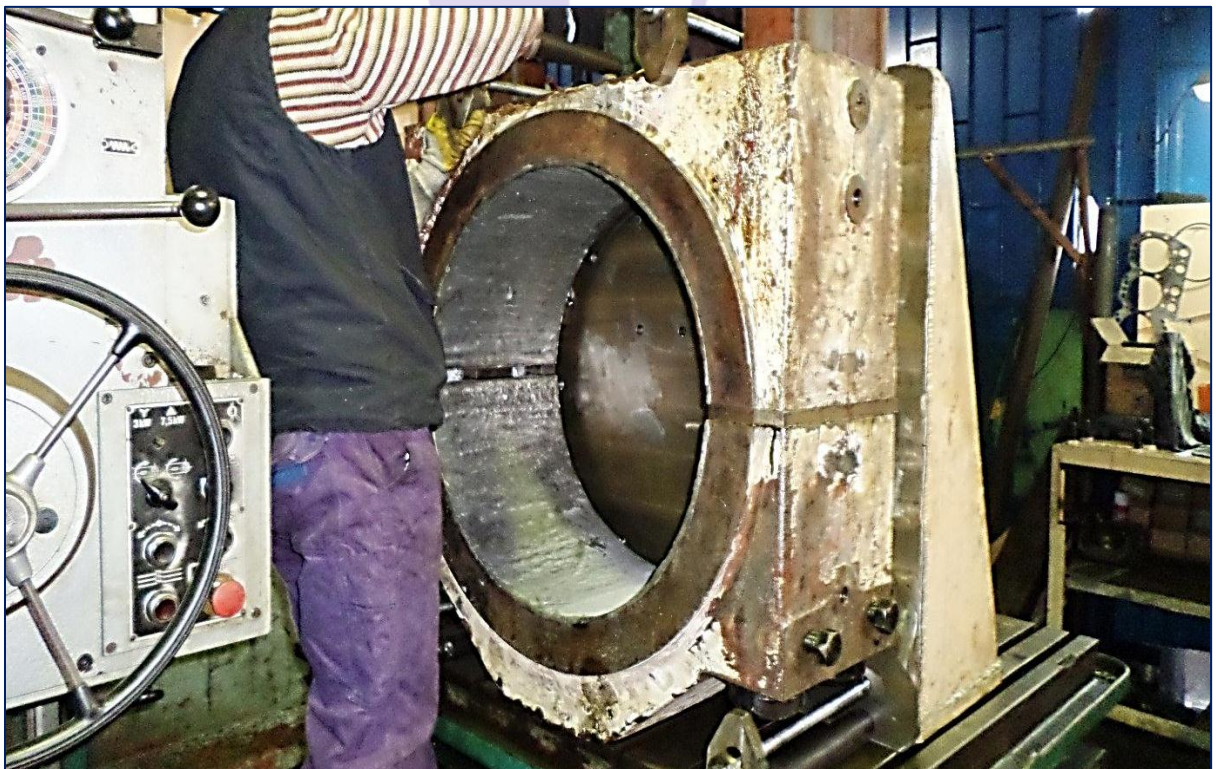
All piston bolts dismounted. All pistons disassembled. All con.rod bearings and main bearings has opened & inspected. Some of big end bearing spotted as damaged toughly. Damaged big end bearings dismounted & transferred to the workshop. Bearing cap housing ovality controlled. Piston ring groove clearence controlled. Connectin Rods bush bearings controlled. After recondition its transferred to the vessel and mounted immediately. Meanwhile security lock for big end bearing studs manufactured and supplied to the vessel. Mounted on stu.

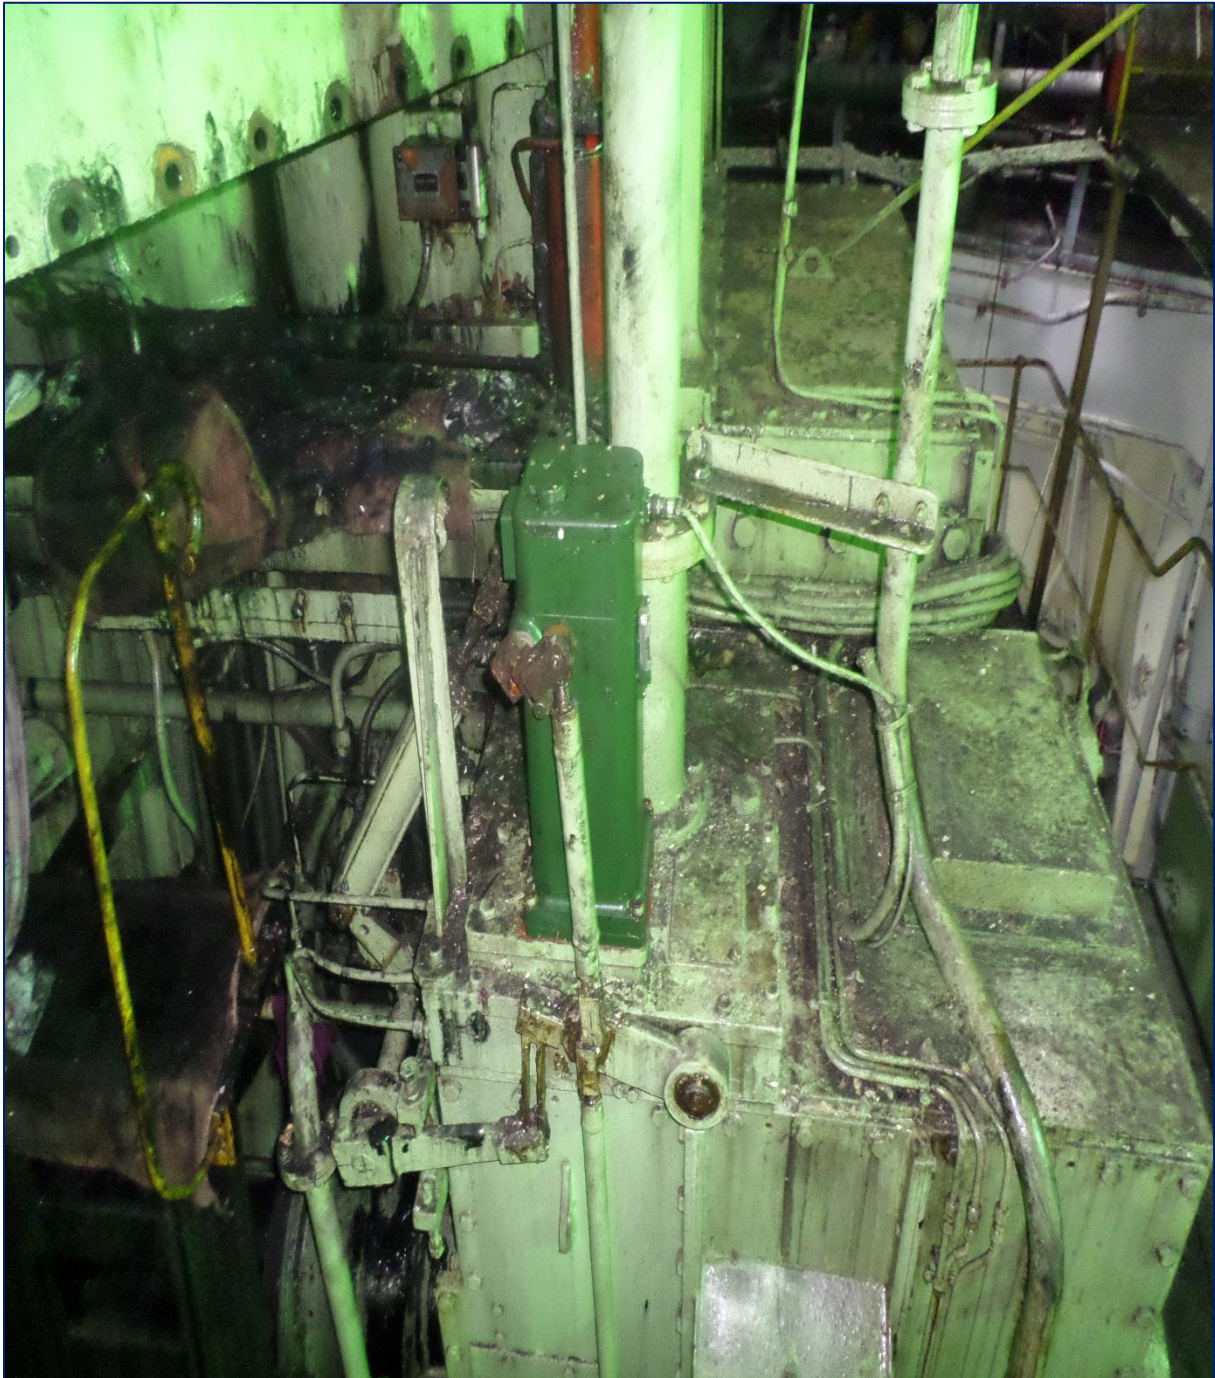
MAIN ENGINE GOVERNOR OVERHAUL;

Governor has dismounted from the M/E and transferred to the workshop. Later by governor has disassembled and checked as inspection. All clutch, lever & bracket system inspected & tested. Shaft & sleeve assemblies checked. Also governor block, bushings & springs inspected & assembled once again. Transferred to the vessel & mounted on stu.

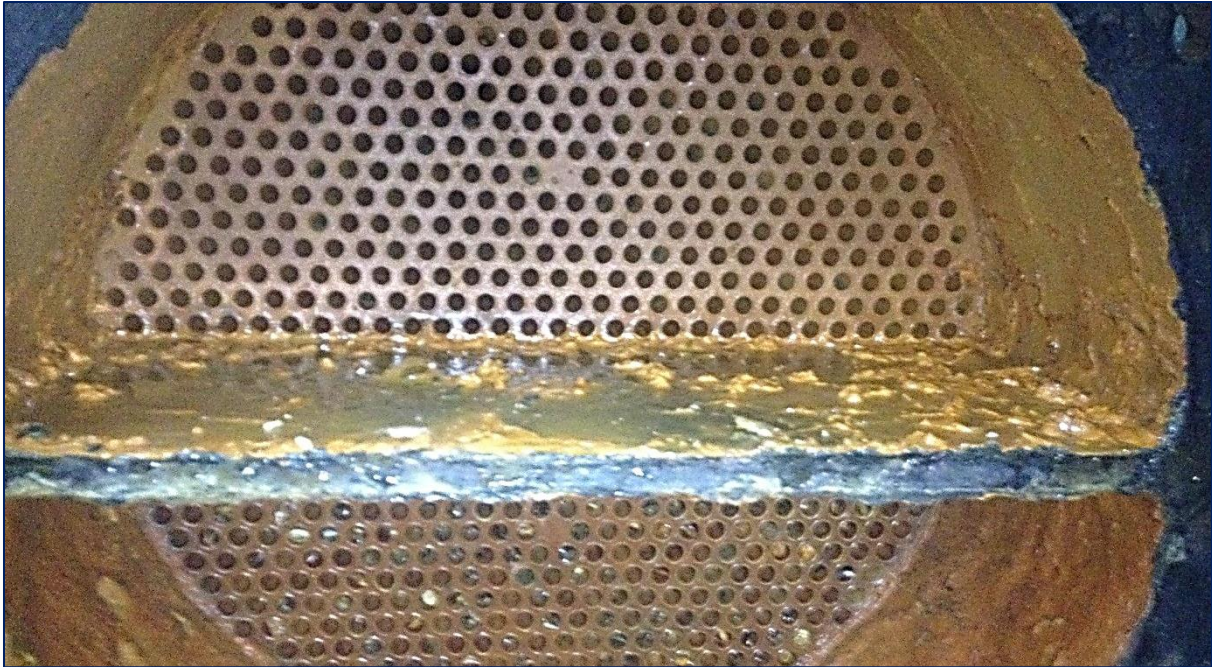
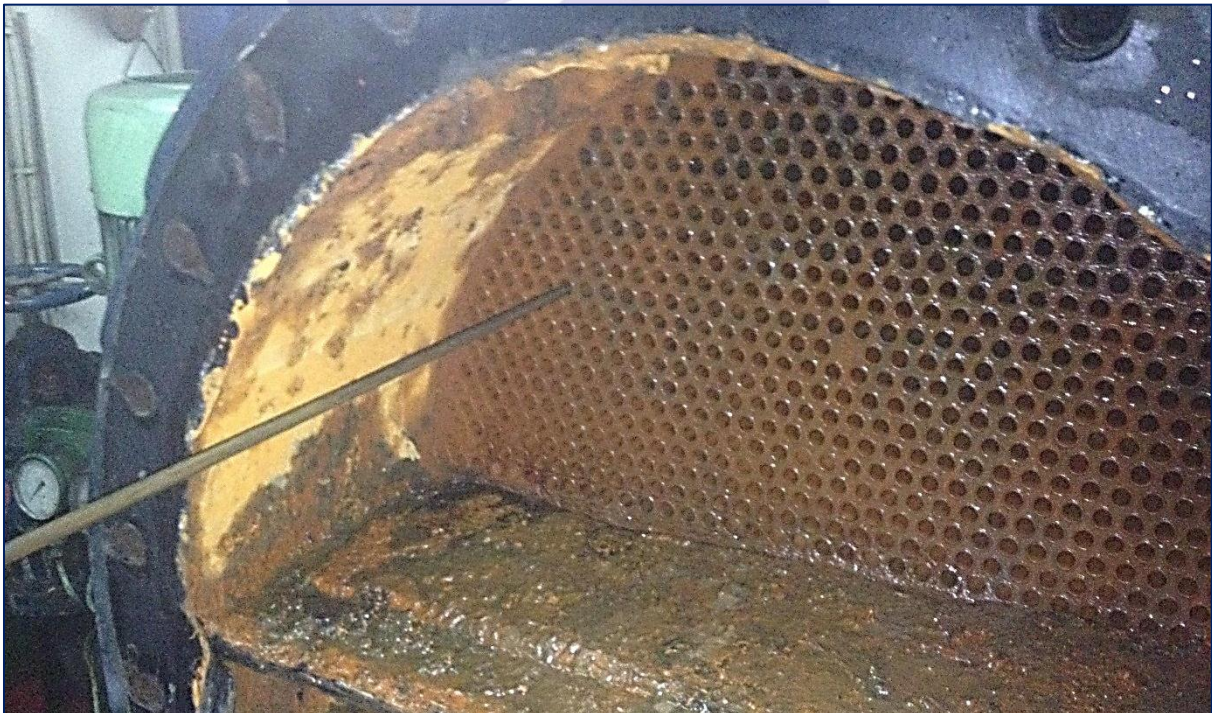
MAIN ENGINE FRESH WATER COOLER COVER RECONDITION;

Regarding to instruction taken from the shif staff, fresh water cooler completely plugged from the cover side. We immediately dismantled the cover, transferred to the workshop. Reconditioned. Later by transferred to the vessel & mounted by ship staff.

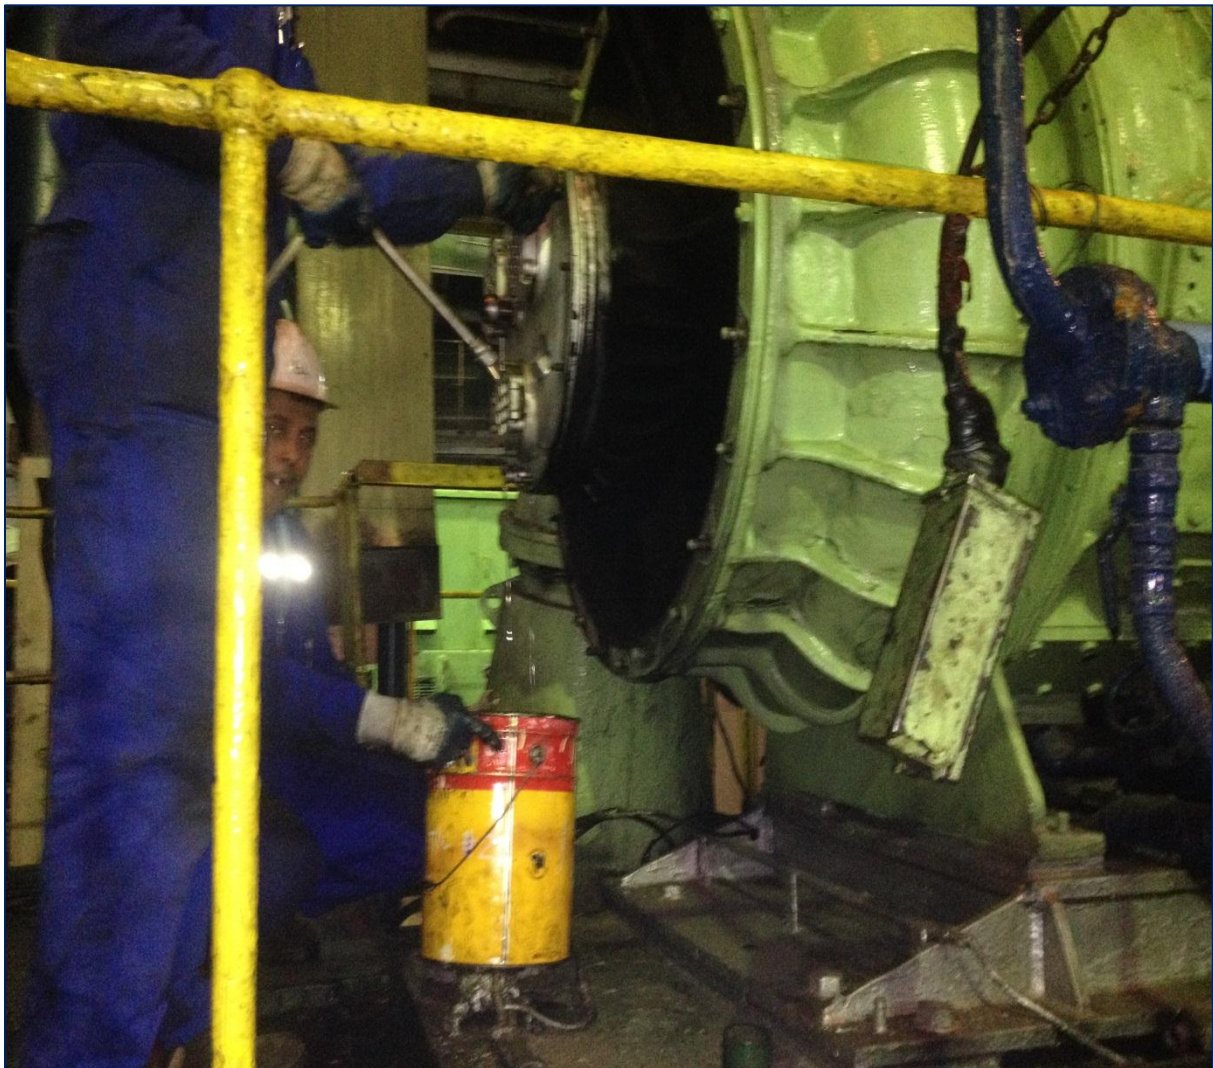
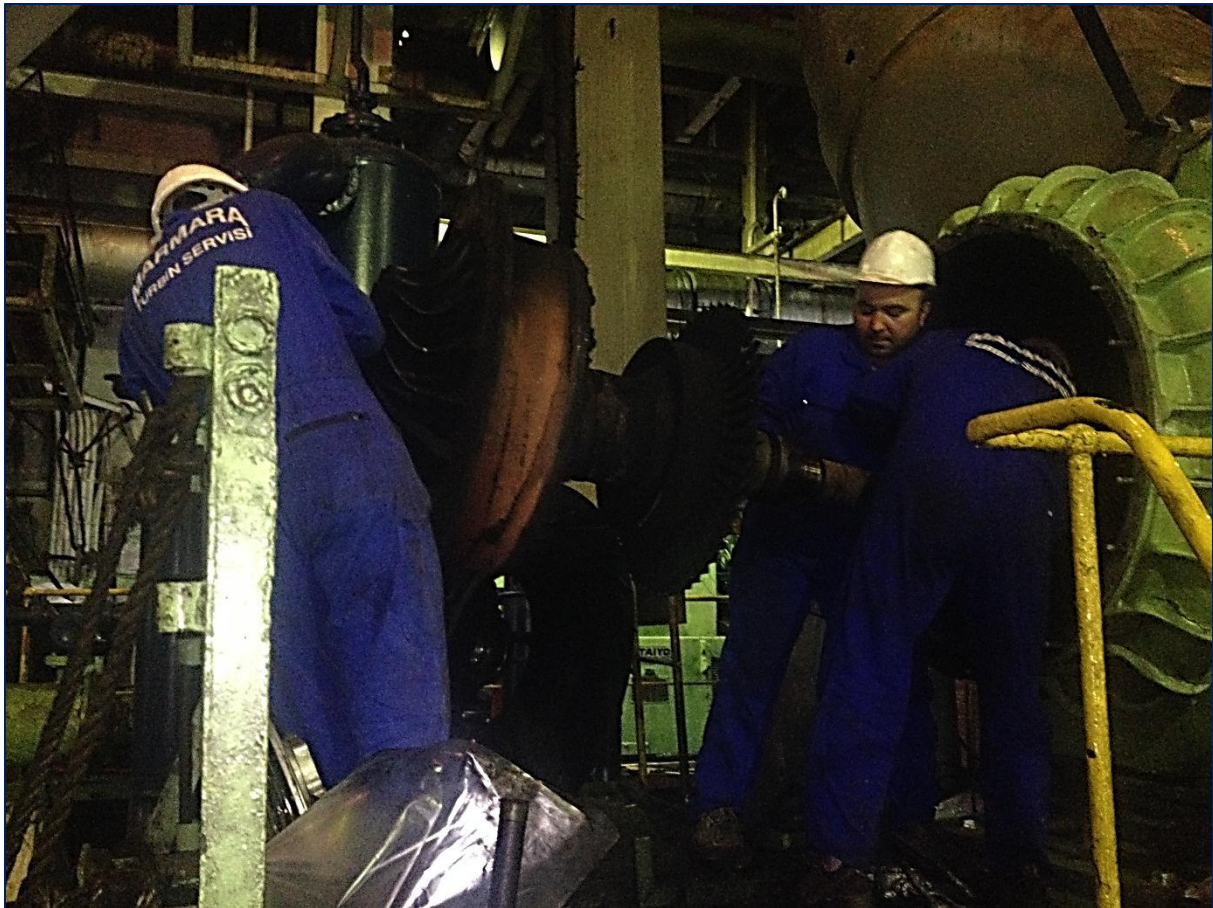
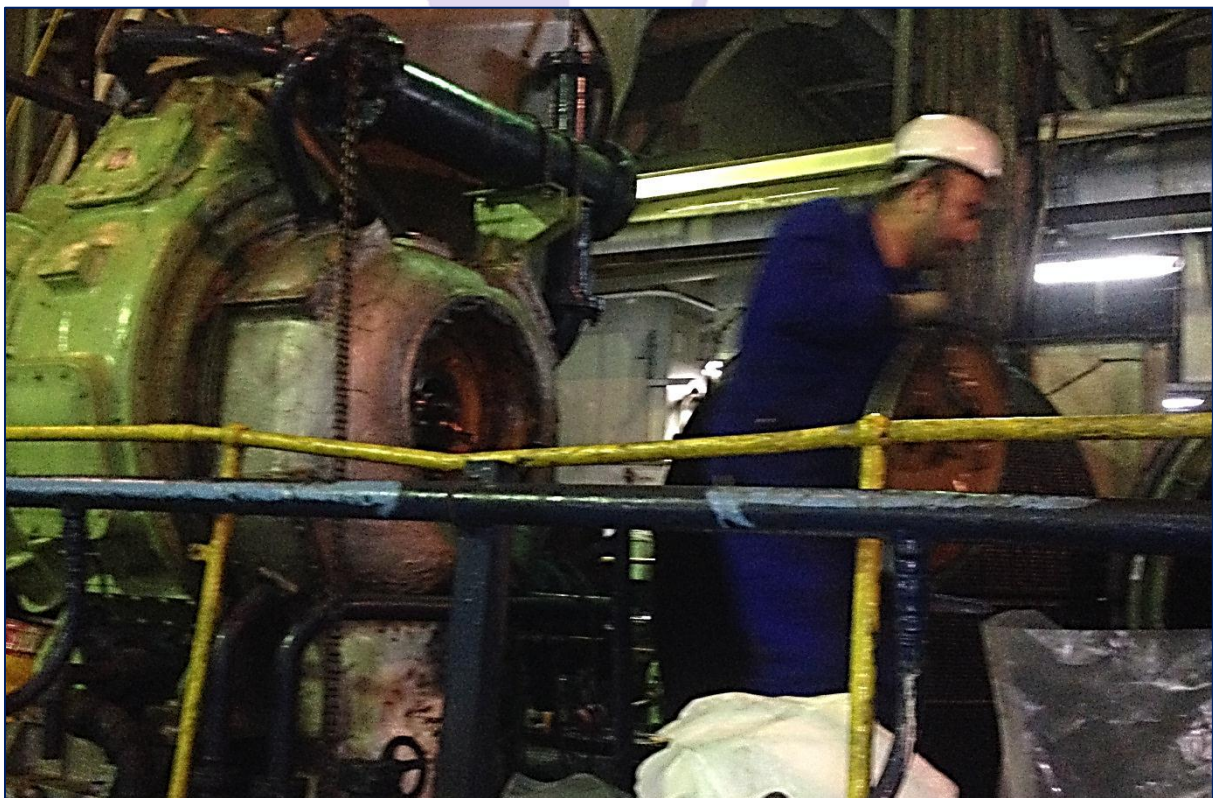
MAIN ENGINE TURBOCHARGERS OVERHAUL;

Turbochargers was dismantled and transferred to the TEKNOMARIN's workshop. The components of the T/Cs to be dismantled according to the manufacturers instructions booklet. It is essential to take measurements and record them prior to the rotor dismantling for axial clearances and radial clearances. Disassembling of all the individual parts such us turbine and compressor wheels, nozzle ring etc. Meticulous cleaning of all the individual parts. Rotor alignment check is to be carried out, before the dynamic balancing. The setting data dimensions of the constructors are utilized for the balancing operation and all readings before and after corrections are recorded. The assembling. Following the assembly, according to makers instructions, all readings are taken and recorded. Mounted on stu.

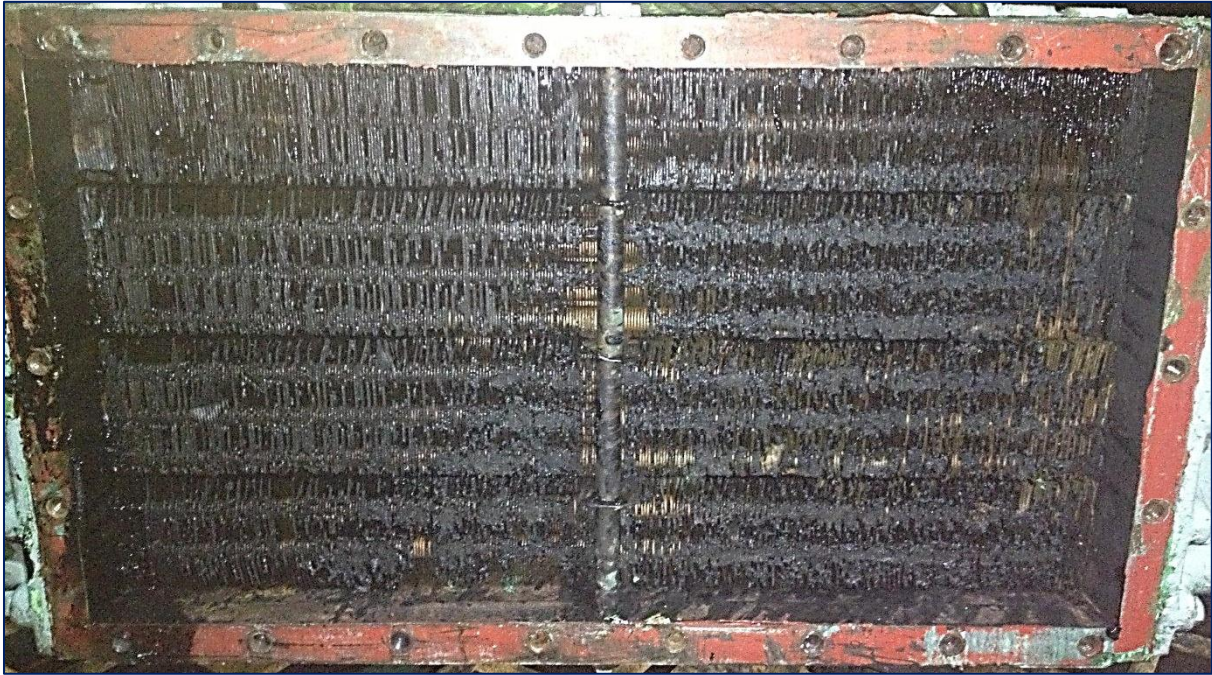
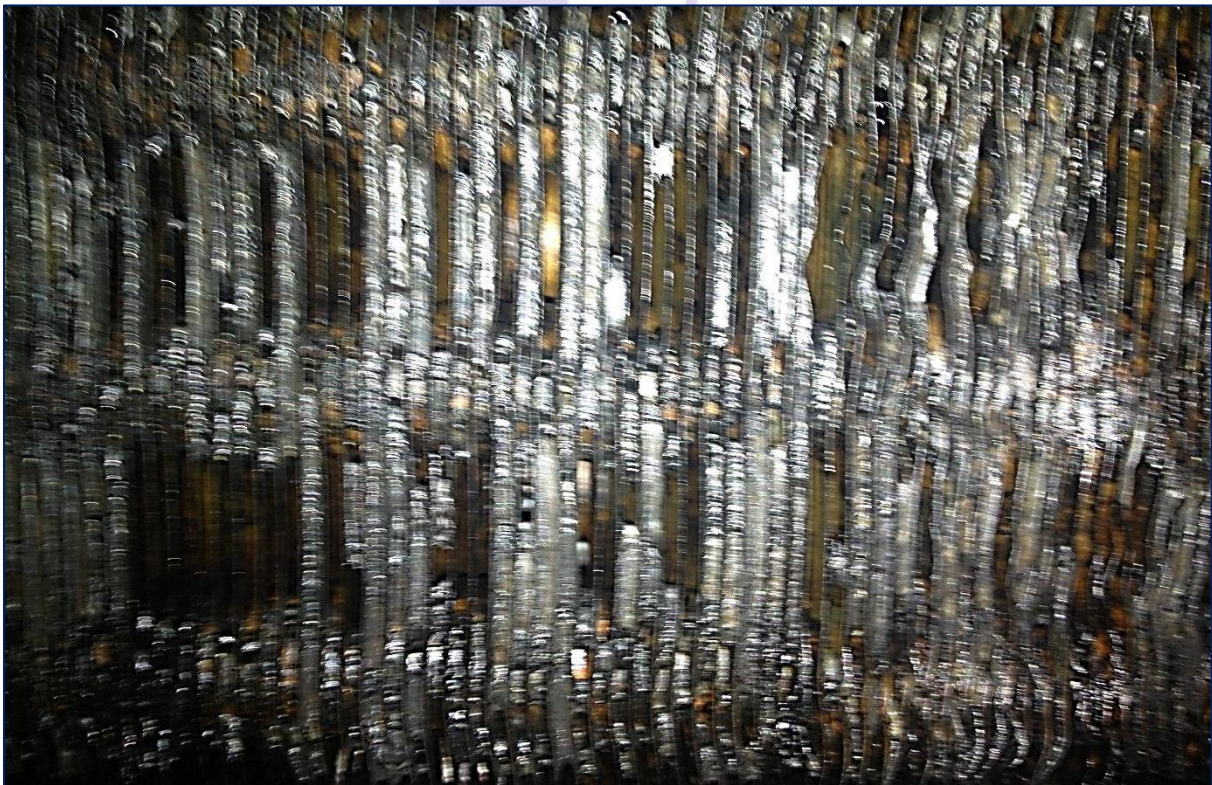
MAIN ENGINE AIR COOLERS CLEANING & OVERHAUL;

Air coolers dismantled and transferred to the TEKNOMARIN's workshop. Air cooler air side and sea water side was cleaned & washed chemically. Later by blanded & some of tubes changed. Air cooler transferred to the vessel and mounted on stu.

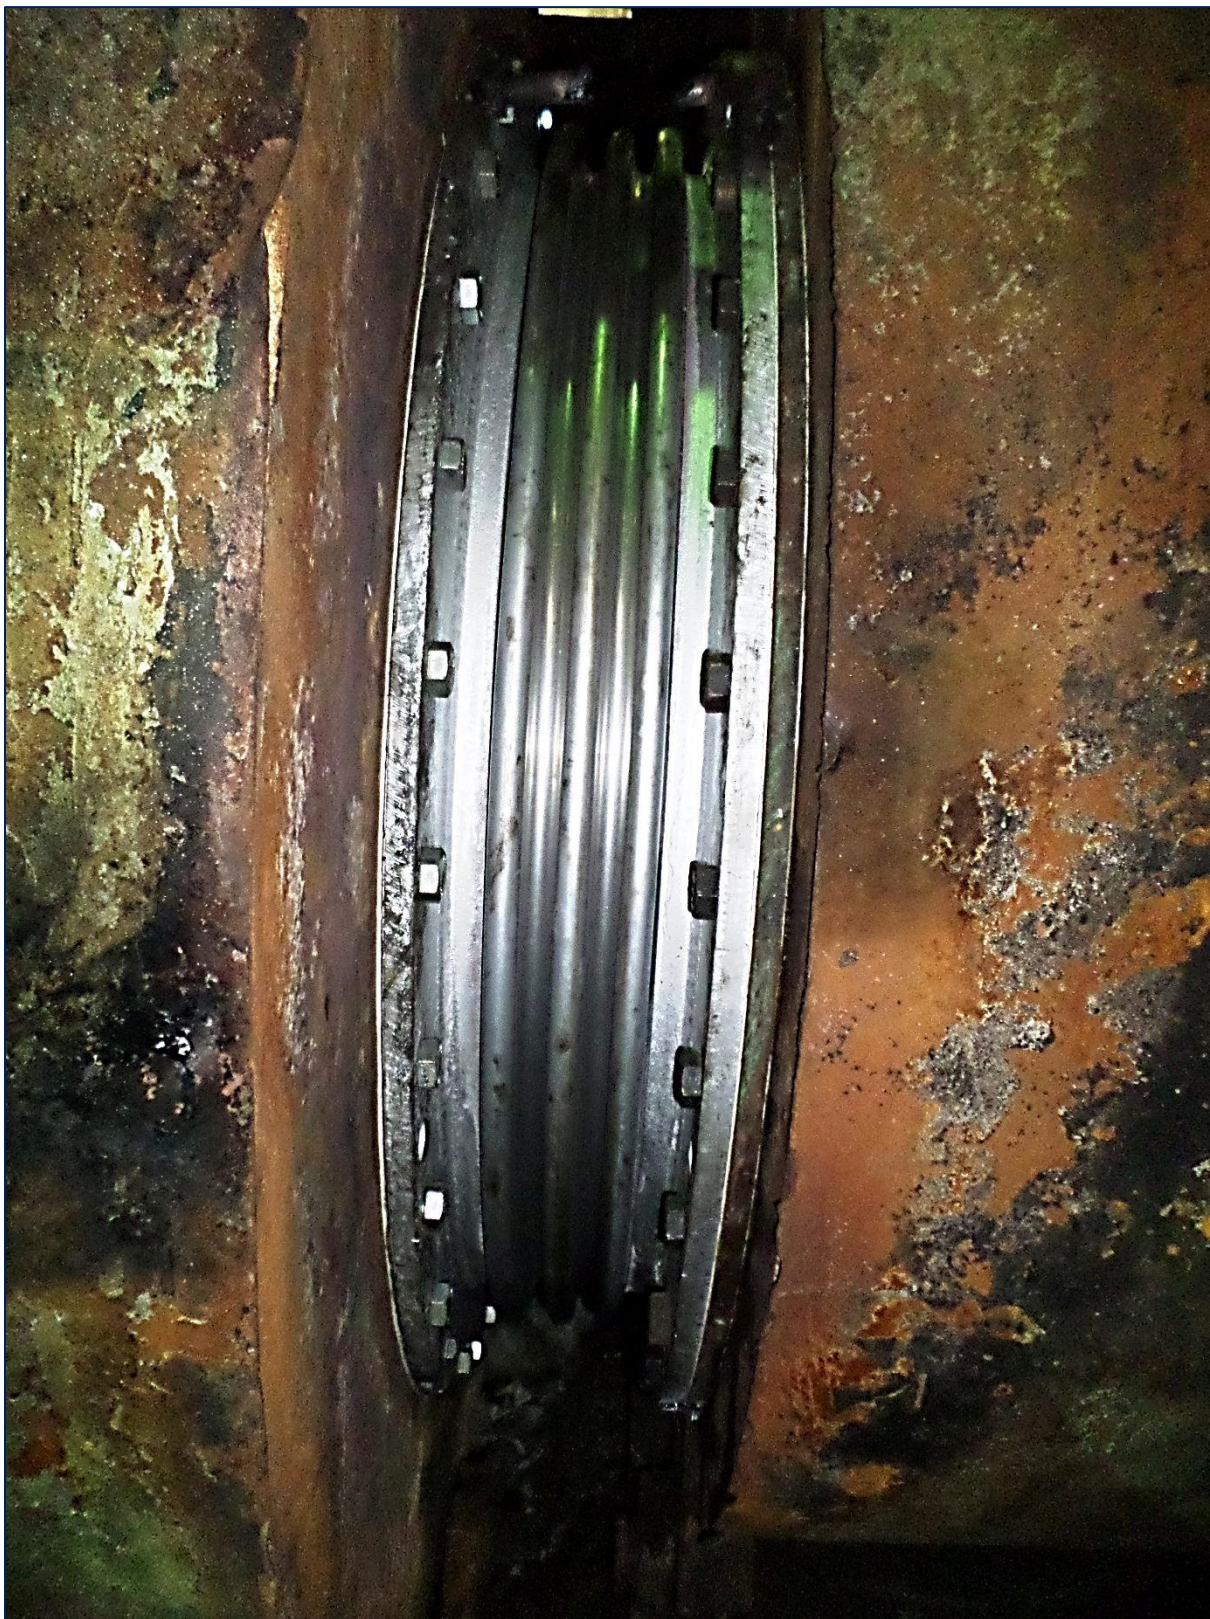
MAIN ENGINE EXHAUST EXPANSION REPAIR & OVERHAUL;

All exhaust expansions belongs to Main Engine, inspected. Two of them spotted as damaged toughly from welding lines. These expansions dismantled & transferred to the workshop. Meanwhile spare expansions mounted on stu. Later by reconditioned expansions transferred to the vessel and kept as spare.

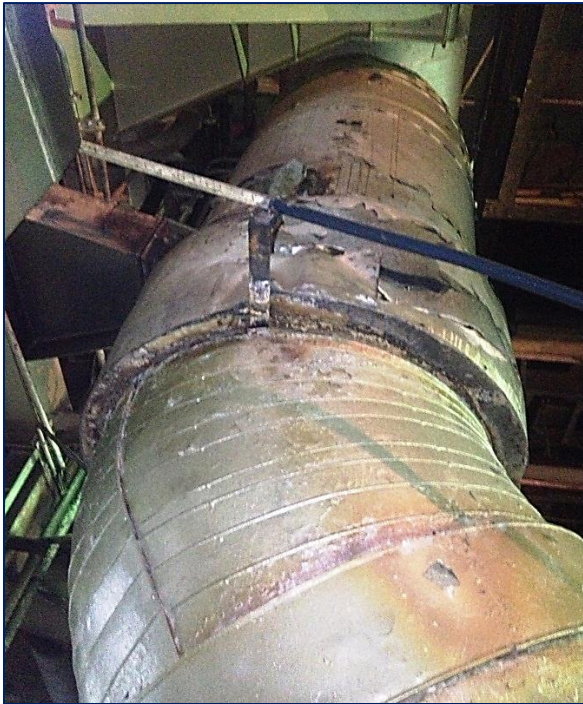
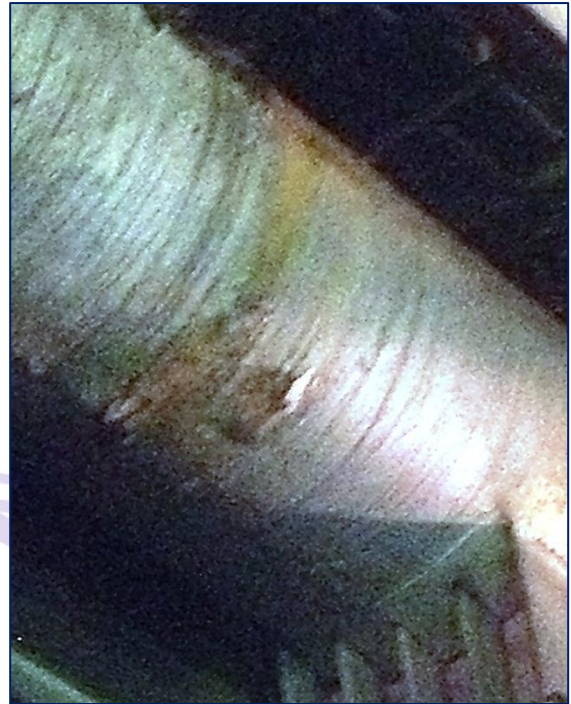
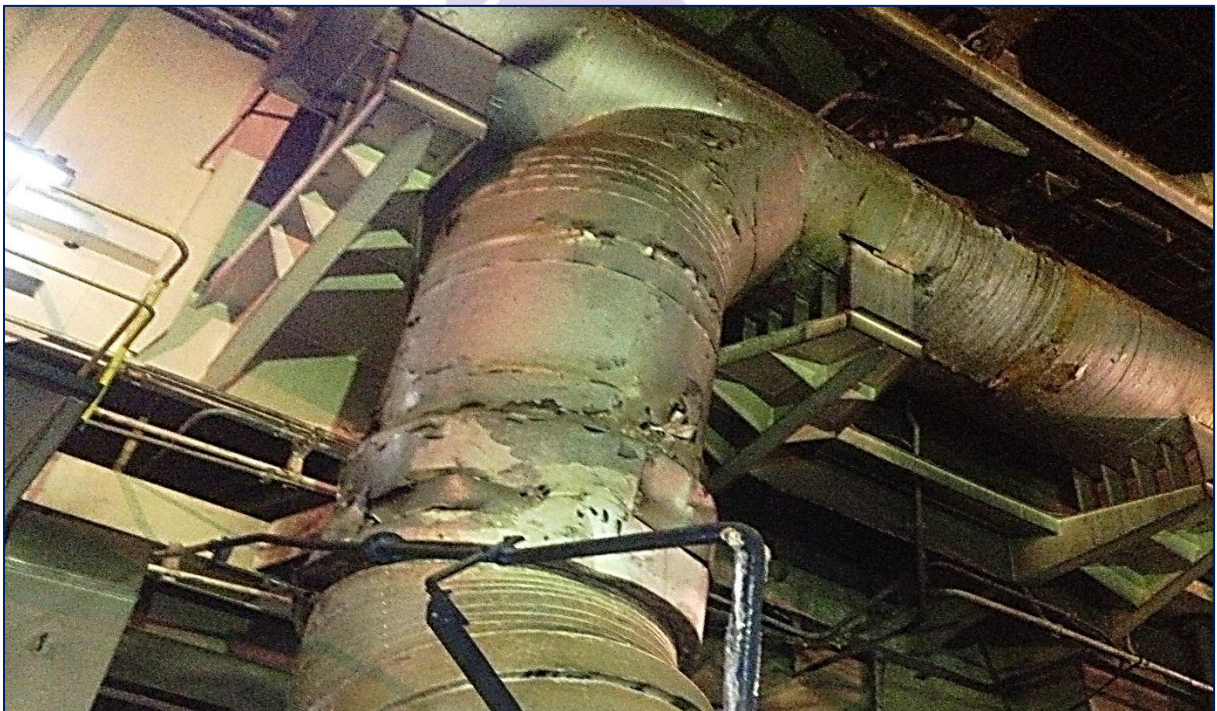
MAIN ENGINE EXHAUST MANIFOLD ISOLATION;

Regarding to our test & inspect, all parts and every spots of main engine exhaust manifold, must be renewed and re-isolation. After the building scaffold to the engine room, we immediately started to isolate and cover the main engine exhaust manifold completely.

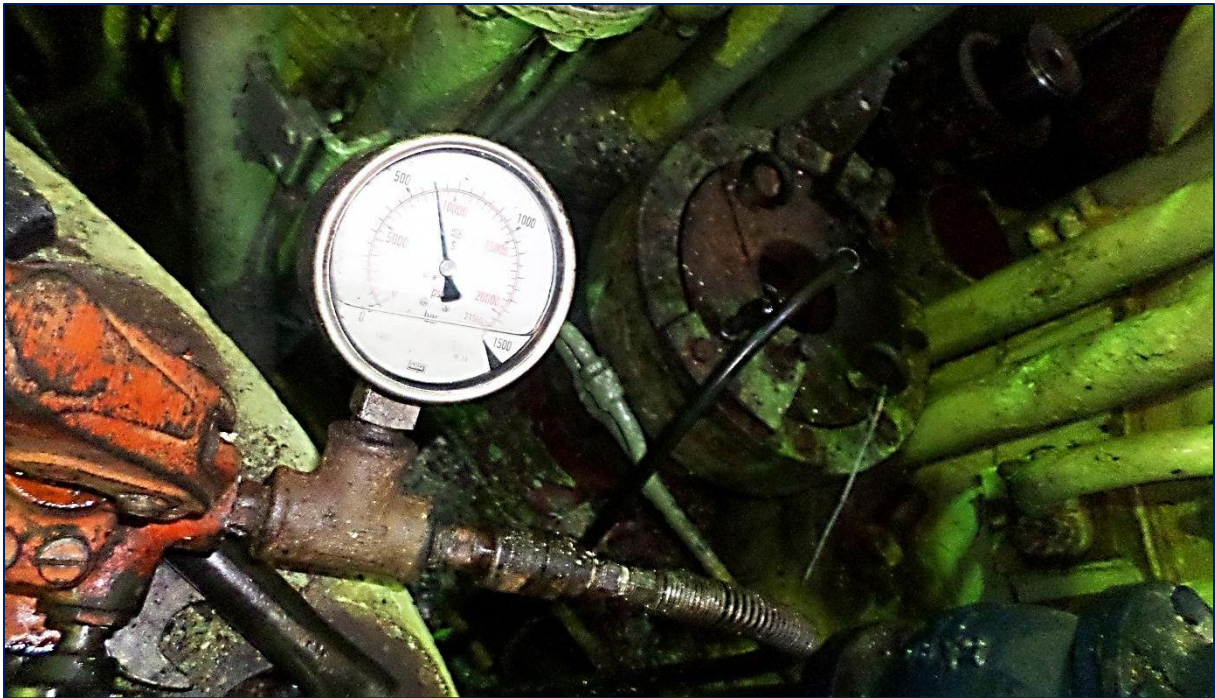
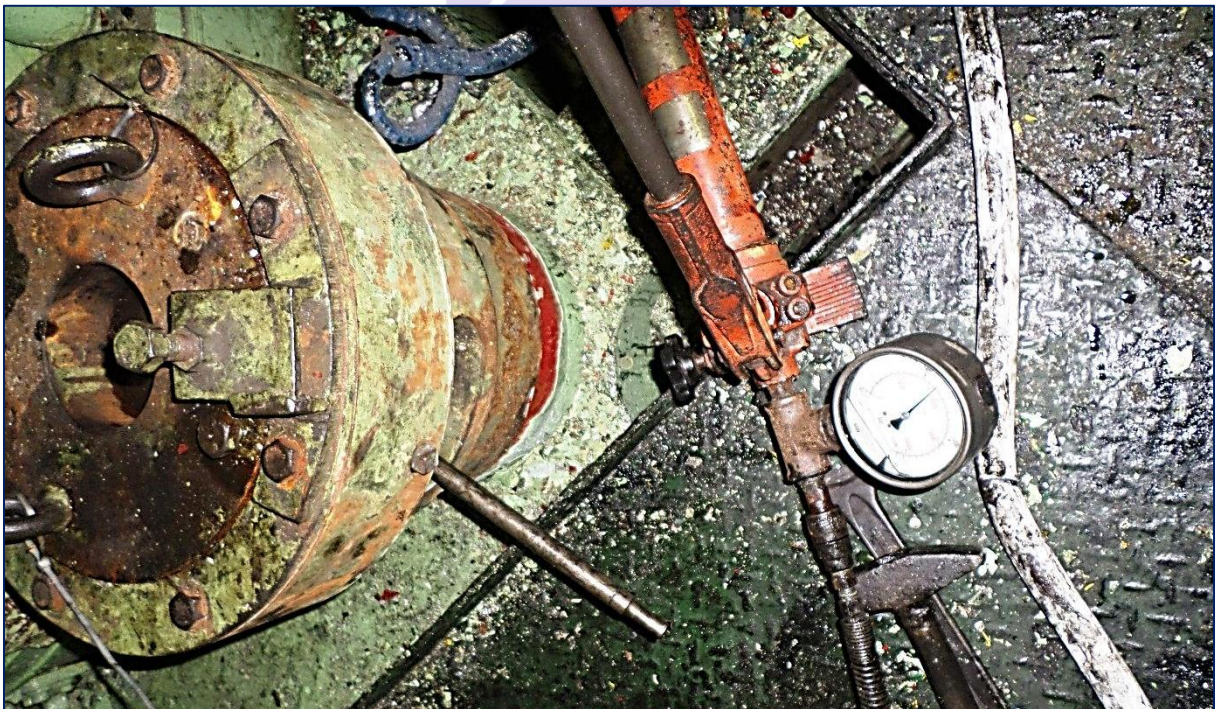
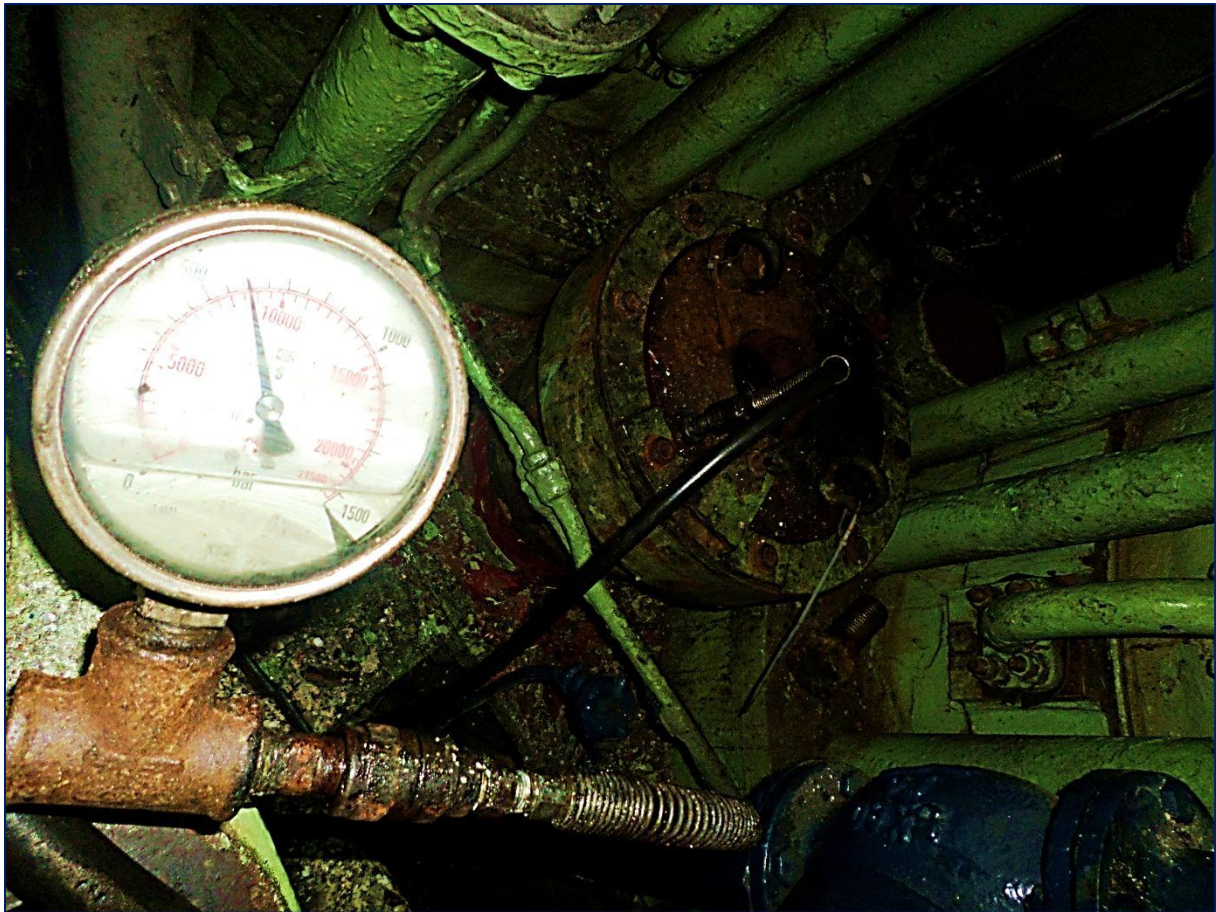
MAIN ENGINE TIEROD JACKS OVERHAUL;

There were two tierod jacks of main engine tierods in vessel. We transferred to the workshop for inspection & overhaul if necessary. Tierod jacks tightened & controlled. After the control of jacks, they are transferred to the vessel & checked on M/E itself with 600 bar. Operative.

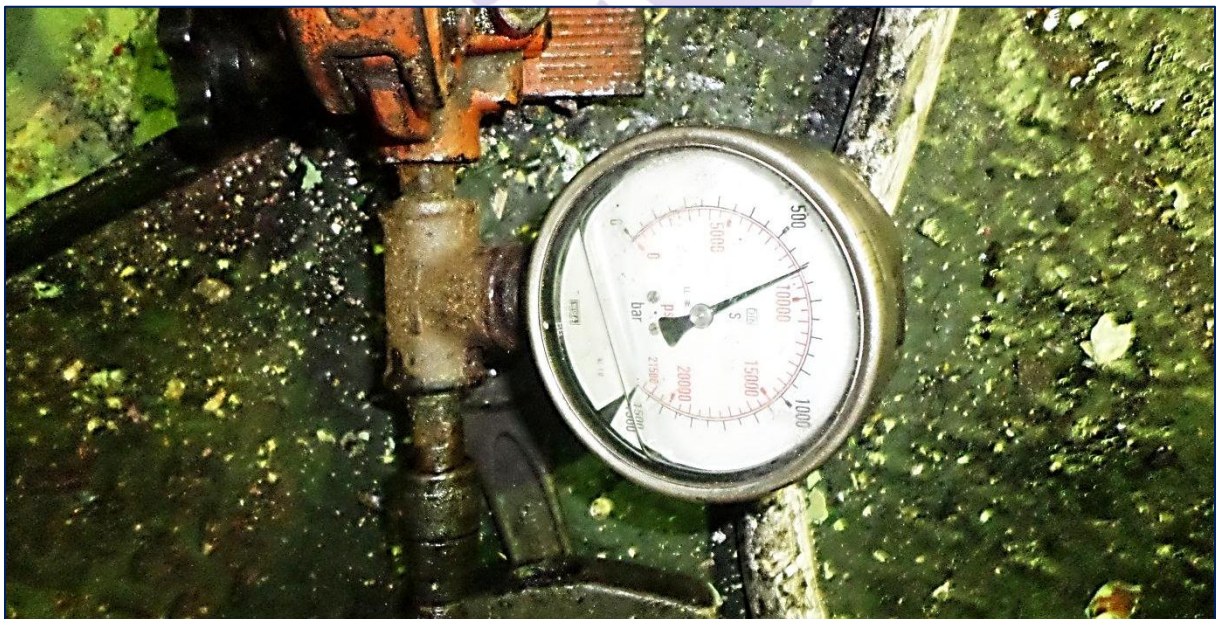
Meanwhile these jacks test was an opportunity for the controlling tierods of main engine. In that moment we tighted & controlled all tierods of main engine immediately with 600 bar.
