INTRODUCTION

Engines need regular interval overhaul. All units of main engine and auxiliary engines needed to be overhauled while the vessel in Tuzla/Anchorage Area, Tuzla/Gemsan Dry Dock & Tuzla/Türkter Shipyard. Regarding to schedule, the added value of Teknomarin's expert diesel repair capabilities were put to the test.

SULZER RND 90 MAIN ENGINE OVERHAUL

Engine Room had some additional works to be done. Alternator rewinding, turbochargers overhauls, governors overhauls, daeration tank fabricating, cooling sea water pump, fuel oil burning pump, hydrophore pump and some other kinds of pumps overhauls, exhaust isolation jobs, inspection & recondition jobs and many others things to be done means that there is an *“engine room complete overhaul”* we can call it. This report includes all jobs to be done in M/V Almawashi.

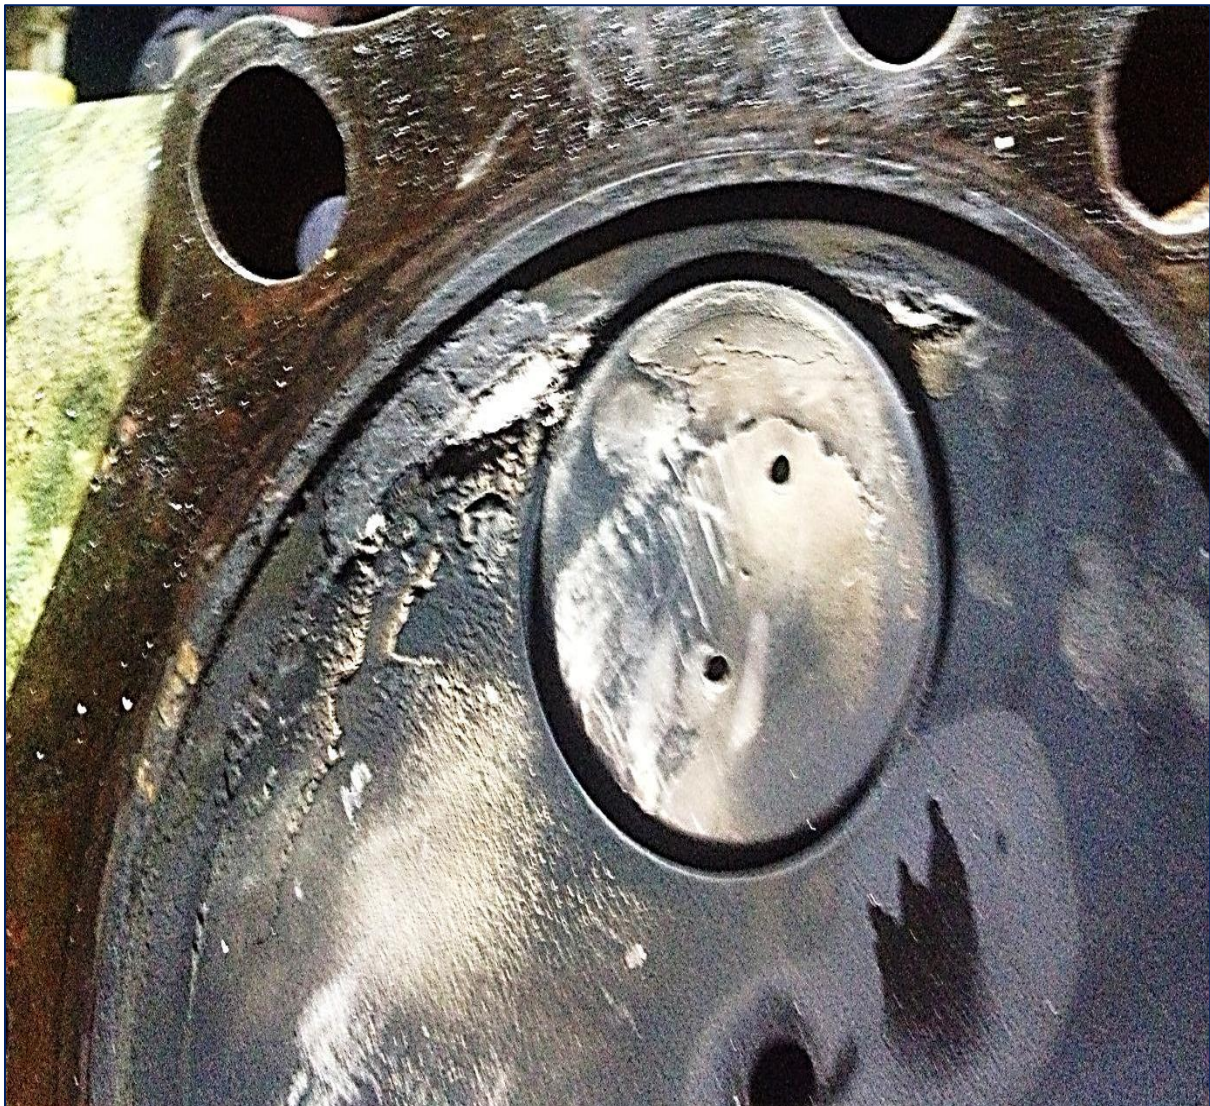
G/E NO:1 CYLINDER HEADS OVERHAUL;

All connections of cylinder heads dismantled. All cylinder heads removed from the engine for overhaul. All safety valves, starting valves and Indicator valves overhauled and tested. Indicator cocks overhauled and tested. Rocker arms dismantled, shafts and bushes measured. All inlet and exhaust valves, guides and seats were grinded and lapped. All o-rings in cylinder heads were replaced. Cylinder covers water side cleaned by chemically and hydrostatic pressure tested. Cylinder heads mounted on stu.

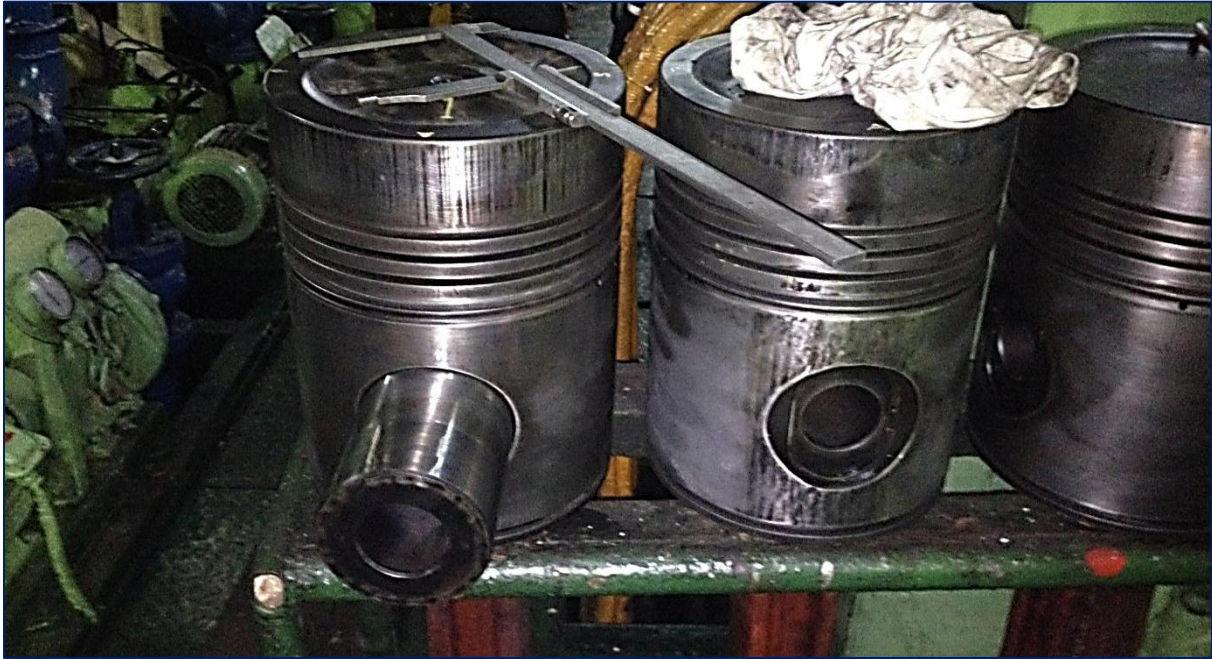
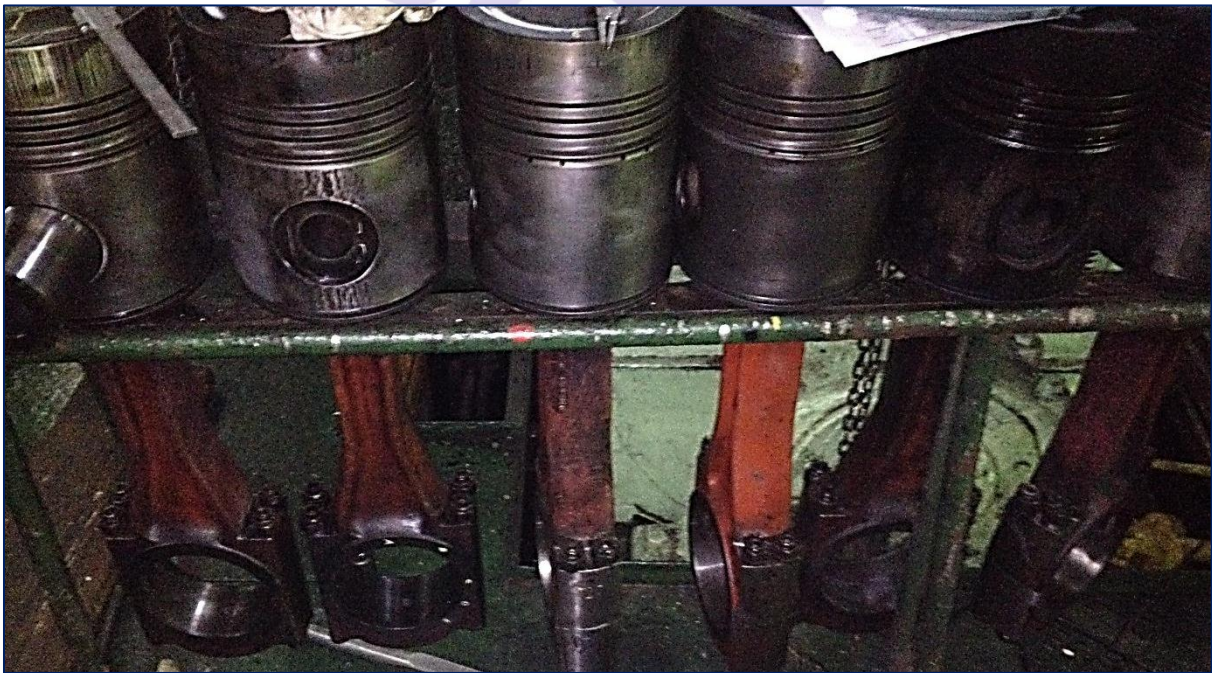
G/E NO:1 PISTONS OVERHAUL;

All pistons dismantled, taken out for inspection and measuring the big end bore ovality, small end bush, piston pin, piston ring grooves, piston pin boss. Piston crowns and skirts checked for possible cracks by dye penetrant. After taken out of measurements, all piston rings were replaced with new piston rings.

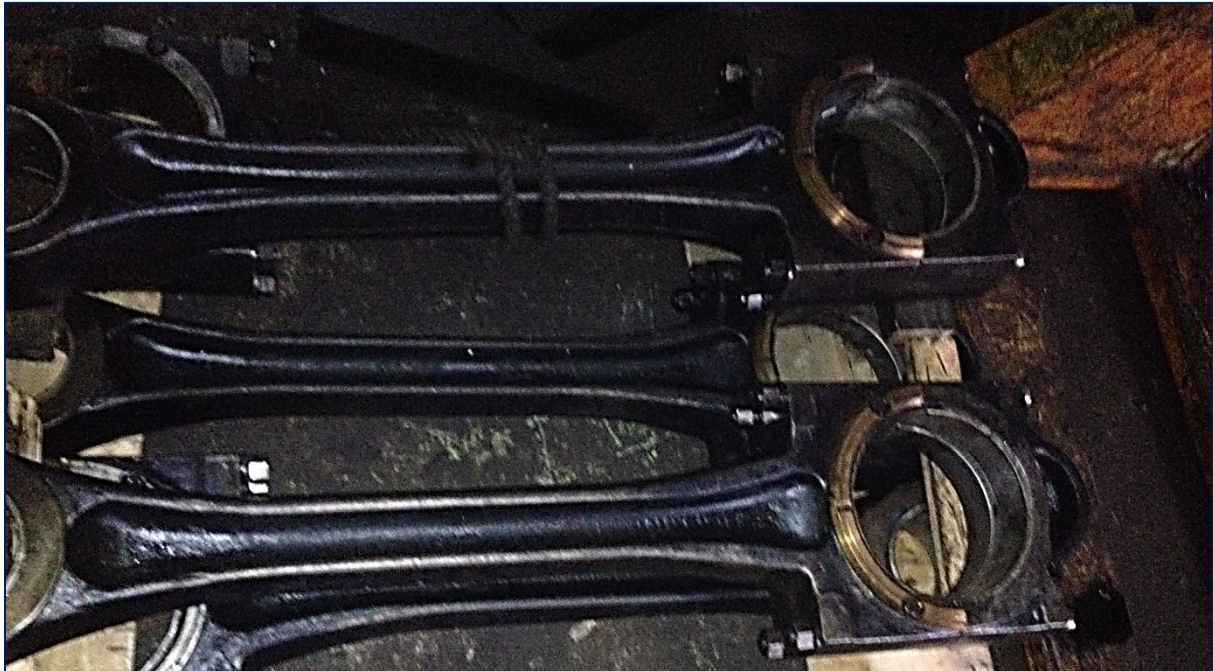
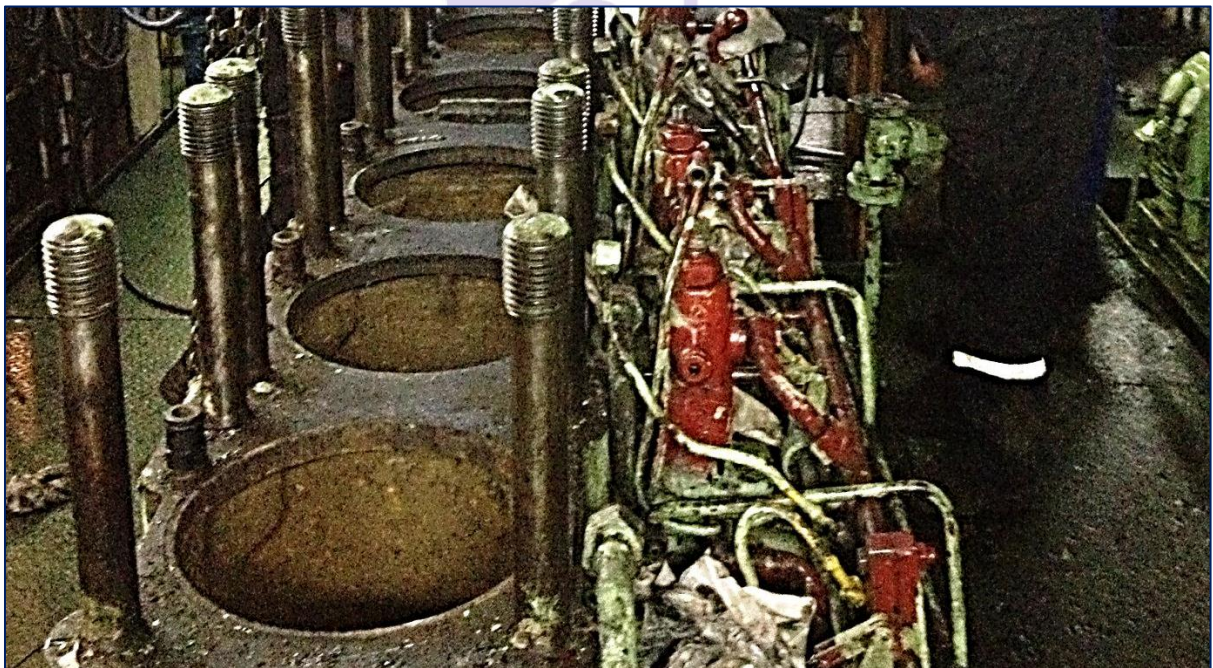
Later by all connectin rods dismantled from pistons & measured one by one. We noticed that all connectin rods needs boring. All connectin rod bearings fabricated according to last measures taken by TEKNOMARIN technicians. Meanwhile connectin rod boring also finished & also rods delivered to the vessel, following all connectin rods with piston crowns mounted on stu. Meanwhile boring has started for connectin rods when liners disassembled.

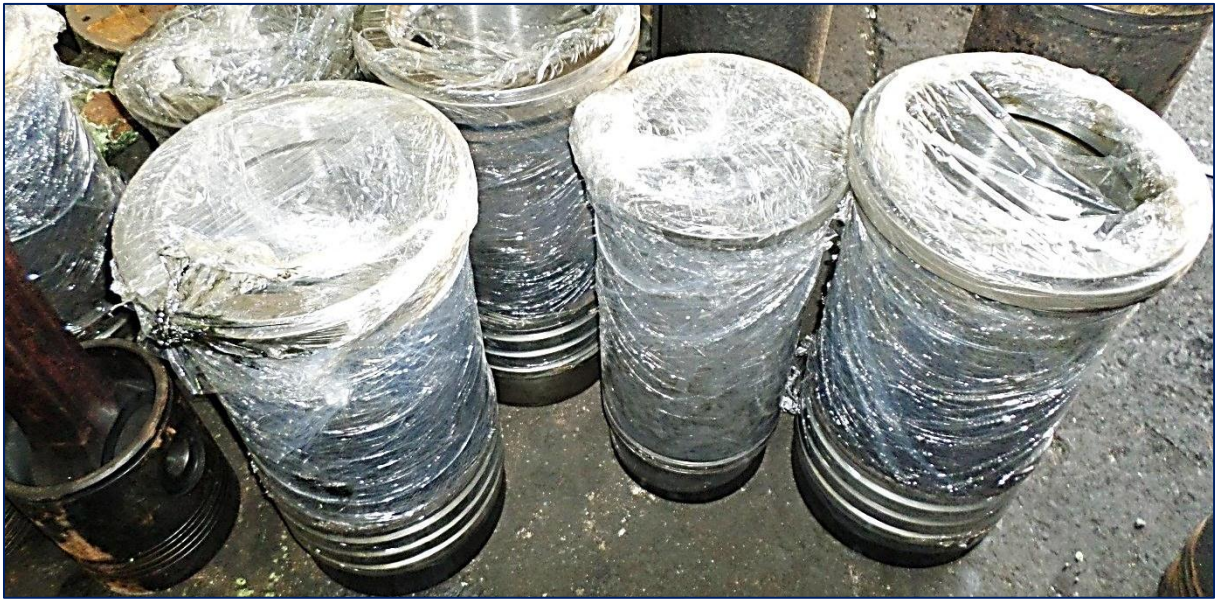
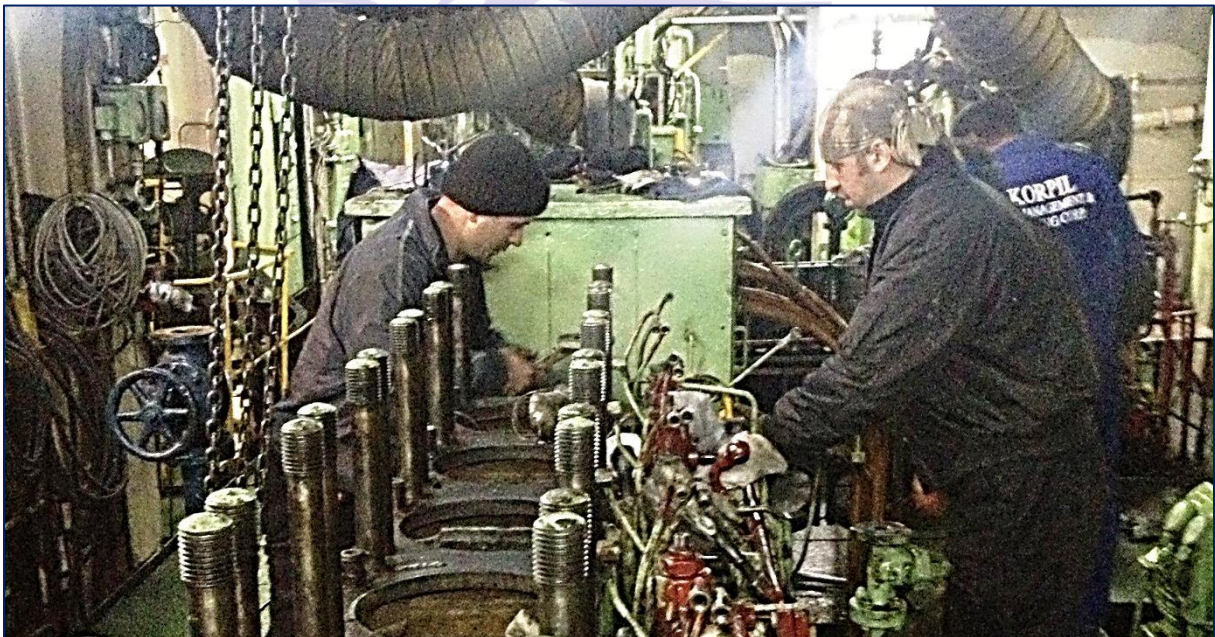
G/E NO:1 LINERS OVERHAUL;

All cylinder liners were dismantled. All liners cleaned, inspected and measured. After measurements and inspections, liners prepared to be re-fitted with new o-rings. Meanwhile liners were already honned and delivered to the vessel and shifted to engine room. Honned liners mounted on block with new o-rings & gaskets that exist supplied from ship store by vessel crew. Missing o-rings & gaskets fabricated by TEKNOMARIN technicians as samples. All liners prepared to mounted on stu.

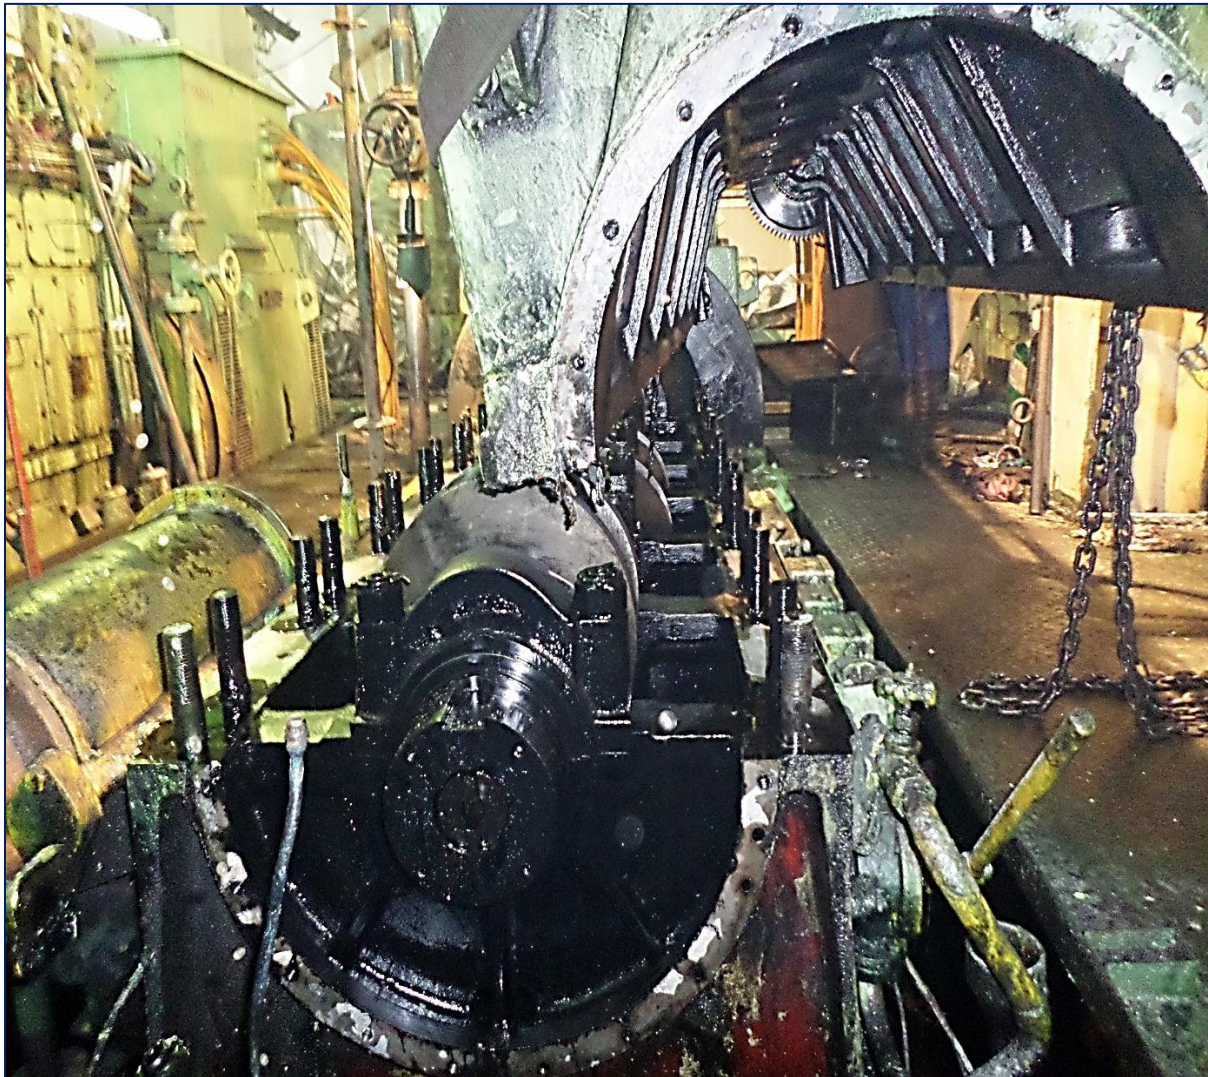
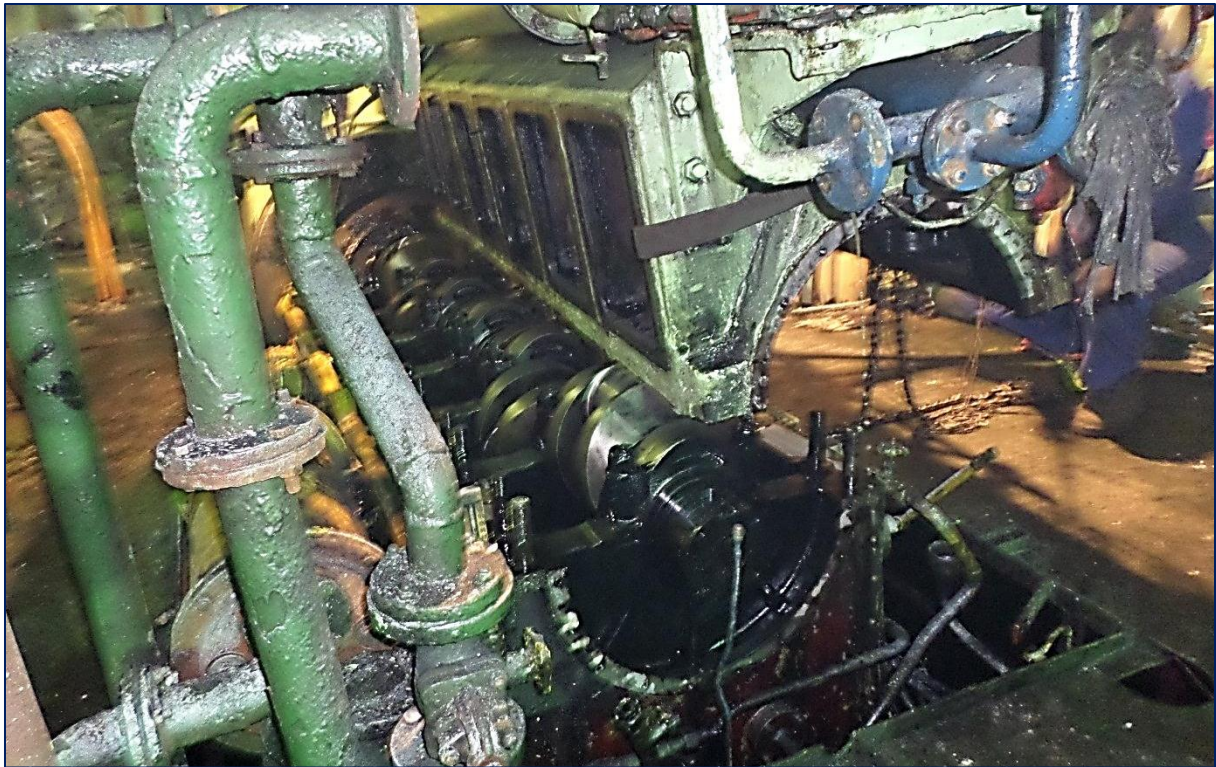
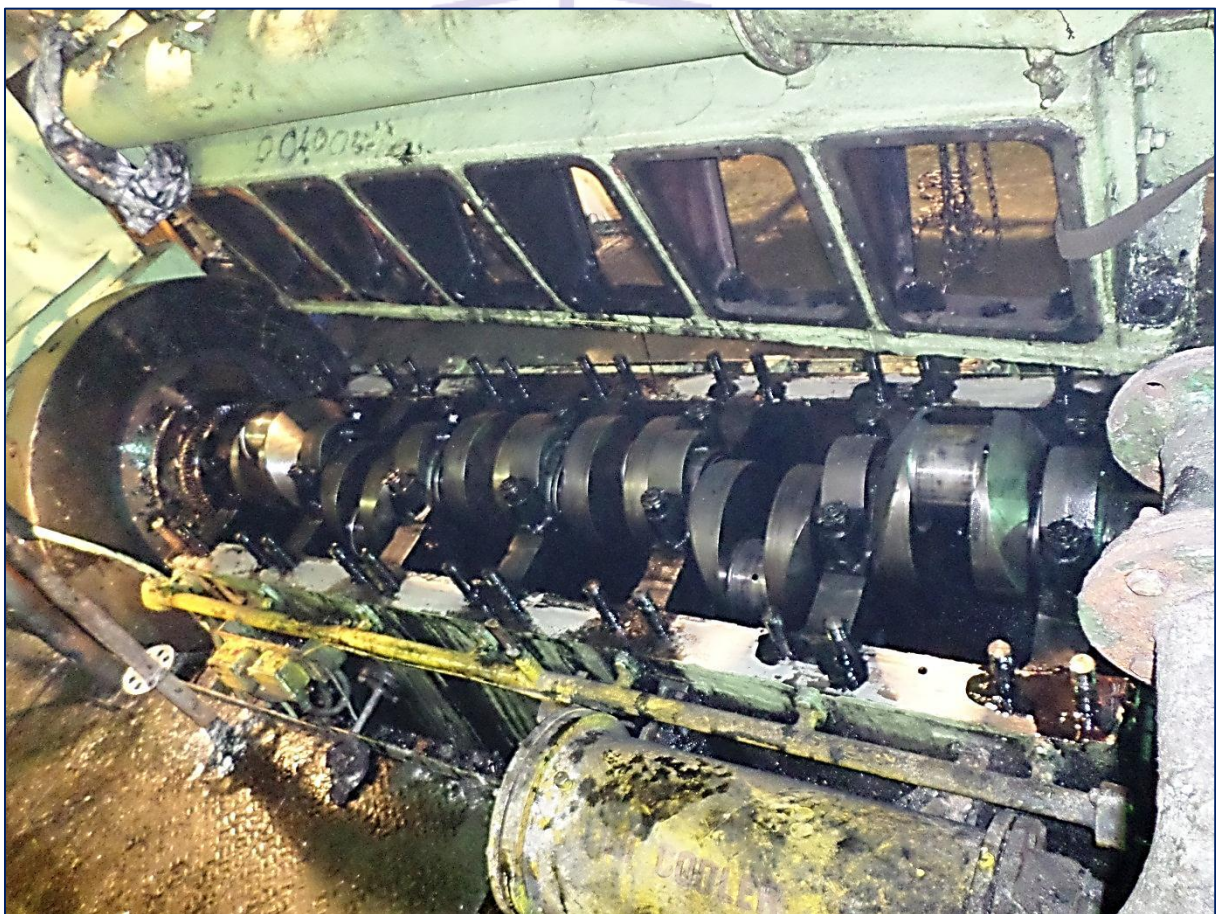
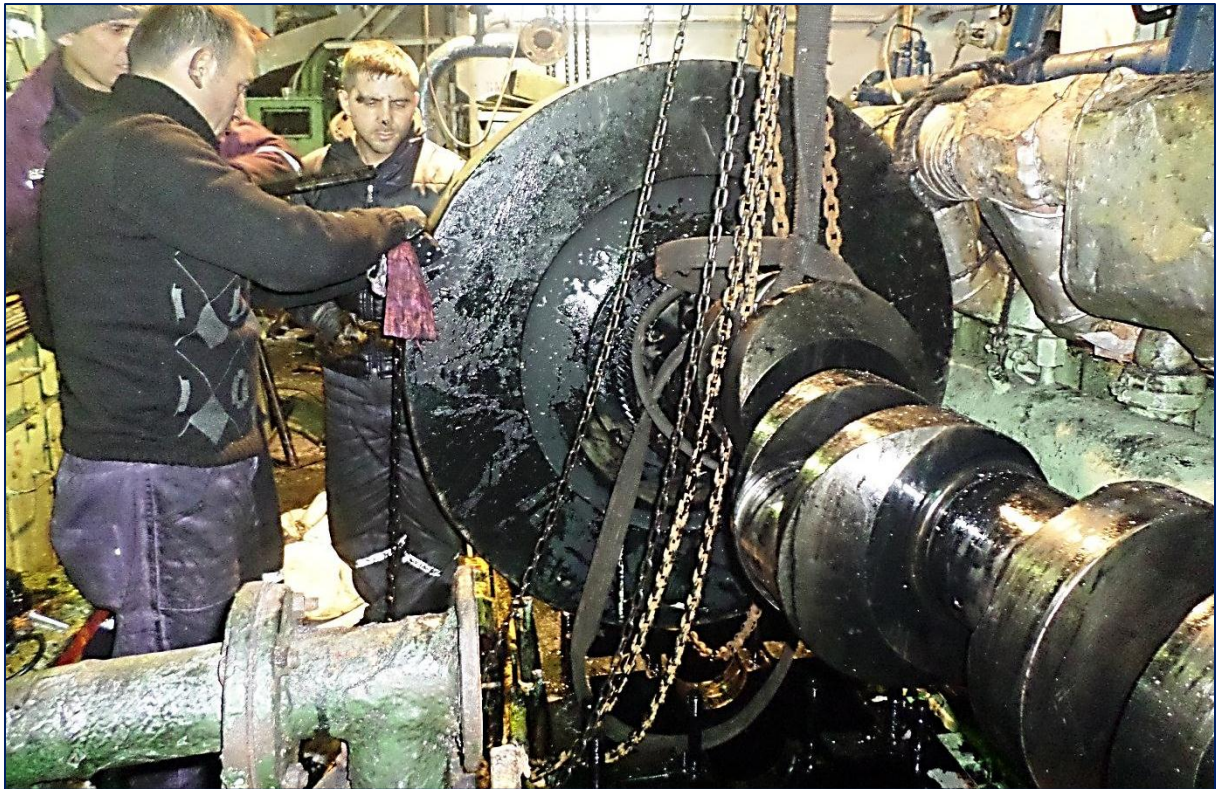
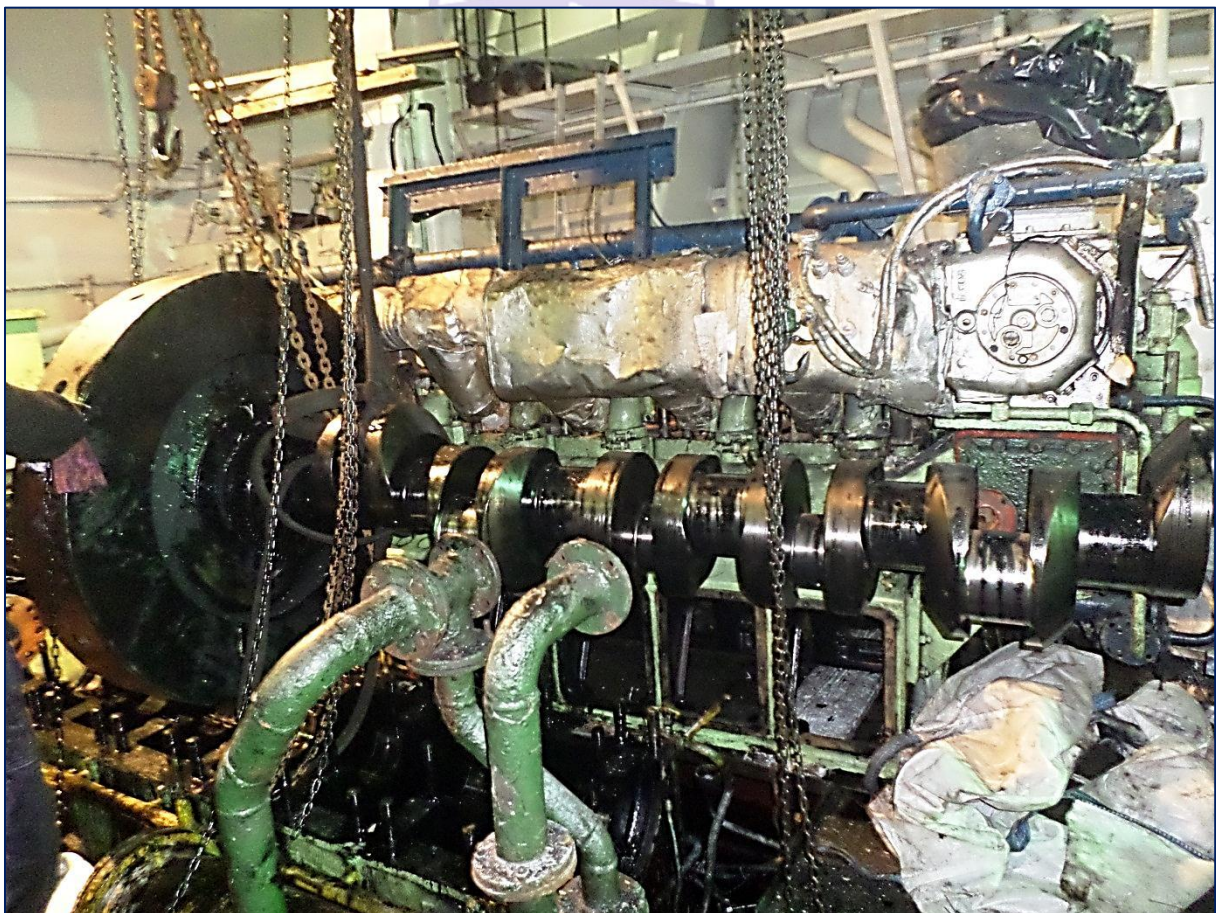
G/E NO:1 CRANKSHAFT INSPECTION & ENGINE BLOCK SHIFTING;

Block completely lifted & shifted in engine room. Alternator also slightly shifted in engine room by vessel crew. Crankshaft has dismantled & transferred to the workshop & inspected. Also measured. After inspection and measurements, cracks and under/oversized bearings noticed & marked. Bedplate boring & main bearing fabricating immediately started and finished. Grinding, boring, welding and fabricating jobs for crankshaft has done and all measurements taken once again and engine started to assembly. After the flywheel studs fabrication, crankshaft mounted and assembled with flywheel in stu. Alternator slightly shifted once again to be connected with crankshaft. In the meantime, deflection of crankshaft has been taken and lined with alternator's rotor. Engine block & jackets inspected for cracks. Found none. Thus engine block immediately mounted & lined with the bedplate.

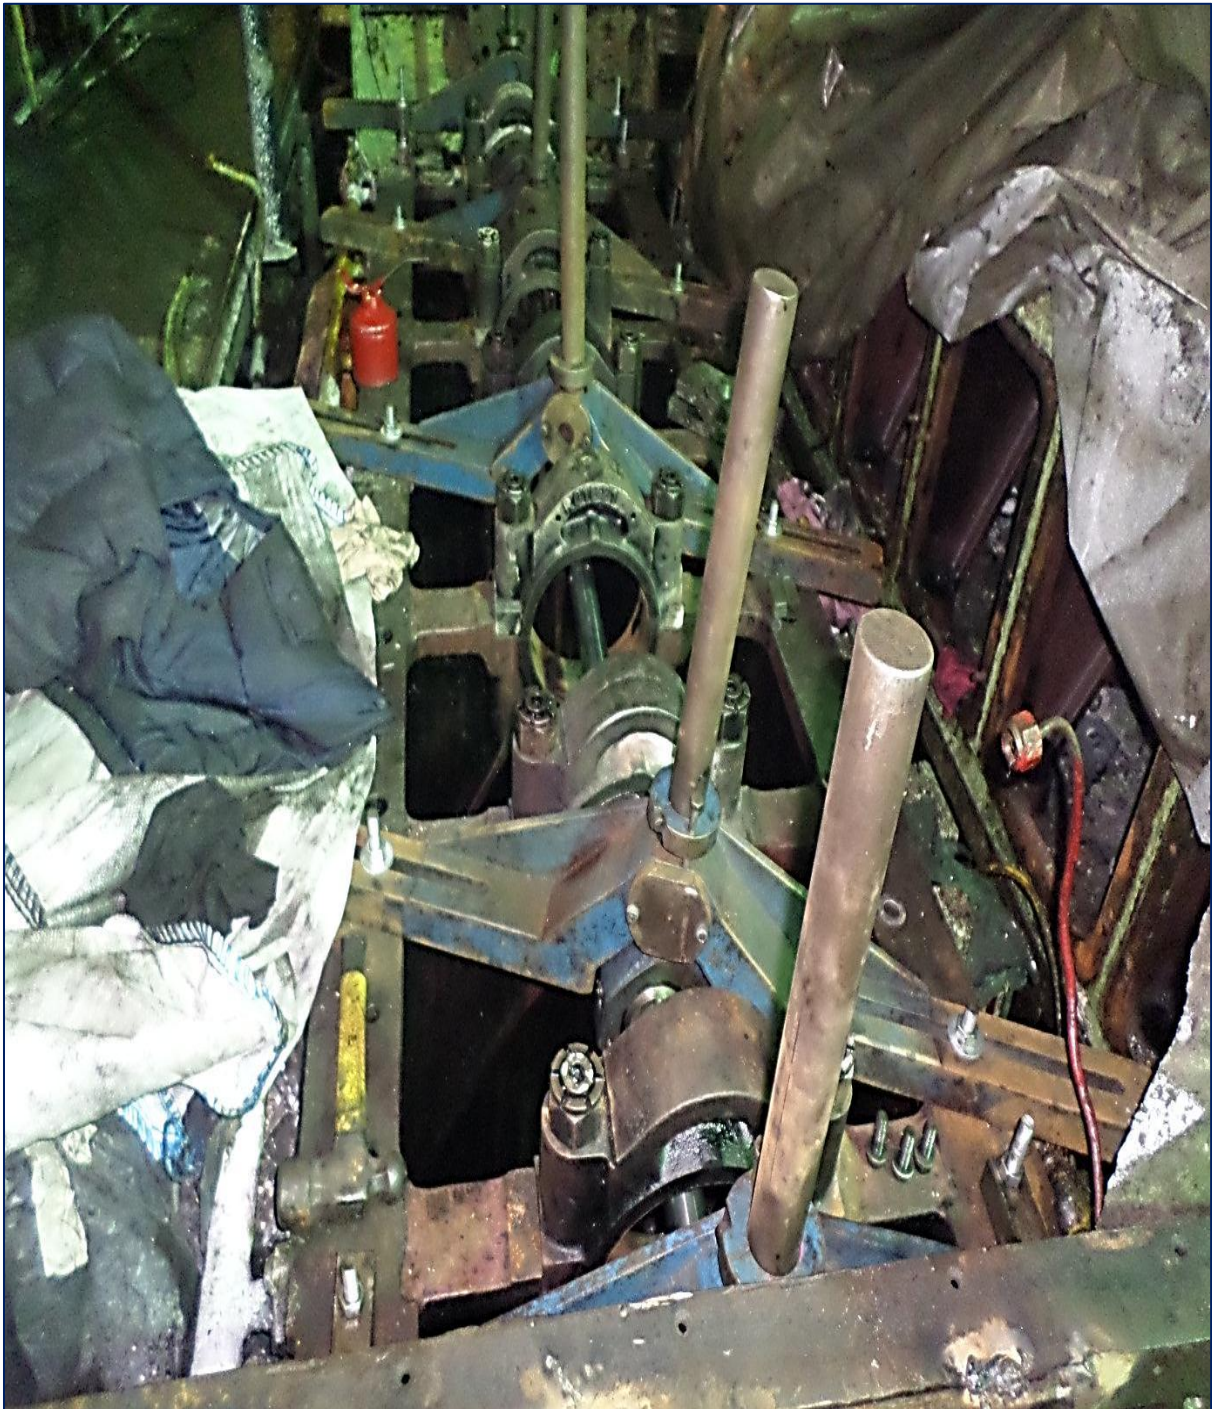
G/E NO:1 CRANKSHAFT GRINDING & BEARINGS BORING;

When the block was dismantled & shifted, crankshaft and main bearings was ready for inspection. Crankshaft also dismantled & transferred to the workshop for measurements. After inspection, we noticed that crankshaft needs to grind, bearings needs to boring. Later by measures has taken then we immediately start the boring job for main bearings.

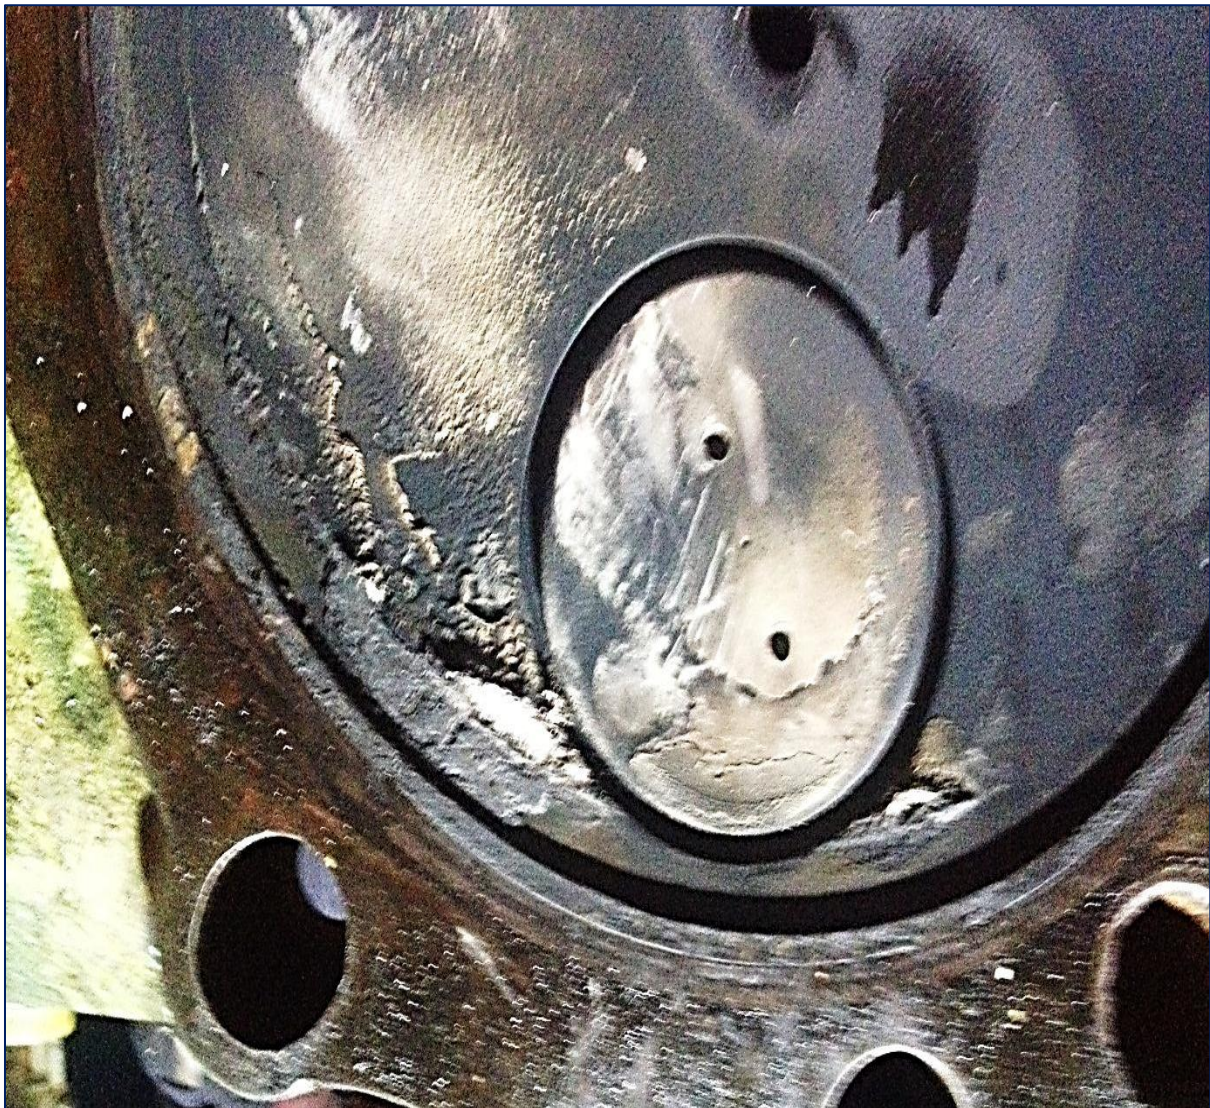
G/E NO:2 CYLINDER HEADS OVERHAUL;

All connections of cylinder heads dismantled. All cylinder heads removed from the engine for overhaul. All safety valves, starting valves and Indicator valves overhauled and tested. Indicator cocks overhauled and tested. Rocker arms dismantled, shafts and bushes measured. All inlet and exhaust valves, guides and seats were grinded and lapped. All o-rings in cylinder heads were replaced. Cylinder covers water side cleaned by chemically and hydrostatic pressure tested. Cylinder heads mounted on stu.

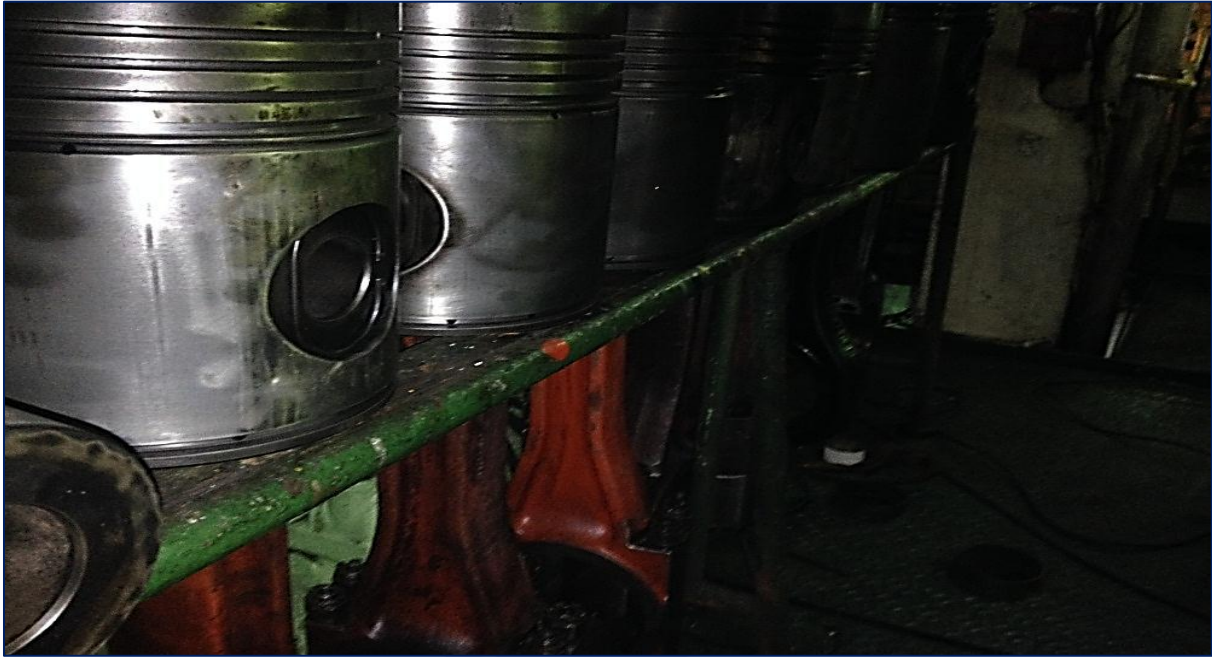
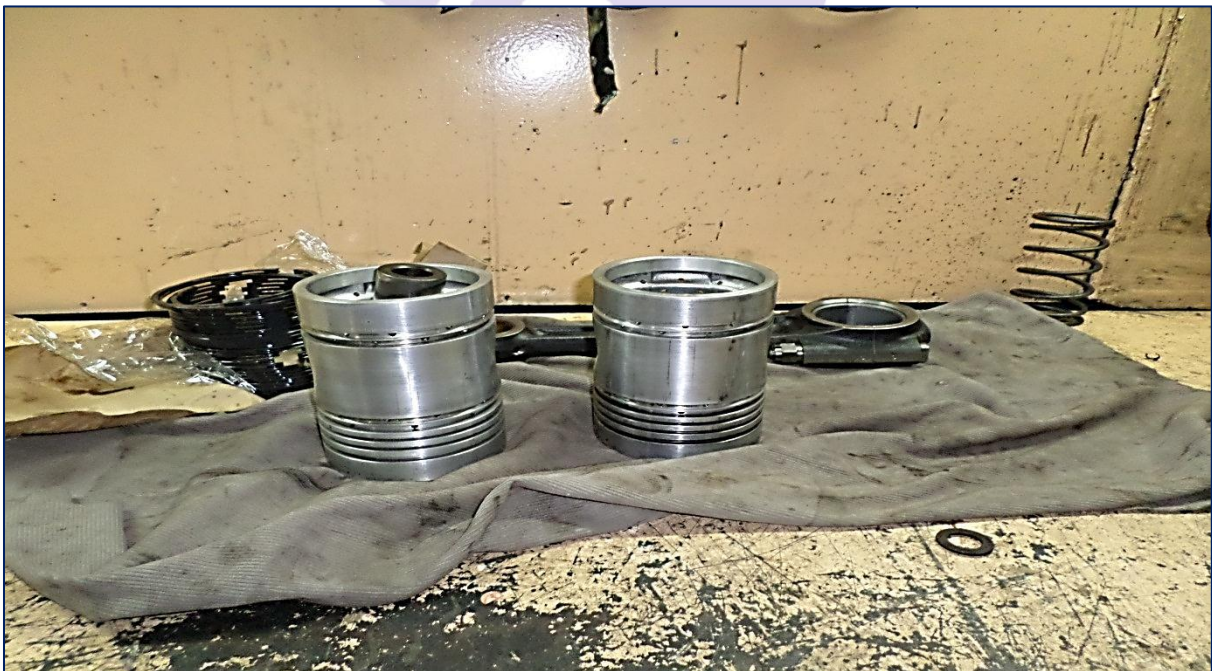
G/E NO:2 PISTONS OVERHAUL;

All pistons dismantled, taken out for inspection and measuring the big end bore ovality, small end bush, piston pin, piston ring grooves, piston pin boss. Piston crowns and skirts checked for possible cracks by dye penetrant. After taken out of measurements, all piston rings were replaced with new piston rings.

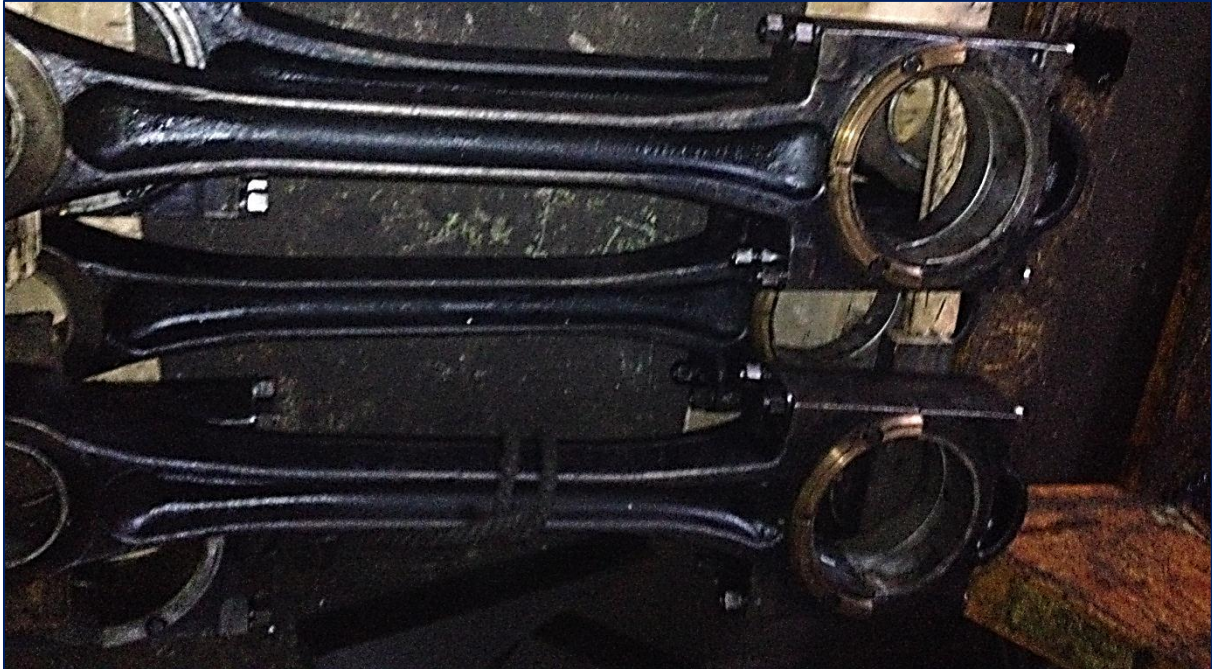
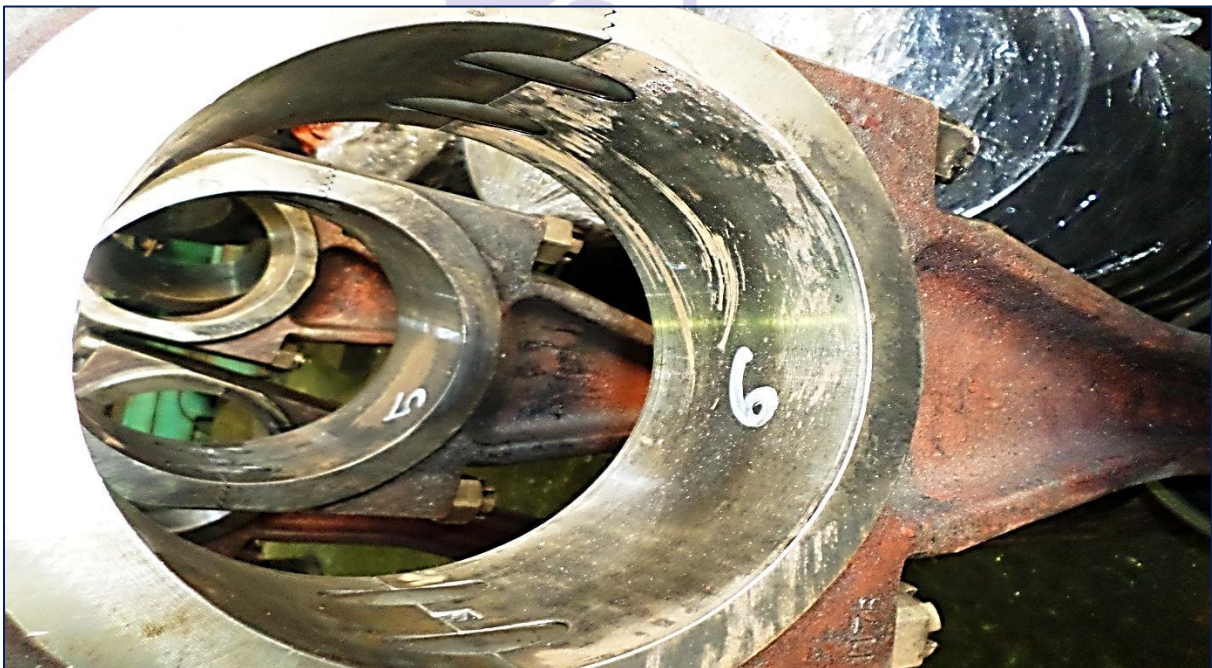
Later by all connectin rods dismantled from pistons & measured one by one. All connectin rod bearings fabricated according to last measures taken by TEKNOMARIN technicians. Meanwhile connectin rod ovality control and with & without bearing measures has already taken. Later by delivered to the vessel, following all connectin rods with piston crowns mounted on stu. Meanwhile boring has started for connectin rods when liners disassembled.

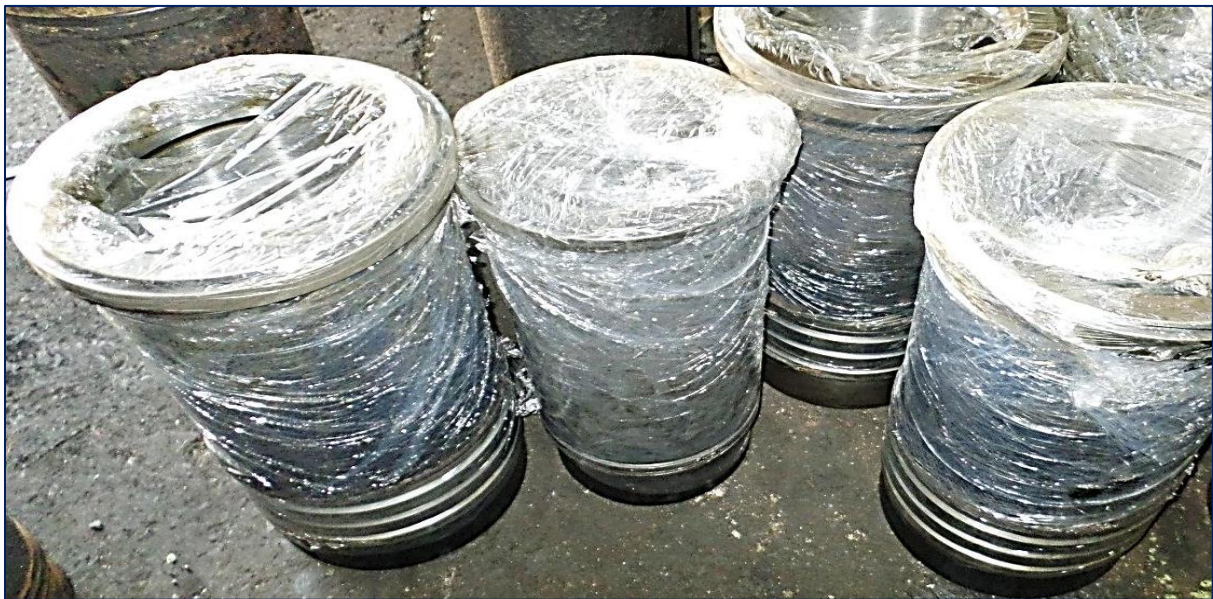
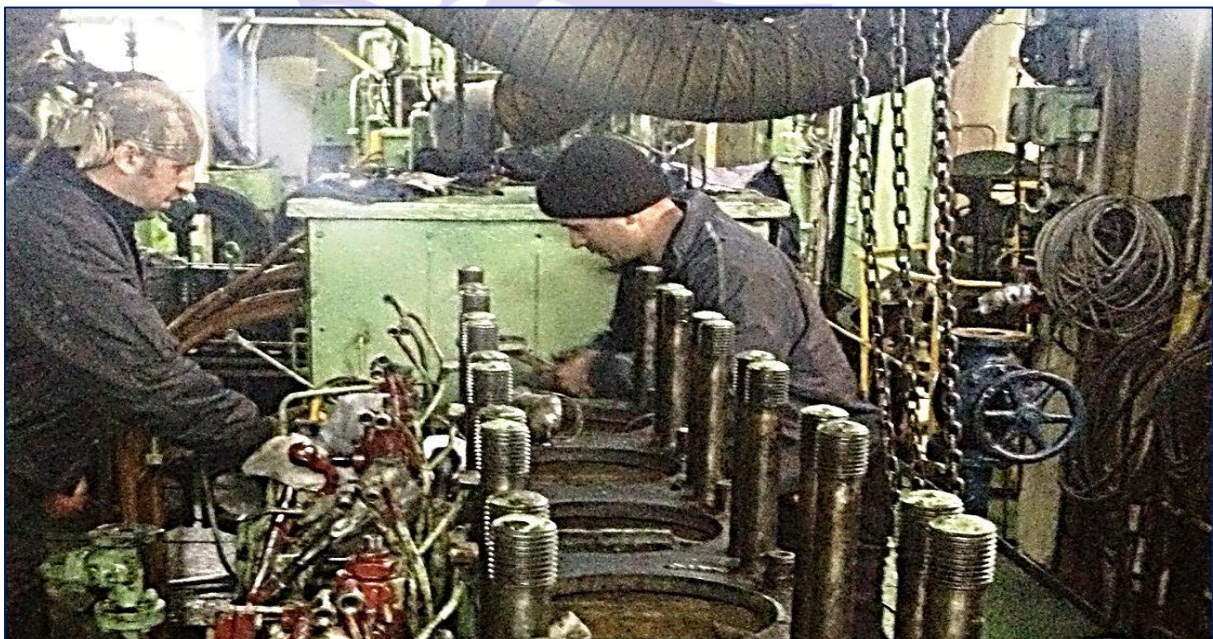
G/E NO:2 LINERS OVERHAUL;

All cylinder liners were dismantled. All liners cleaned, inspected and measured. After measurements and inspections, liners prepared to be re-fitted with new o-rings. Meanwhile liners were already honned and delivered to the vessel and shifted to engine room. Honned liners mounted on block with new o-rings & gaskets that exist supplied from ship store by vessel crew. Missing o-rings & gaskets fabricated by TEKNOMARIN technicians as samples. All liners prepared to mounted on stu.

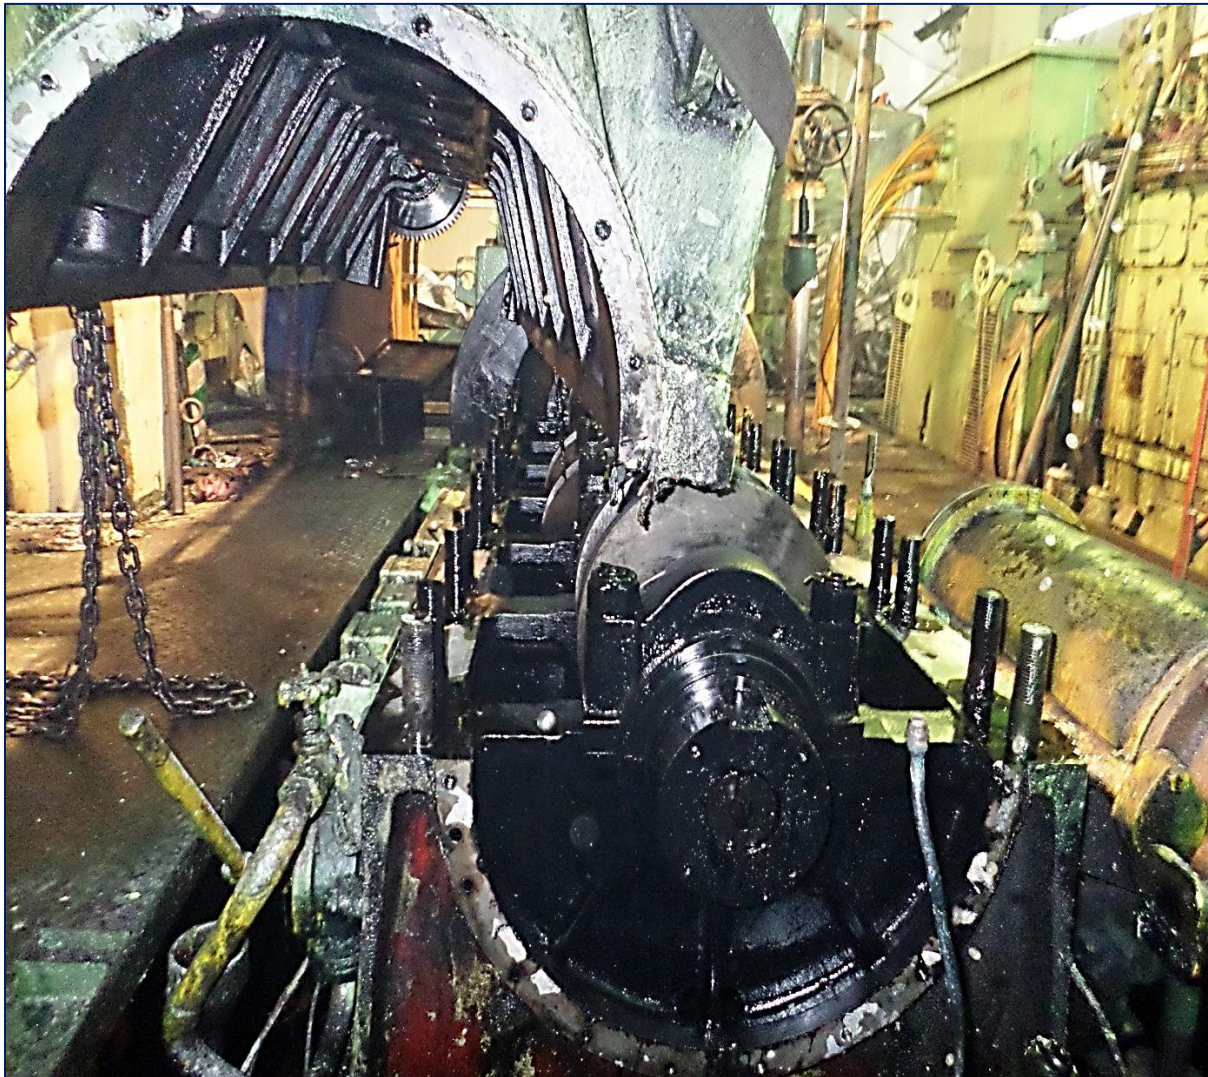
G/E NO:2 CRANKSHAFT INSPECTION & ENGINE BLOCK SHIFTING;

Block completely lifted & shifted in engine room. Alternator also slightly shifted in engine room by vessel crew. Crankshaft has dismantled & transferred to the workshop & inspected. Also measured. After inspection and measurements, cracks and under/oversized bearings noticed & marked. Bedplate boring & main bearing fabricating immediately started and finished. Grinding, boring, welding and fabricating jobs for crankshaft has done and all measurements taken once again and engine started to assembly. After the flywheel studs fabrication, crankshaft mounted and assembled with flywheel in stu. Alternator slightly shifted once again to be connected with crankshaft. In the meantime, deflection of crankshaft has been taken and lined with alternator's rotor. Engine block & jackets inspected for cracks. Found none. Thus engine block immediately mounted & lined with the bedplate.
