INTRODUCTION

Engines need regular interval overhaul. All units of main engine and auxiliary engines needed to be overhauled while the vessel in Tuzla/Anchorage Area, Tuzla/Gemsan Dry Dock & Tuzla/Türkter Shipyard. Regarding to schedule, the added value of Teknomarin's expert diesel repair capabilities were put to the test.

SULZER RND 90 MAIN ENGINE OVERHAUL

Engine Room had some additional works to be done. Alternator rewinding, turbochargers overhauls, governors overhauls, daeration tank fabricating, cooling sea water pump, fuel oil burning pump, hydrophore pump and some other kinds of pumps overhauls, exhaust isolation jobs, inspection & recondition jobs and many others things to be done means that there is an *“engine room complete overhaul”* we can call it. This report includes all jobs to be done in M/V Almawashi.

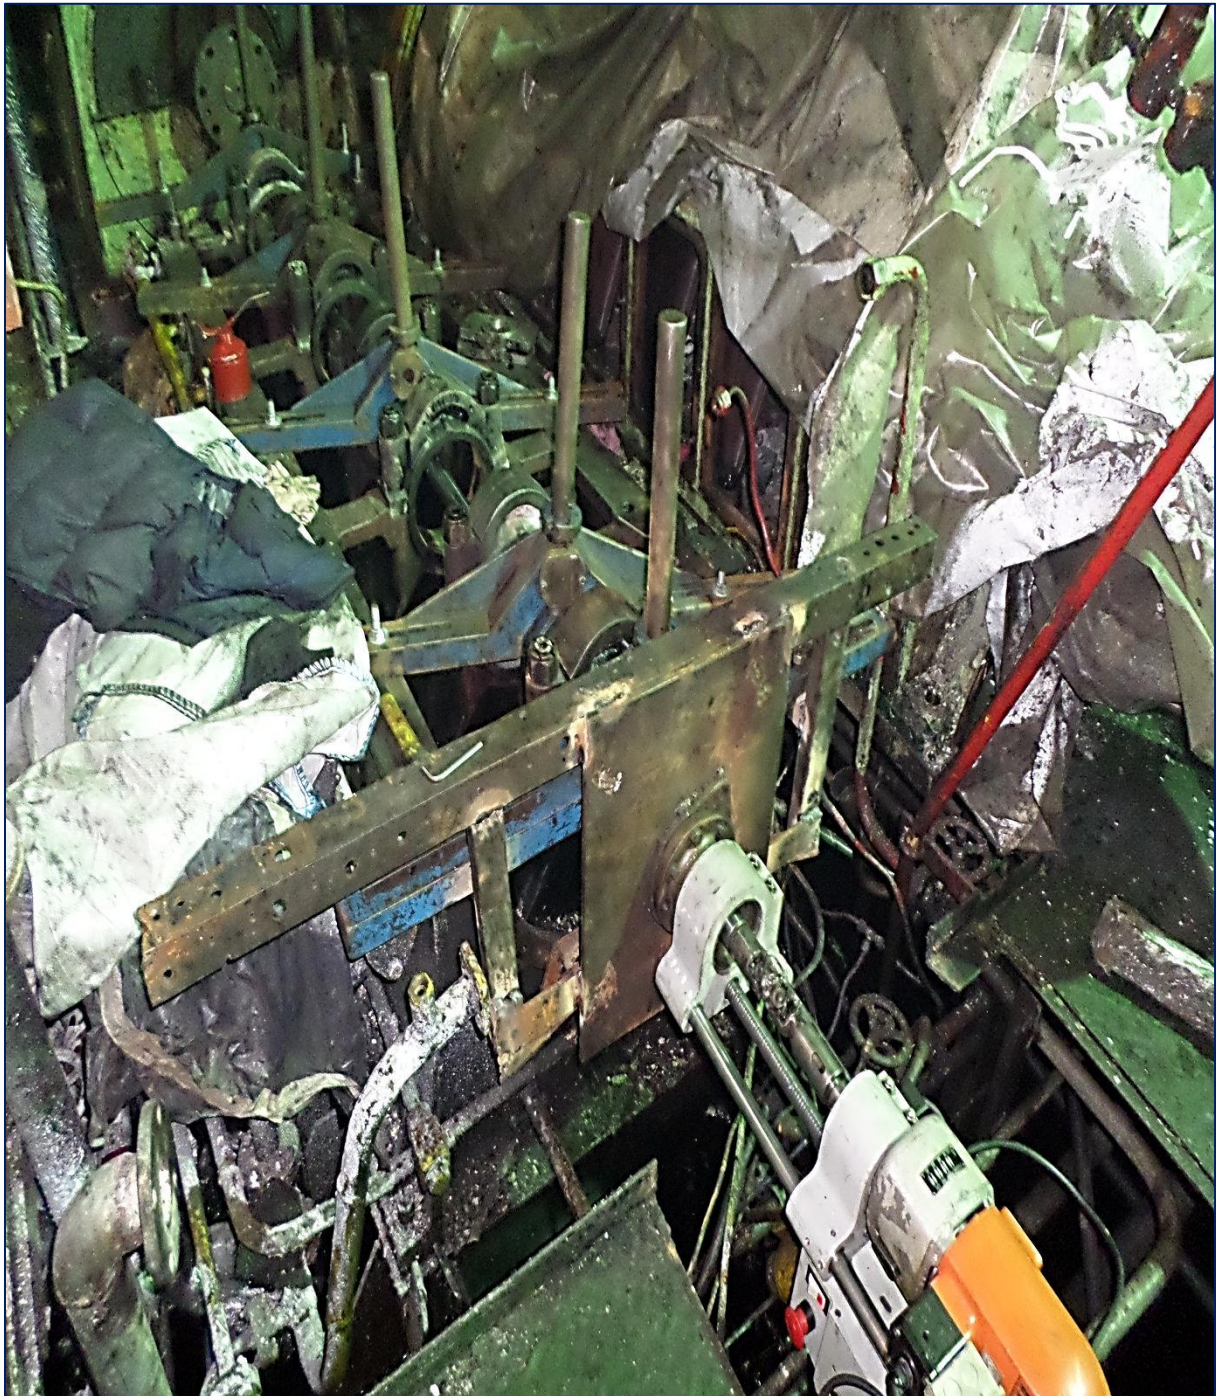
G/E NO:2 CRANKSHAFT GRINDING & BEARINGS BORING;

When the block was dismantled & shifted, crankshaft and main bearings was ready for inspection. Crankshaft also dismantled & transferred to the workshop for measurements. After inspection, we noticed that crankshaft needs to grind, bearings needs to boring. Later by measures has taken then we immediately start the boring job for main bearings.

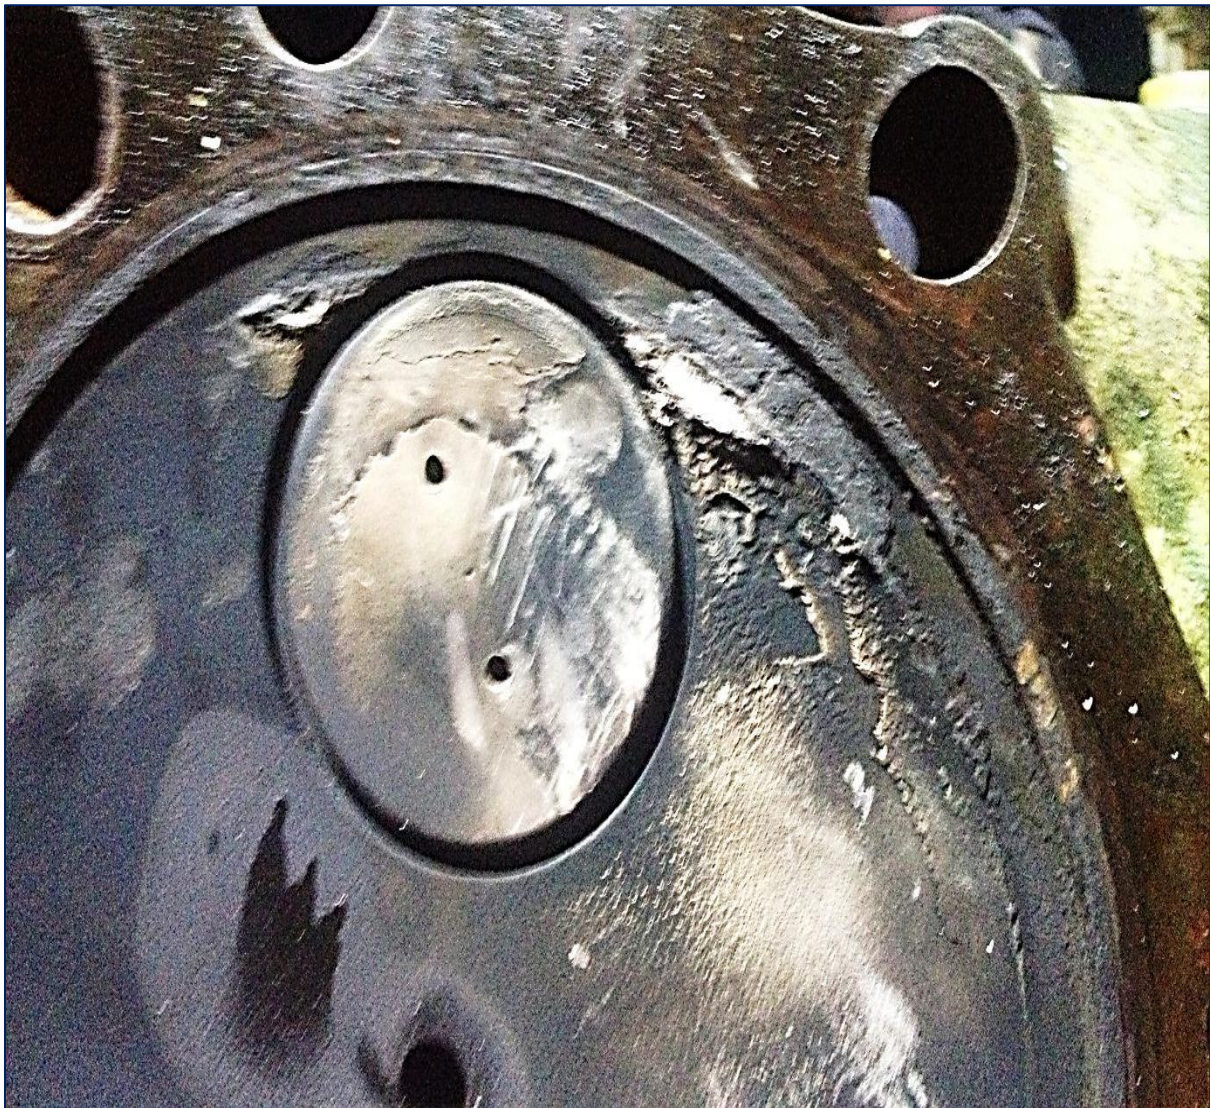
G/E NO:3 CYLINDER HEADS OVERHAUL;

All connections of cylinder heads dismantled. All cylinder heads removed from the engine for overhaul. All safety valves, starting valves and Indicator valves overhauled and tested. Indicator cocks overhauled and tested. Rockerarms dismantled, shafts and bushes measured. All inlet and exhaust valves, guides and seats were grinded and lapped. All o-rings in cylinder heads were replaced. Cylinder covers water side cleaned by chemically and hydrostatic pressure tested. Cylinder heads mounted on stu.

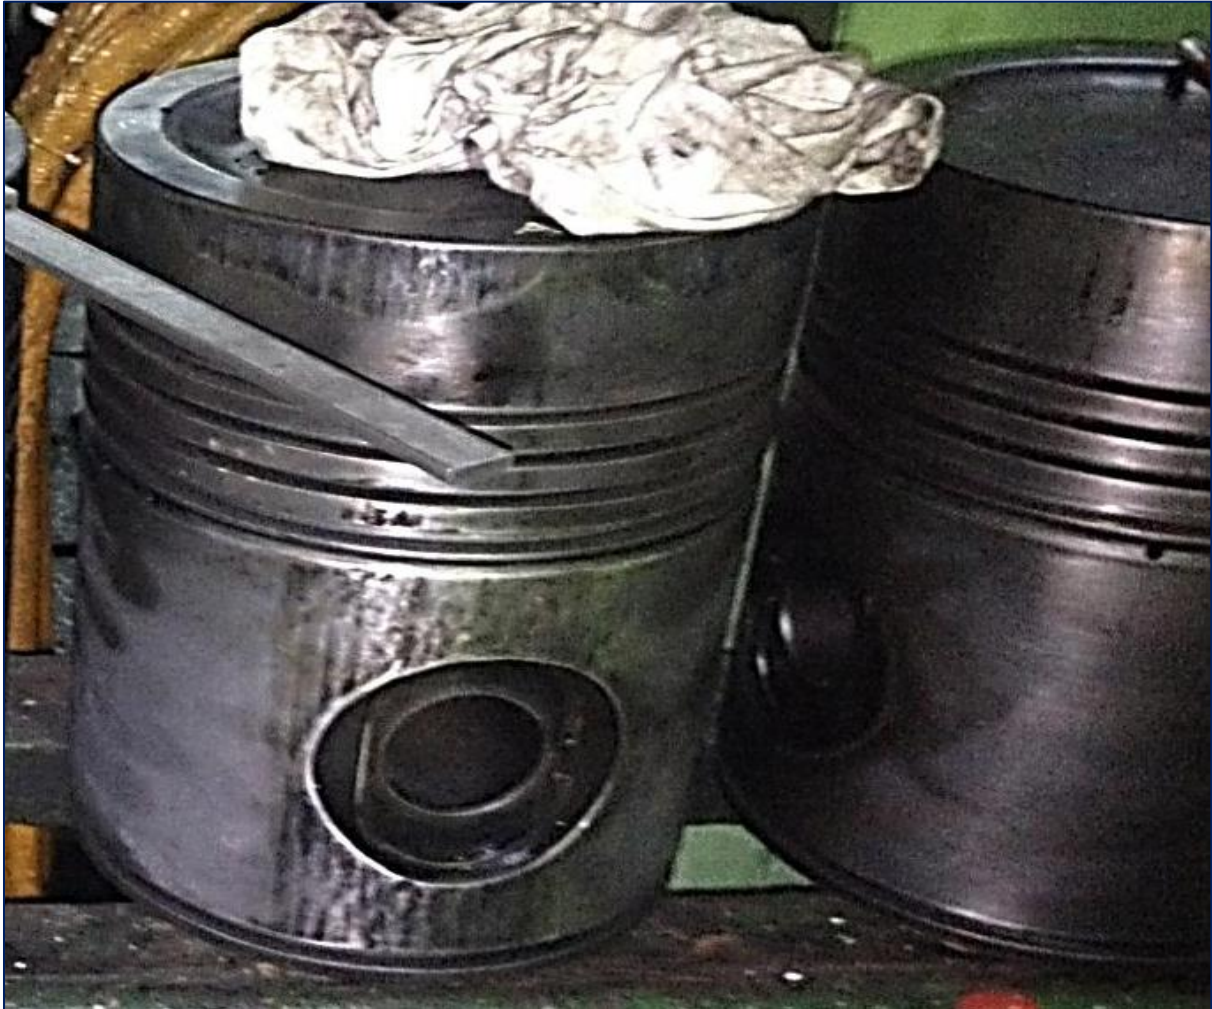
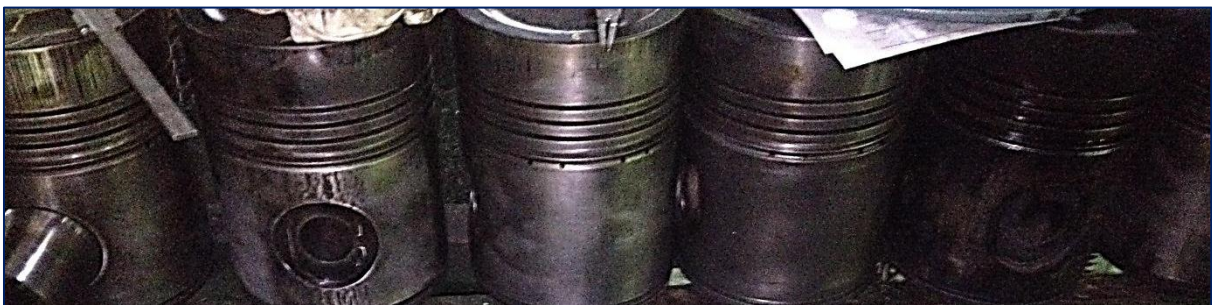
G/E NO:3 PISTONS OVERHAUL;

All pistons dismantled, taken out for inspection and measuring the big end bore ovality, small end bush, piston pin, piston ring grooves, piston pin boss. Piston crowns and skirts checked for possible cracks by dye penetrant. After taken out of measurements, all piston rings were replaced with new piston rings.

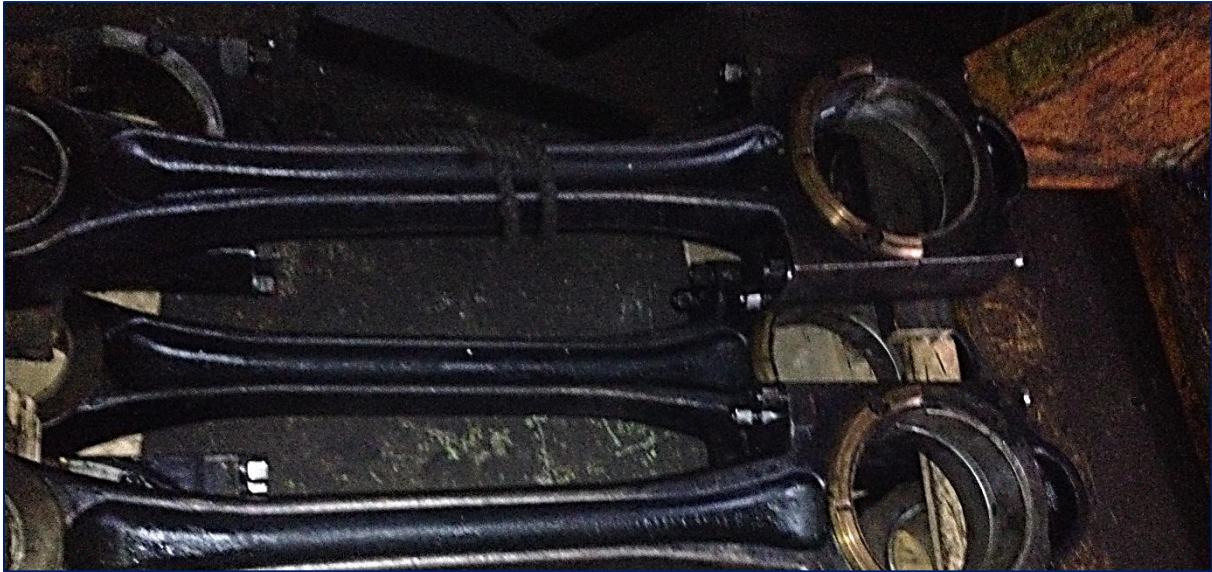
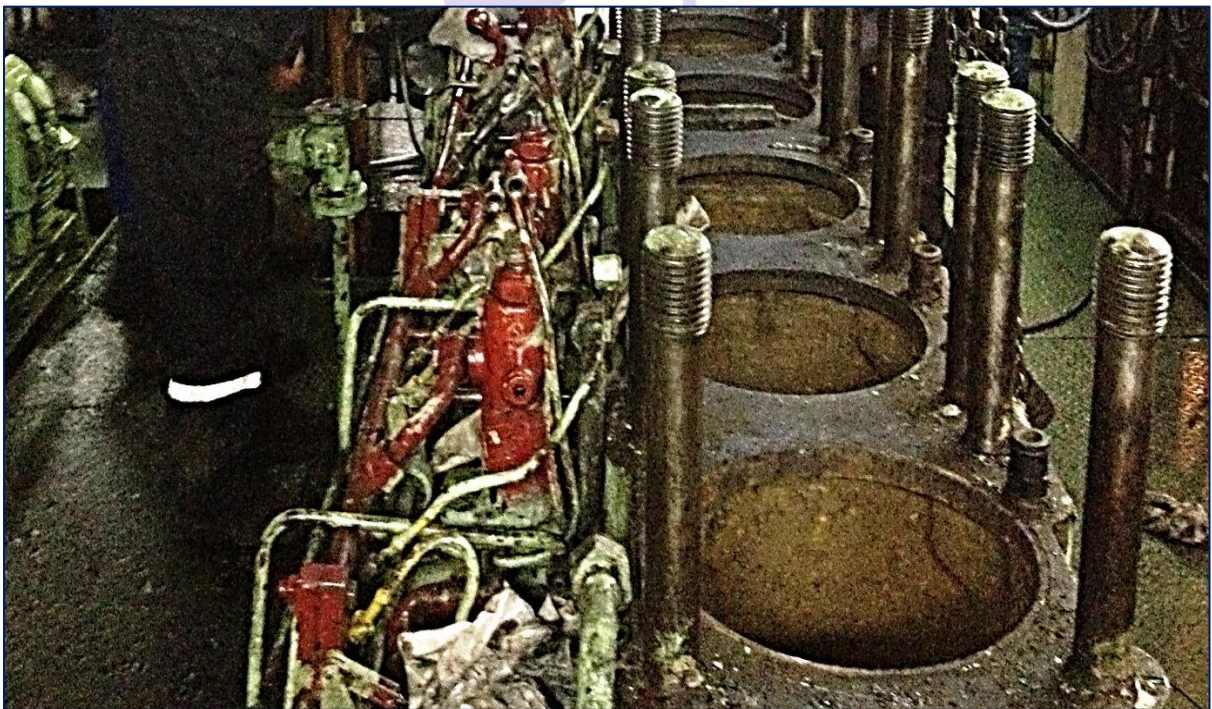
Later by all connectin rods dismantled from pistons & measured one by one. Meanwhile connectin rod ovality control and with & without bearing measures has already taken .We noticed that all connectin rods needs boring after measures. All connectin rod bearings fabricated according to last measures taken by TEKNOMARIN technicians. Meanwhile connectin rod boring also finished & also rods delivered to the vessel, following all connectin rods with piston crowns mounted on stu. Meanwhile boring has started for connectin rods when liners disassembled.

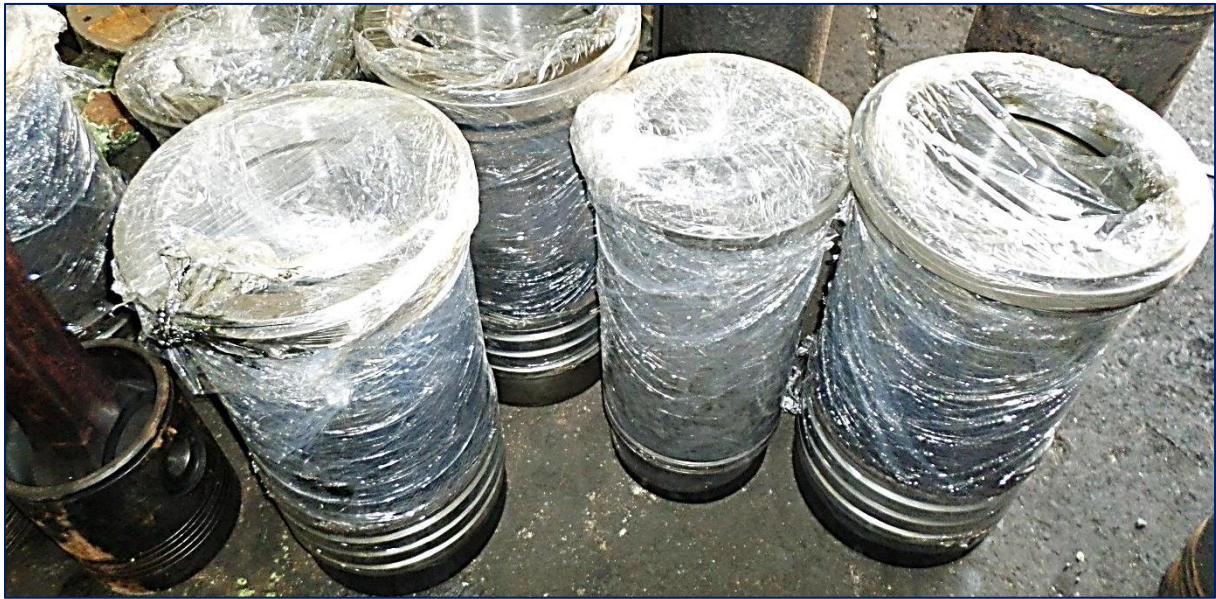
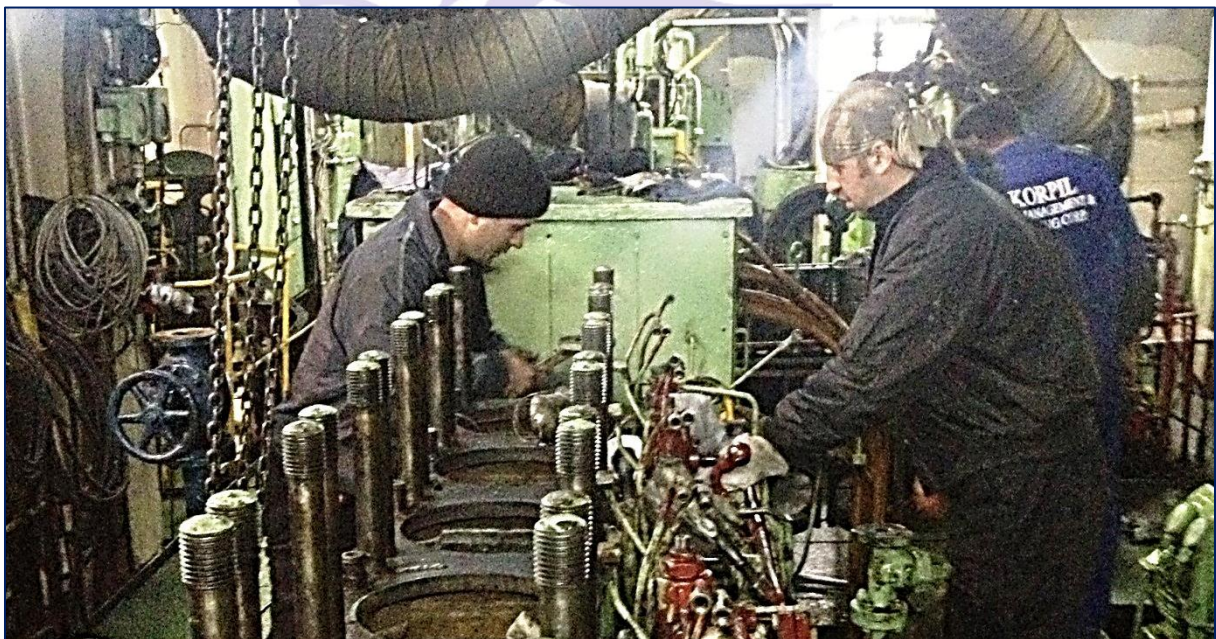
G/E NO:3 LINERS OVERHAUL;

All cylinder liners were dismantled. All liners cleaned, inspected and measured. After measurements and inspections, liners prepared to be re-fitted with new o-rings. Meanwhile liners were already honned and delivered to the vessel and shifted to engine room. Honned liners mounted on block with new o-rings & gaskets that exist supplied from ship store by vessel crew. Missing o-rings & gaskets fabricated by TEKNOMARIN technicians as samples. All liners prepared to mounted on stu.

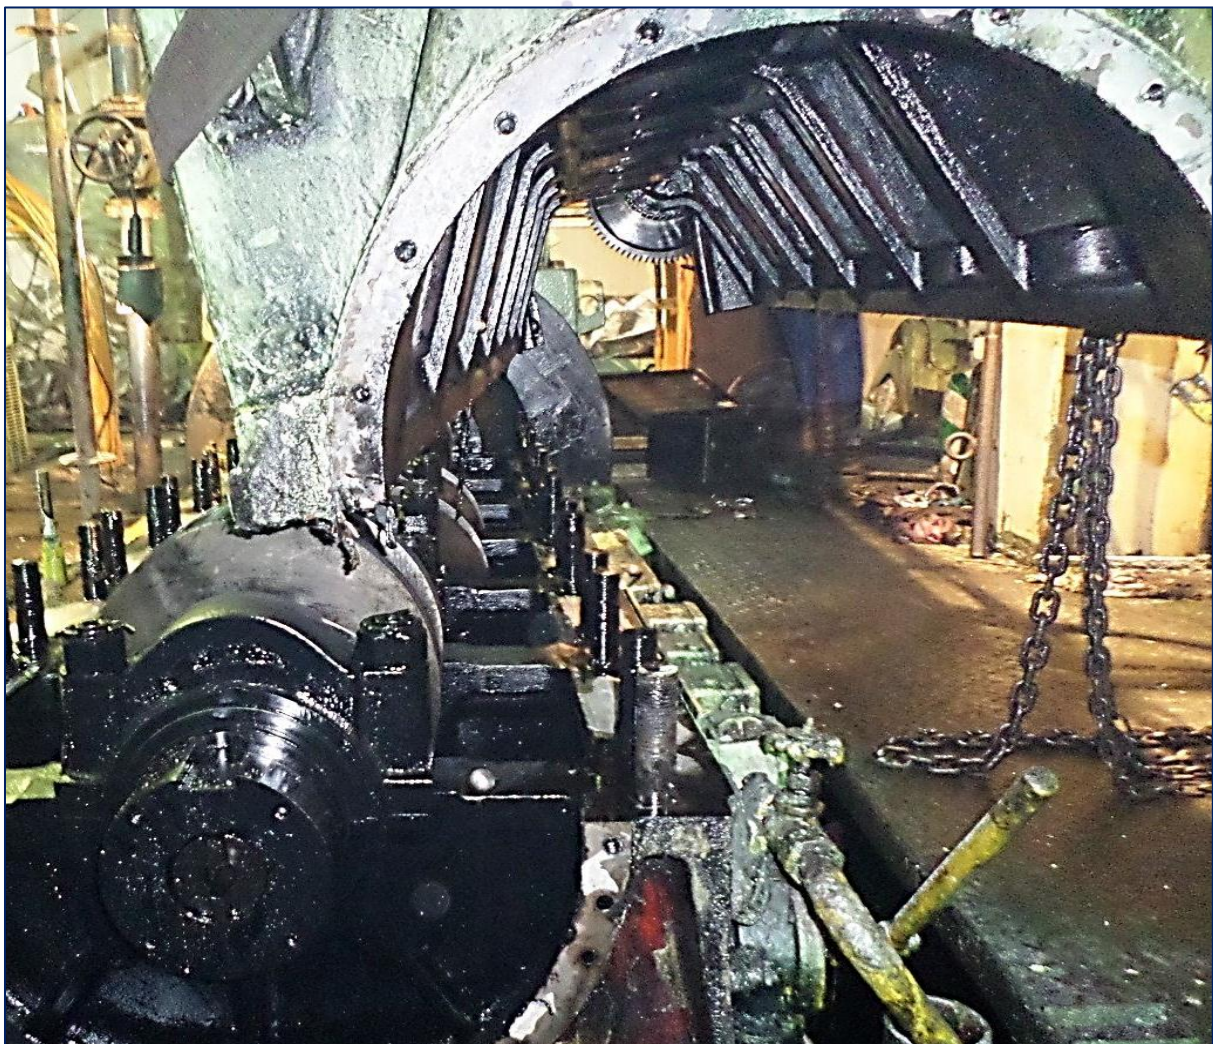
G/E NO:3 CRANKSHAFT INSPECTION & ENGINE BLOCK SHIFTING;

Block completely lifted & shifted in engine room. Alternator also slightly shifted in engine room by vessel crew. Crankshaft has dismantled & transferred to the workshop & inspected. Also measured. After inspection and measurements, cracks and under/oversized bearings noticed & marked. Also we noticed that two of the top cap has cracked. Welding job has started for the cracked top cap. Bedplate boring & main bearing fabricating immediately started and finished. Grinding, boring, welding and fabricating jobs for crankshaft has done and all measurements taken once again and engine started to assembly. After the flywheel studs fabrication, crankshaft mounted and assembled with flywheel in stu. Alternator slightly shifted once again to be connected with crankshaft. In the meantime, deflection of crankshaft has been taken and lined with alternator's rotor. Engine block & jackets inspected for cracks. Found none. Thus engine block immediately mounted & lined with the bedplate.

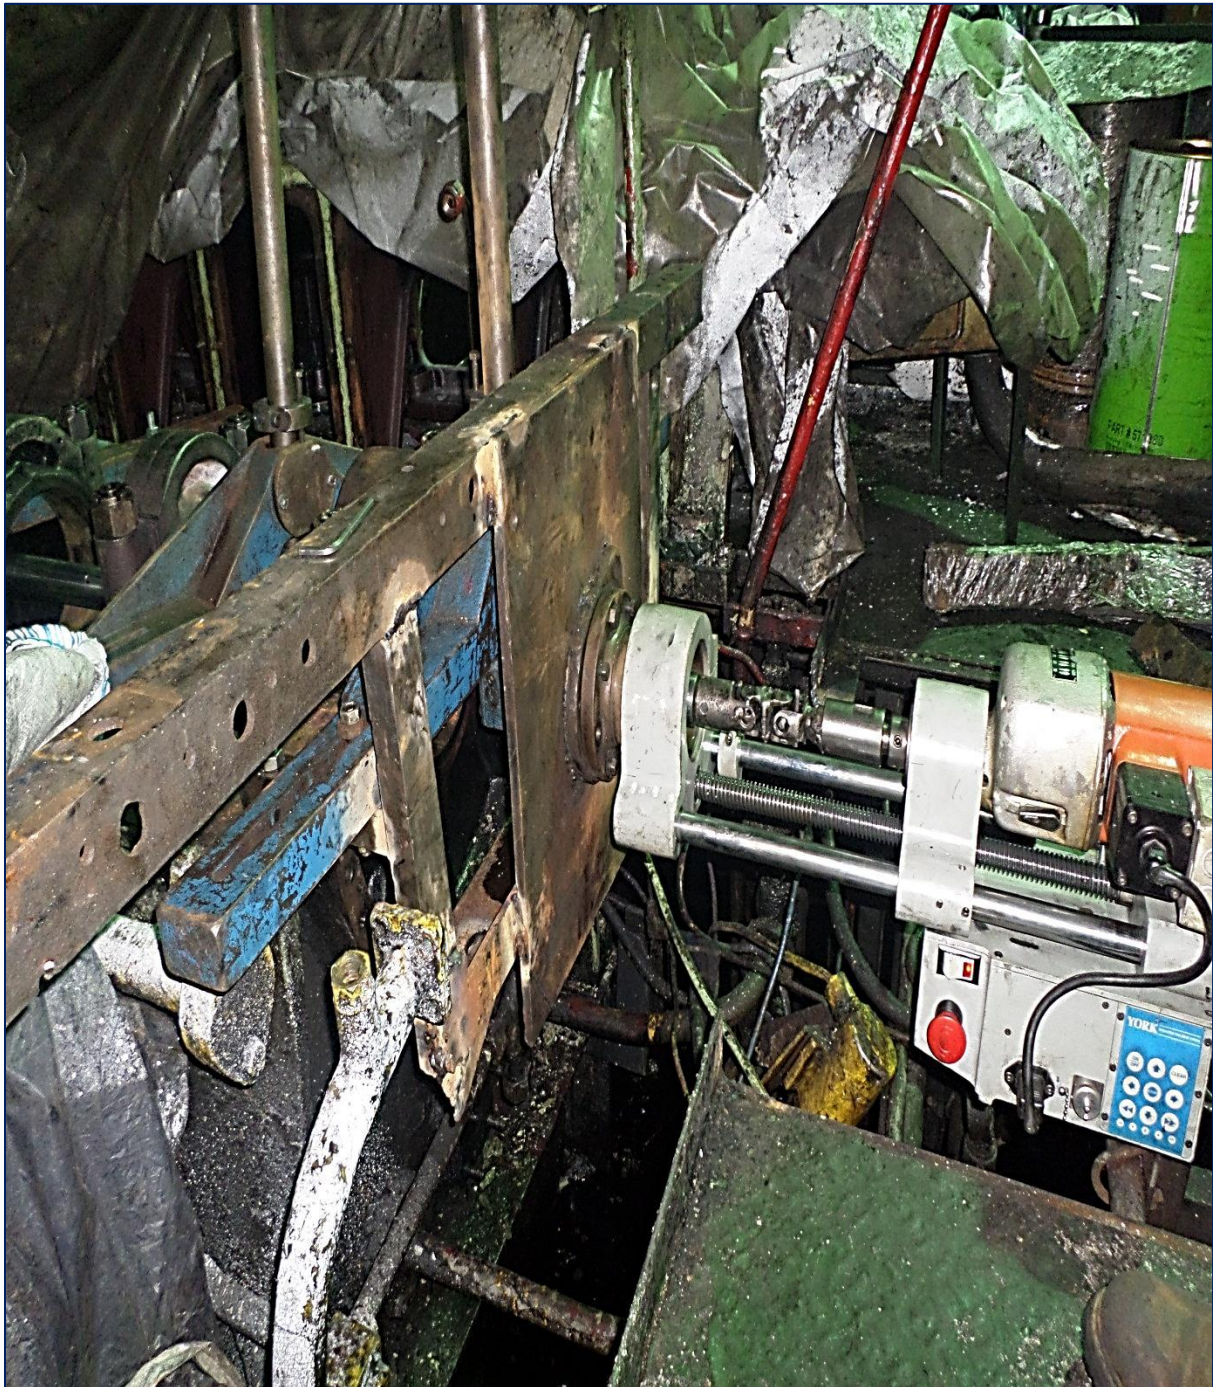
G/E NO:3 CRANKSHAFT GRINDING & BEARINGS BORING;

When the block was dismantled & shifted, crankshaft and main bearings was ready for inspection. Crankshaft also dismantled & transferred to the workshop for measurements. After inspection, we noticed that crankshaft needs to grind, bearings needs to boring. Later by measures has taken then we immediately start the boring job for main bearings.

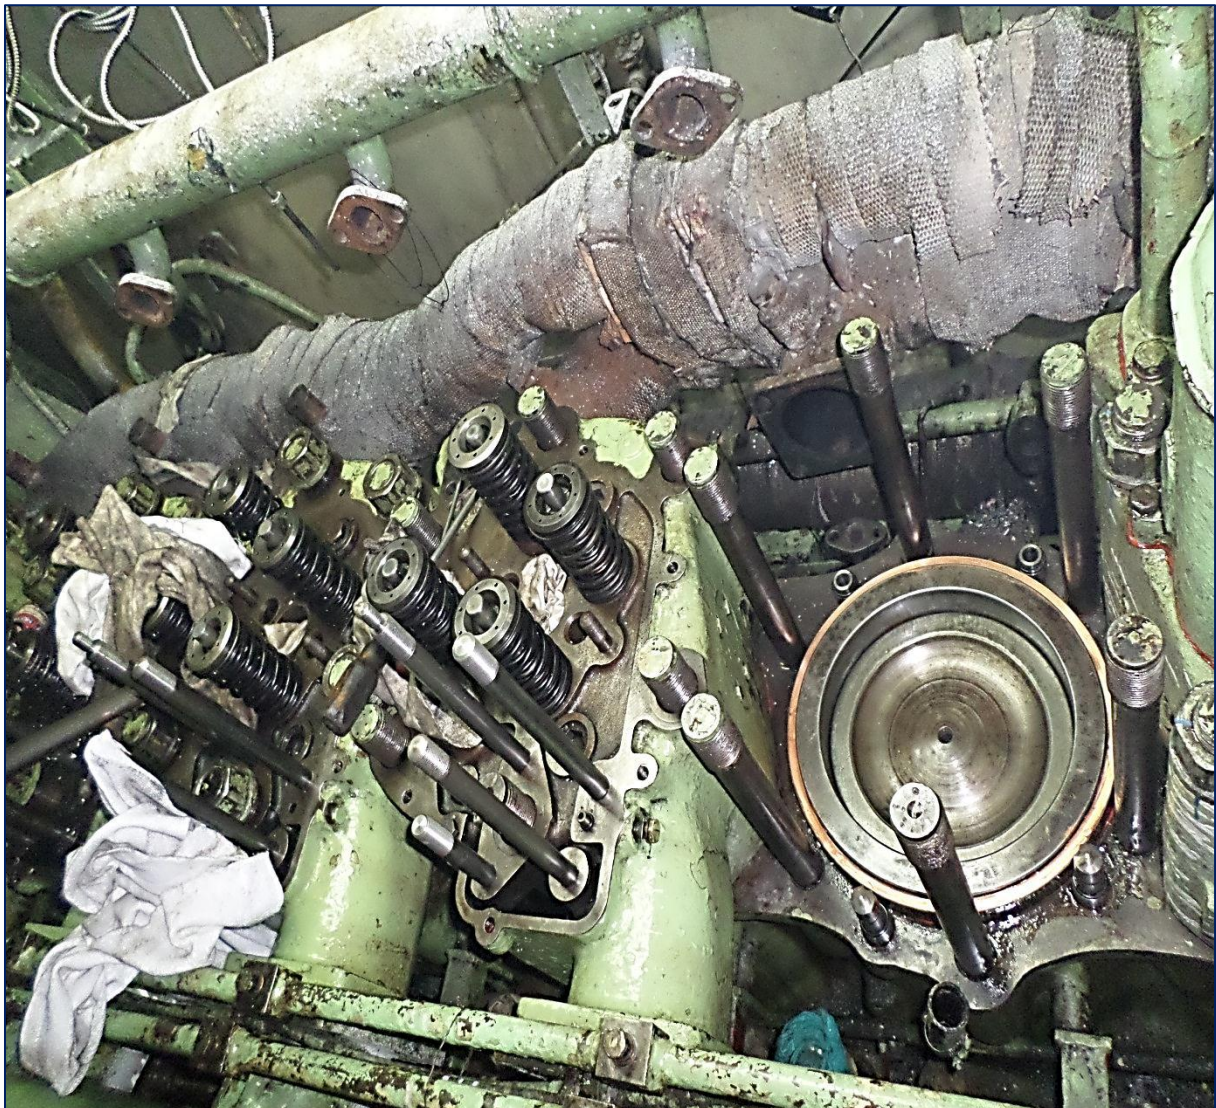
G/E NO:4 CYLINDER HEADS OVERHAUL;

All connections of cylinder heads dismantled. All cylinder heads removed from the engine for overhaul. All safety valves, starting valves and Indicator valves overhauled and tested. Indicator cocks overhauled and tested. Rockerarms dismantled, shafts and bushes measured. All inlet and exhaust valves, guides and seats were grinded and lapped. All o-rings in cylinder heads were replaced. Cylinder covers water side cleaned by chemically and hydrostatic pressure tested. Cylinder heads mounted on stu.

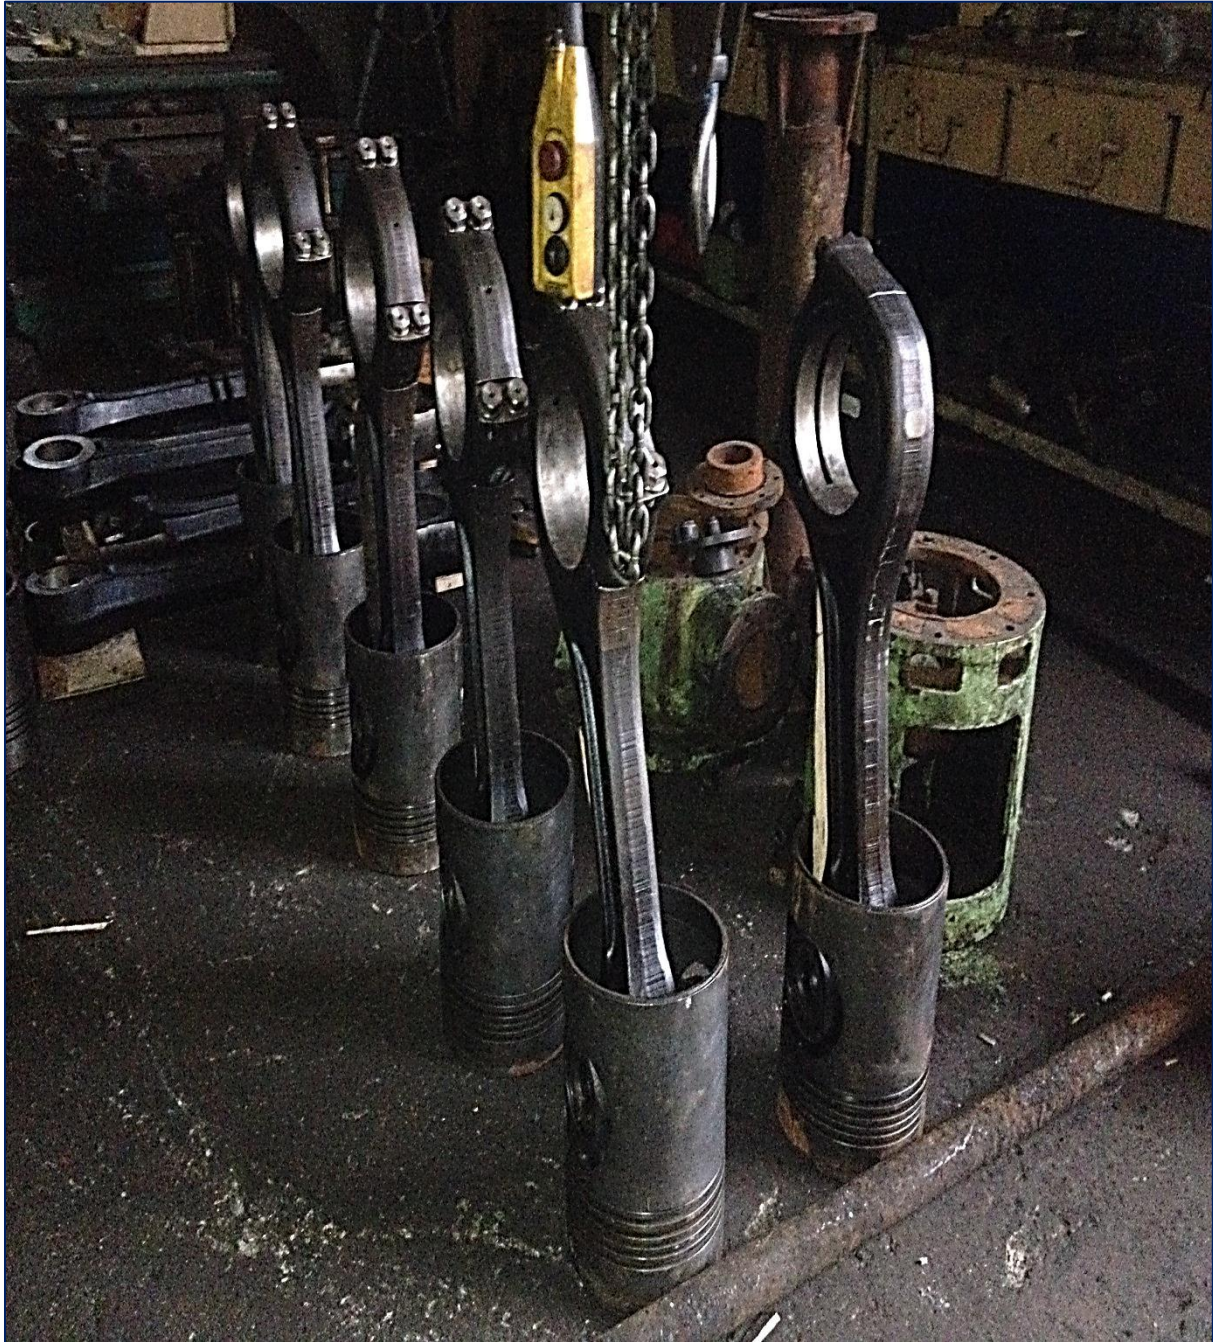
G/E NO:4 PISTONS OVERHAUL;

All pistons dismantled, taken out for inspection and measuring the big end bore ovality, small end bush, piston pin, piston ring grooves, piston pin boss. Piston crowns and skirts checked for possible cracks by dye penetrant. After taken out of measurements, all piston rings were replaced with new piston rings. And all piston reconditioned.

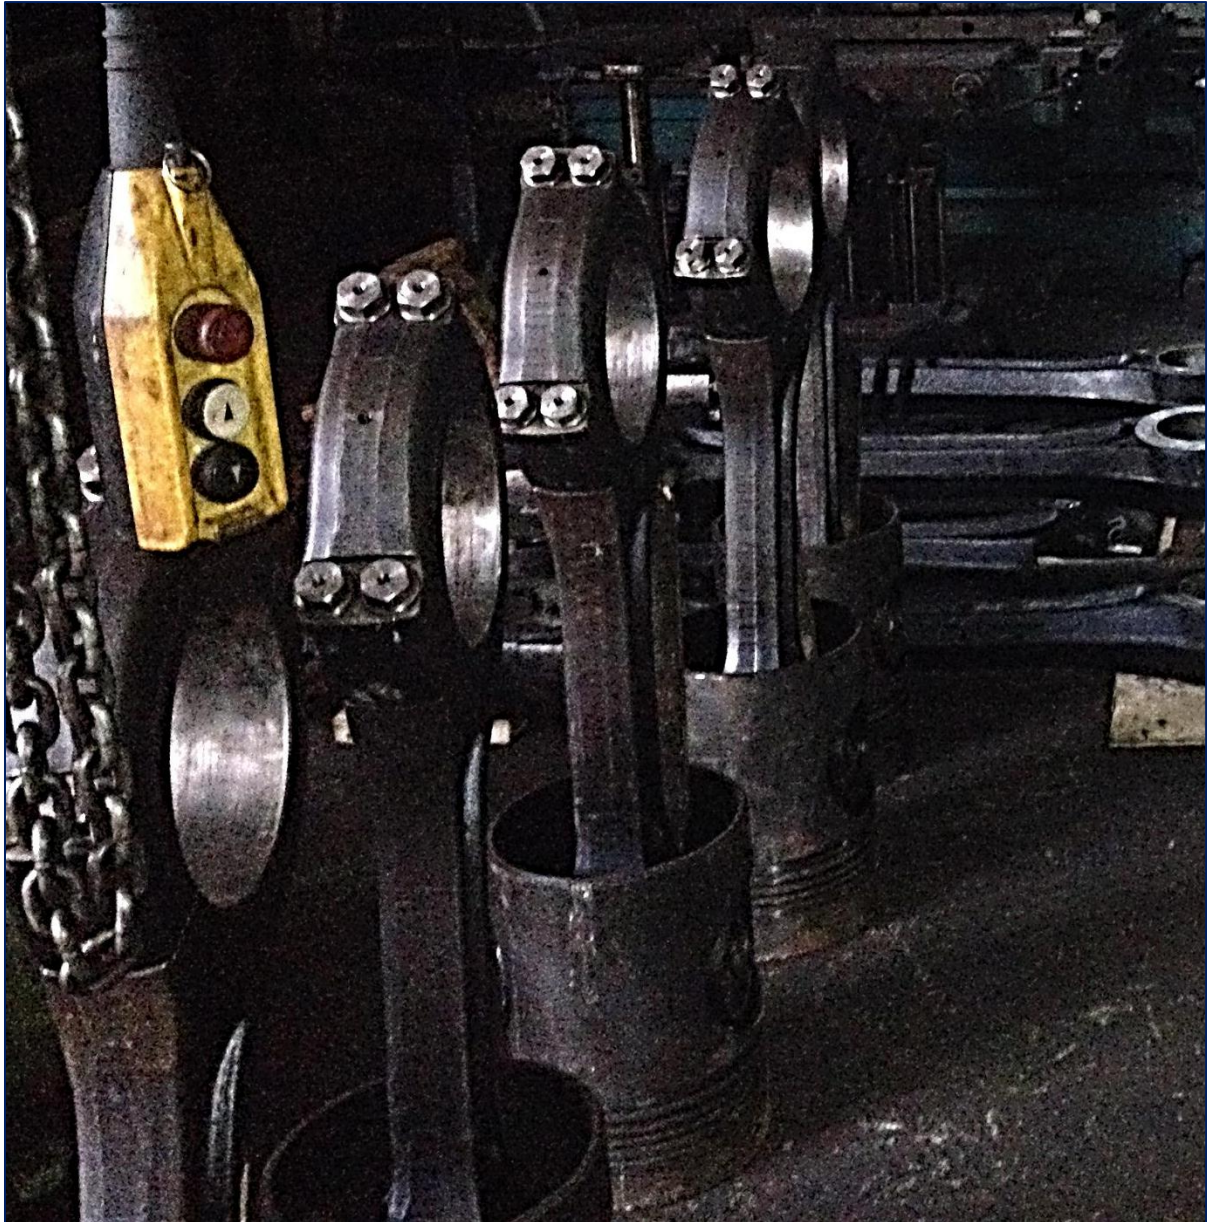
Later by all connectin rods dismantled from pistons & measured one by one including the spare that in vessel. Meanwhile connectin rod ovality control and with & without bearing measures has already taken . We noticed that all connectin rods needs boring after measures. All connectin rod bearings fabricated according to last measures taken by TEKNOMARIN technicians. Meanwhile connectin rod boring also finished & also rods delivered to the vessel, following all connectin rods with piston crowns mounted on stu. Meanwhile boring has started for connectin rods when liners disassembled.

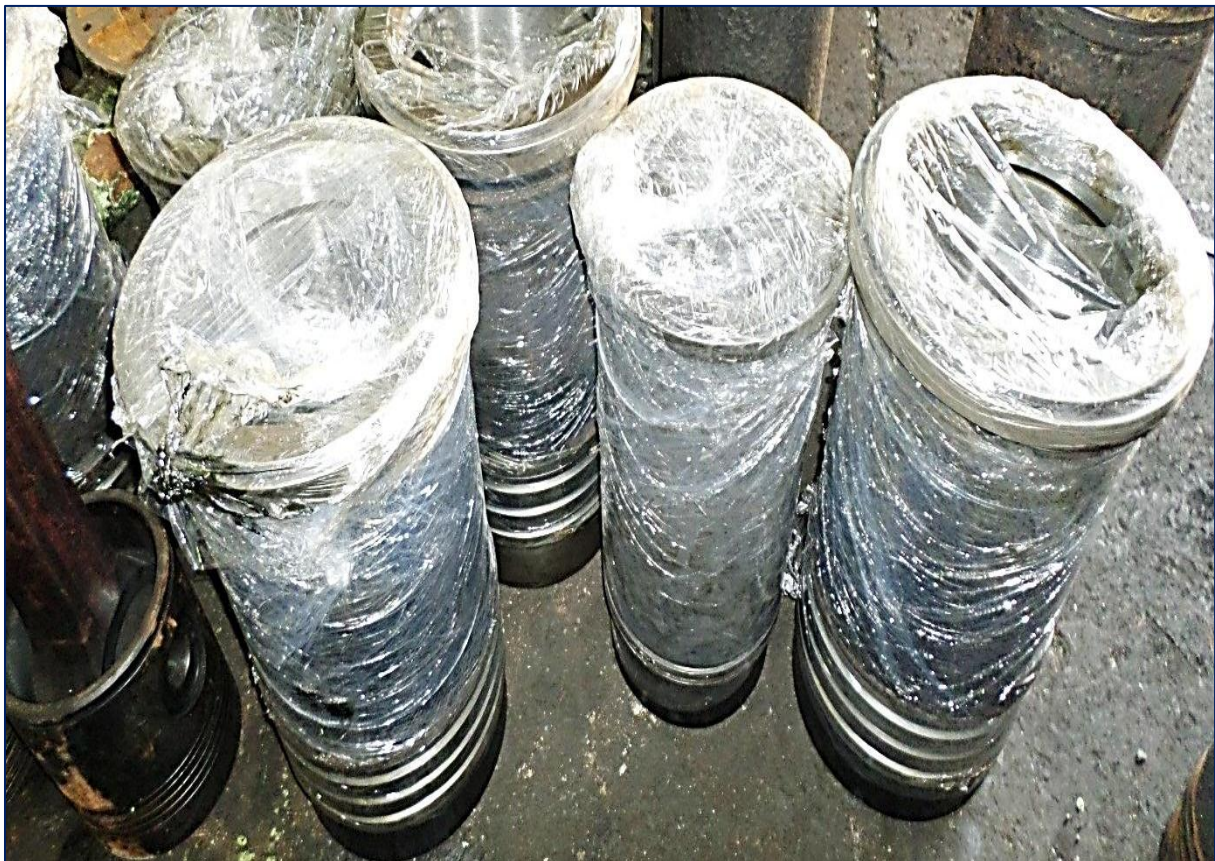
G/E NO:4 LINERS OVERHAUL;

All cylinder liners were dismantled. All liners cleaned, inspected and measured. After measurements and inspections, liners prepared to be re-fitted with new o-rings. Meanwhile liners were already honned and delivered to the vessel and shifted to engine room. Honned liners mounted on block with new o-rings & gaskets that exist supplied from ship store by vessel crew. Missing o-rings & gaskets fabricated by TEKNOMARIN technicians as samples. All liners prepared to mounted on stu.

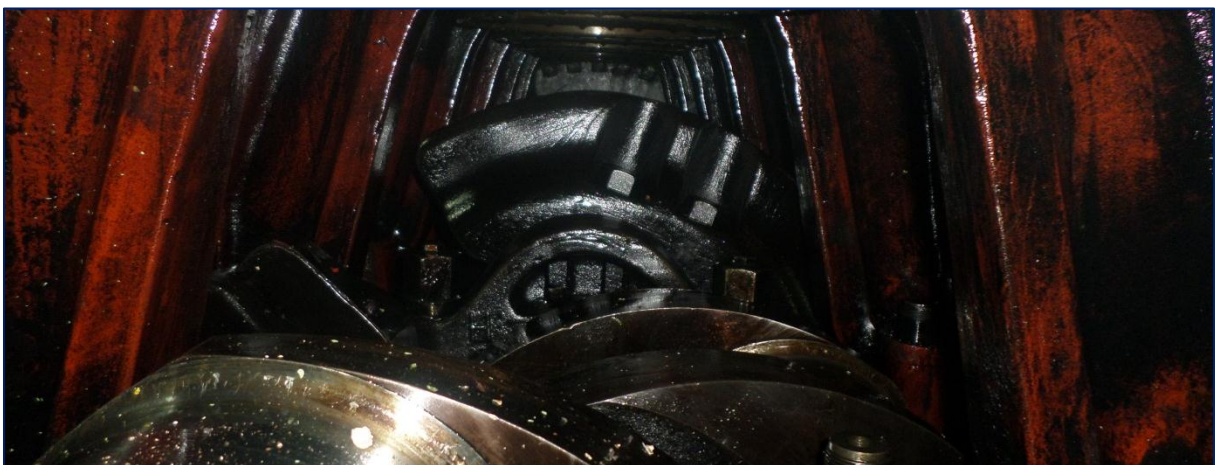
G/E NO:4 BLOCK LIFTING & CRANKSHAFT DISMOUNTING;

Regarding to our inspection with Generator Engine No:4 Crankshaft, we noticed that the crankshaft non-flywheel sides bushes has broken & there was some bending on crankshaft & should be boring. After the dismantling of crankshaft, it has transferred to the workshop & main bearing, crankshaft boring job has already started.

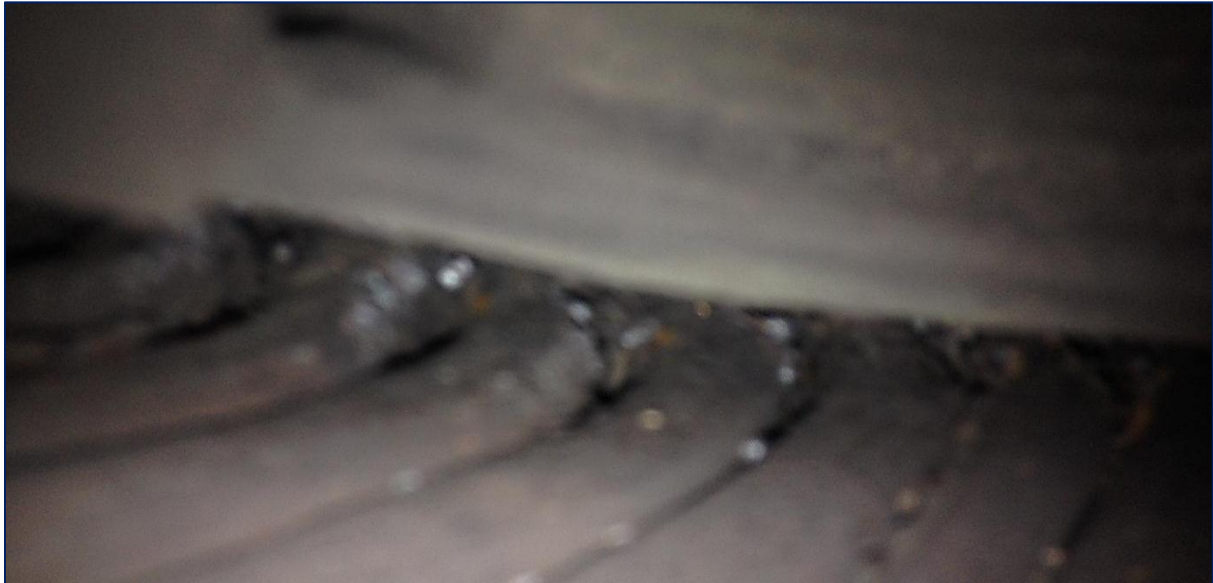
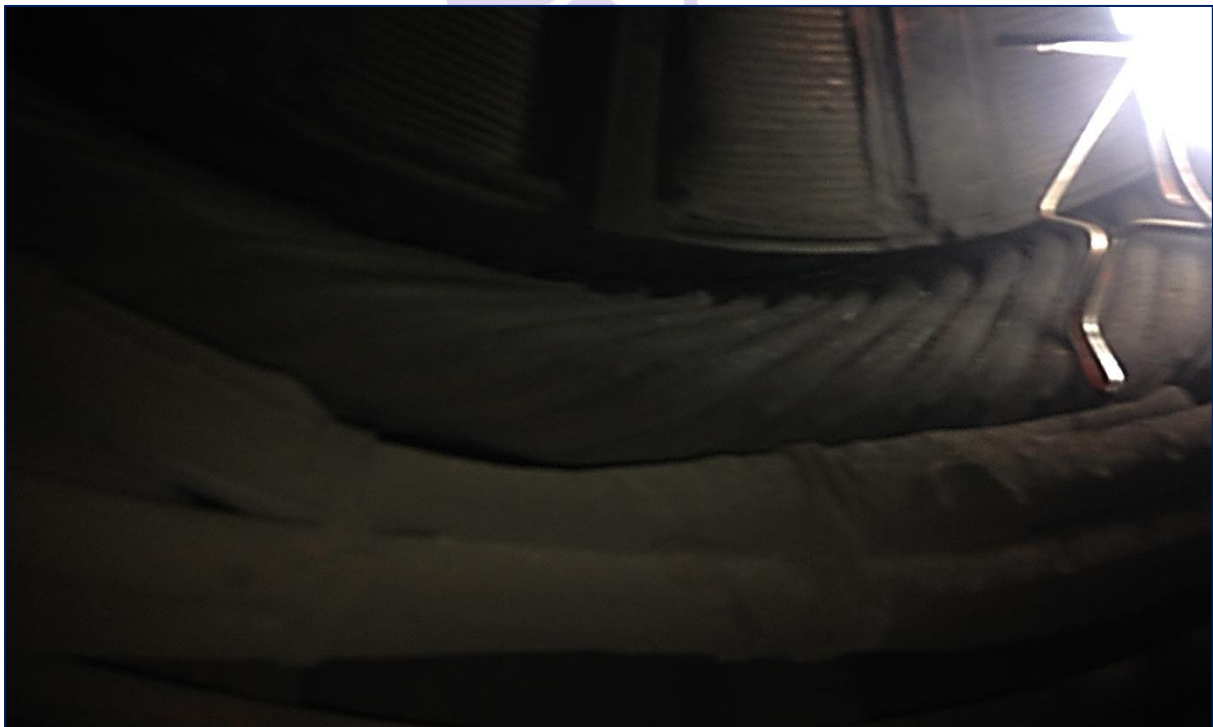
G/E NO:4 ALTERNATOR REWINDING;

Regarding to our inspection with Generator Engine No:4 Alternator, we noticed that the alternator was burned & should be rewind. Cause of the place & terms, rewind must to be on stu. After the measurements & continuos inspection, alternator has disassembled & rotor has been taken out. Alternator rewinding started immediately, after the completion of rewinding, mounted on stu & tested. **Operative.**

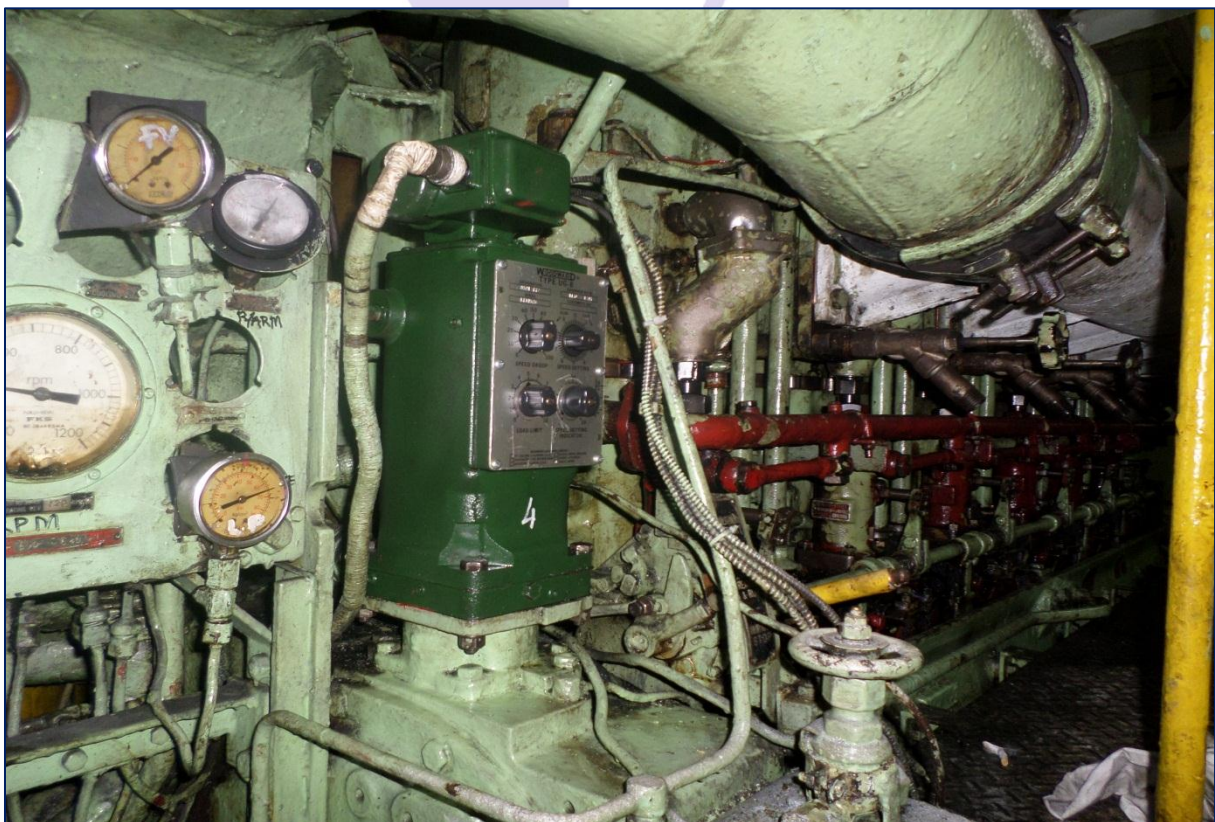
G/E NO:4 GOVERNOR OVERHAUL;

Governor has dismantled from the Generator Engine No:4 and transferred to the workshop. Later by governor has disassembled and checked as inspection. All clutch, lever & bracket system inspected & tested. Shaft & sleeve assemblies checked. Also governor block, bushings & springs inspected & assembled once again. Transferred to the vessel & mounted on stu.
