INTRODUCTION

Engines need regular interval overhaul. All units of main engine and auxiliary engines needed to be overhauled while the vessel in Tuzla/Anchorage Area, Tuzla/Gemsan Dry Dock & Tuzla/Türkter Shipyard. Regarding to schedule, the added value of Teknomarin's expert diesel repair capabilities were put to the test.

SULZER RND 90 MAIN ENGINE OVERHAUL

Engine Room had some additional works to be done. Alternator rewinding, turbochargers overhauls, governors overhauls, daeration tank fabricating, cooling sea water pump, fuel oil burning pump, hydrophore pump and some other kinds of pumps overhauls, exhaust isolation jobs, inspection & recondition jobs and many others things to be done means that there is an *“engine room complete overhaul”* we can call it. This report includes all jobs to be done in M/V Almawashi.

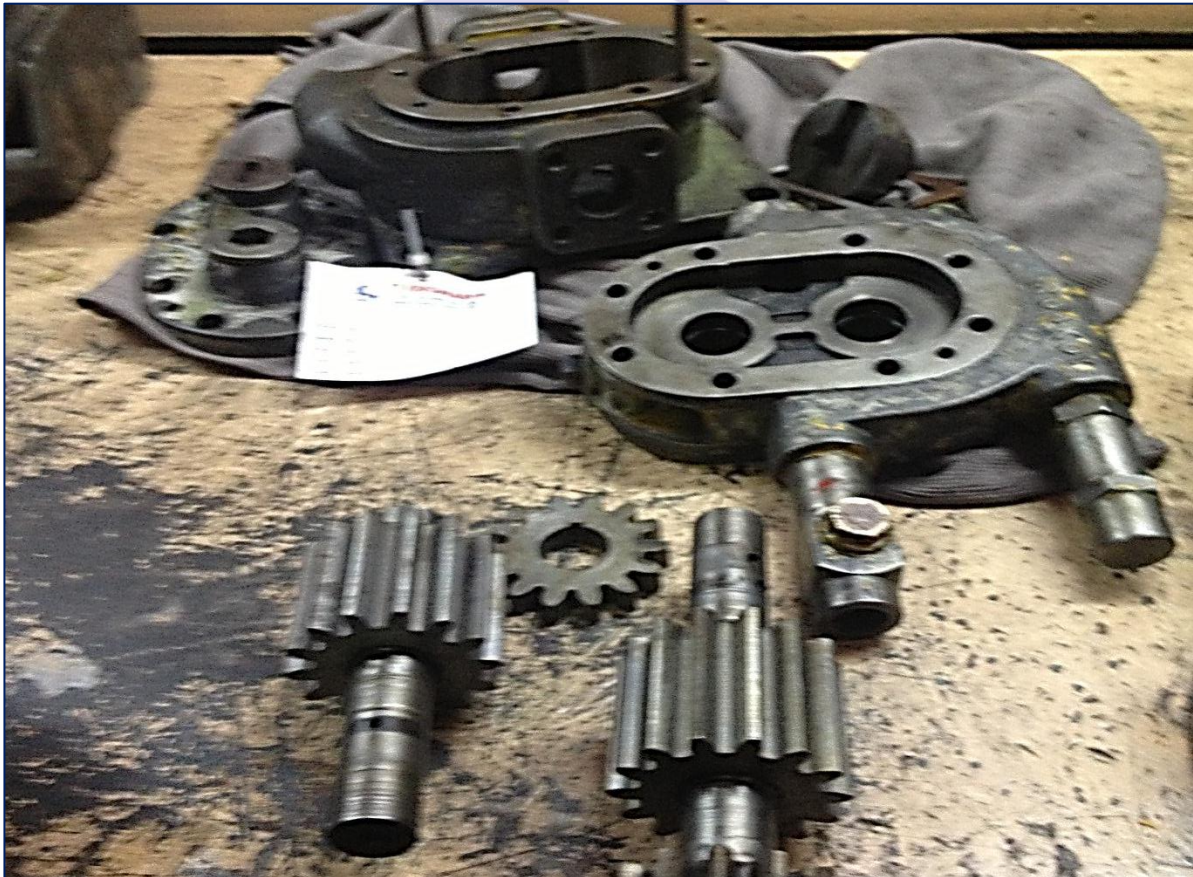
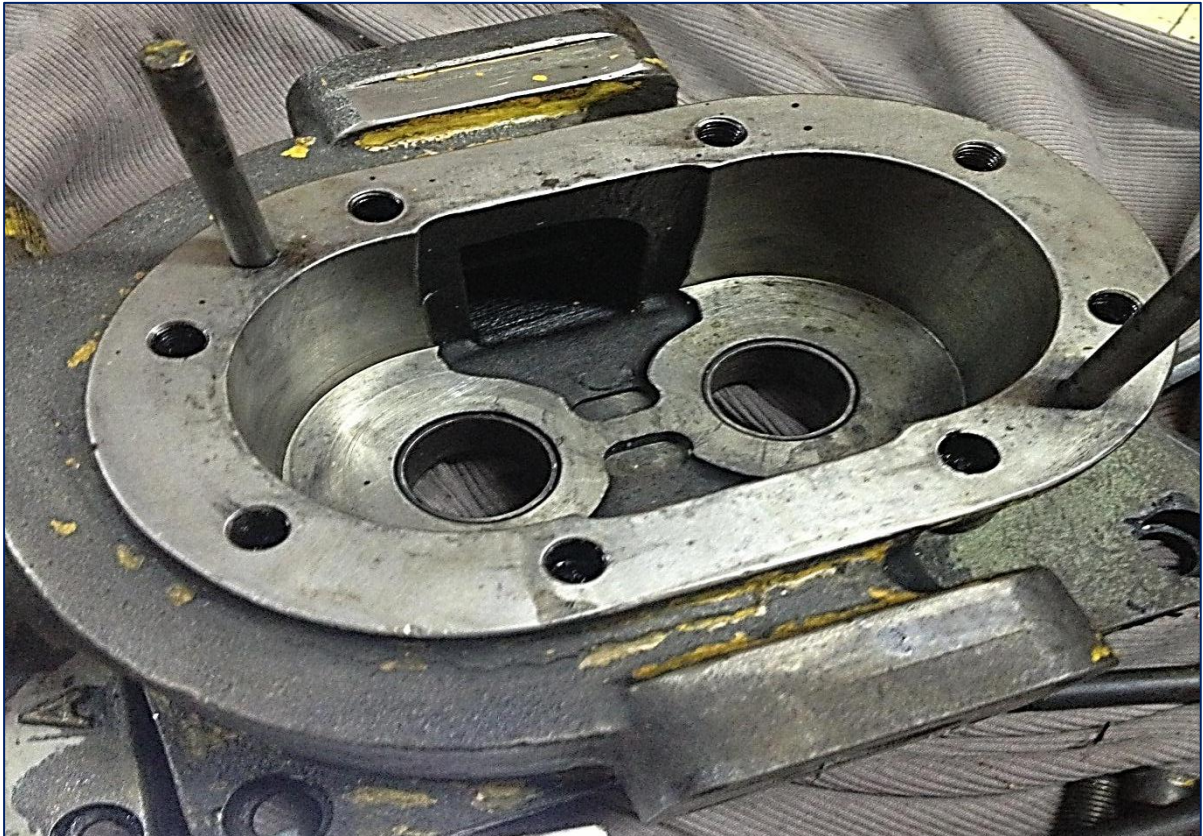
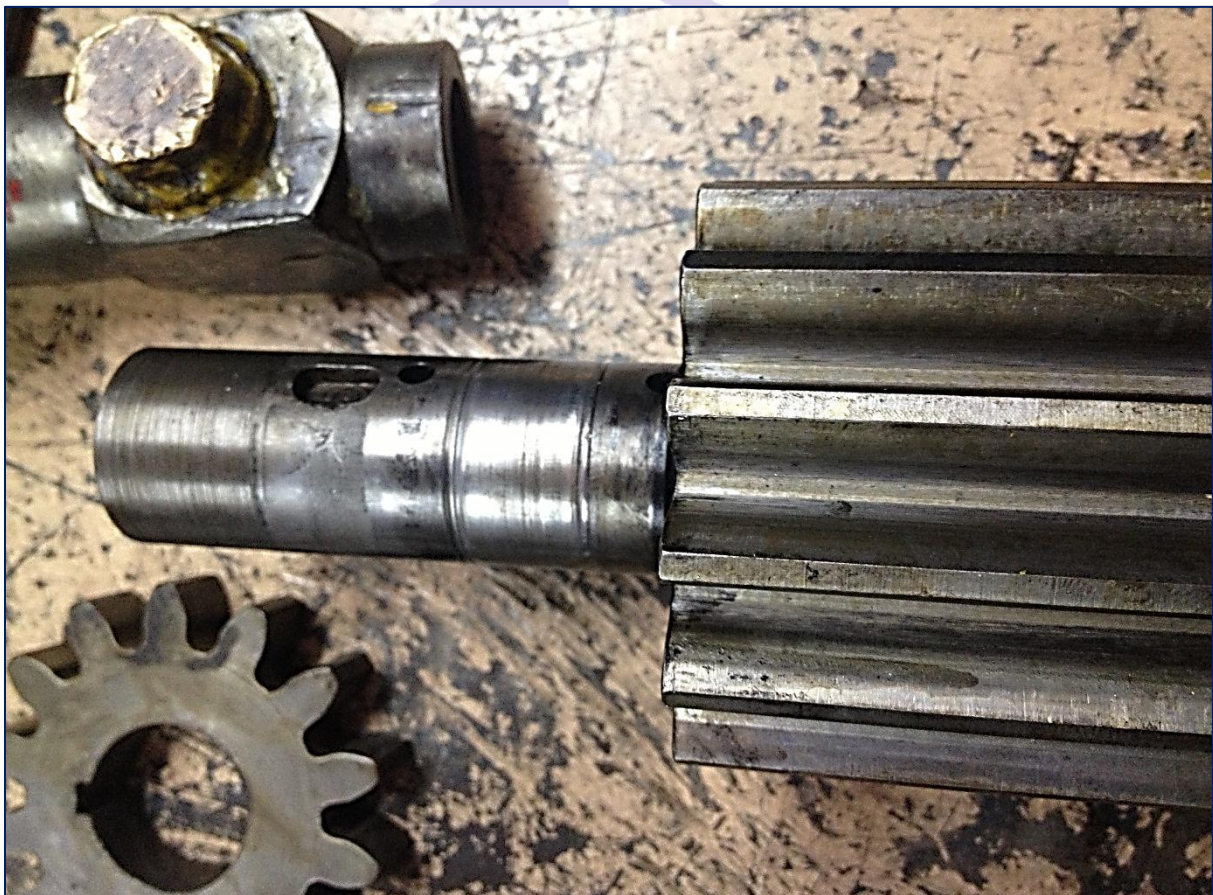
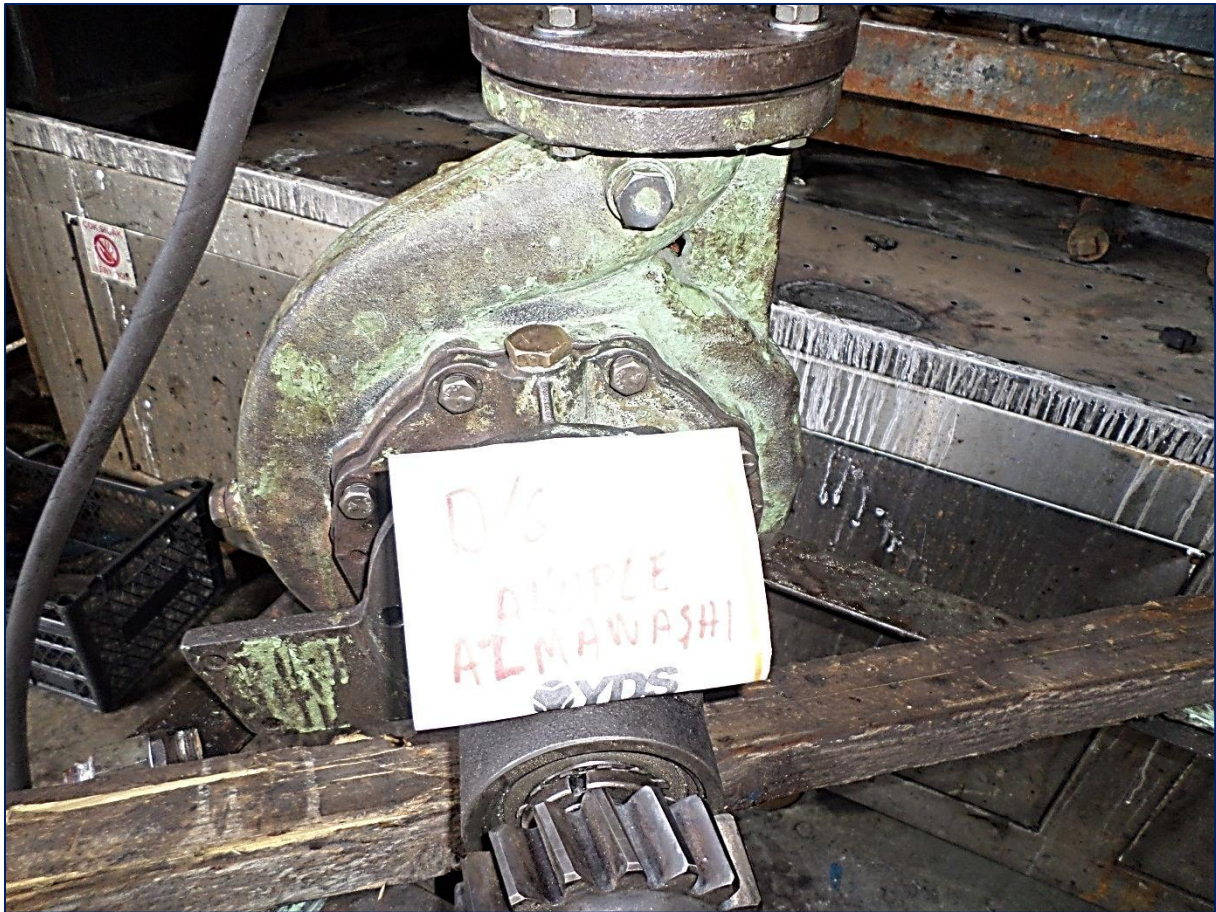
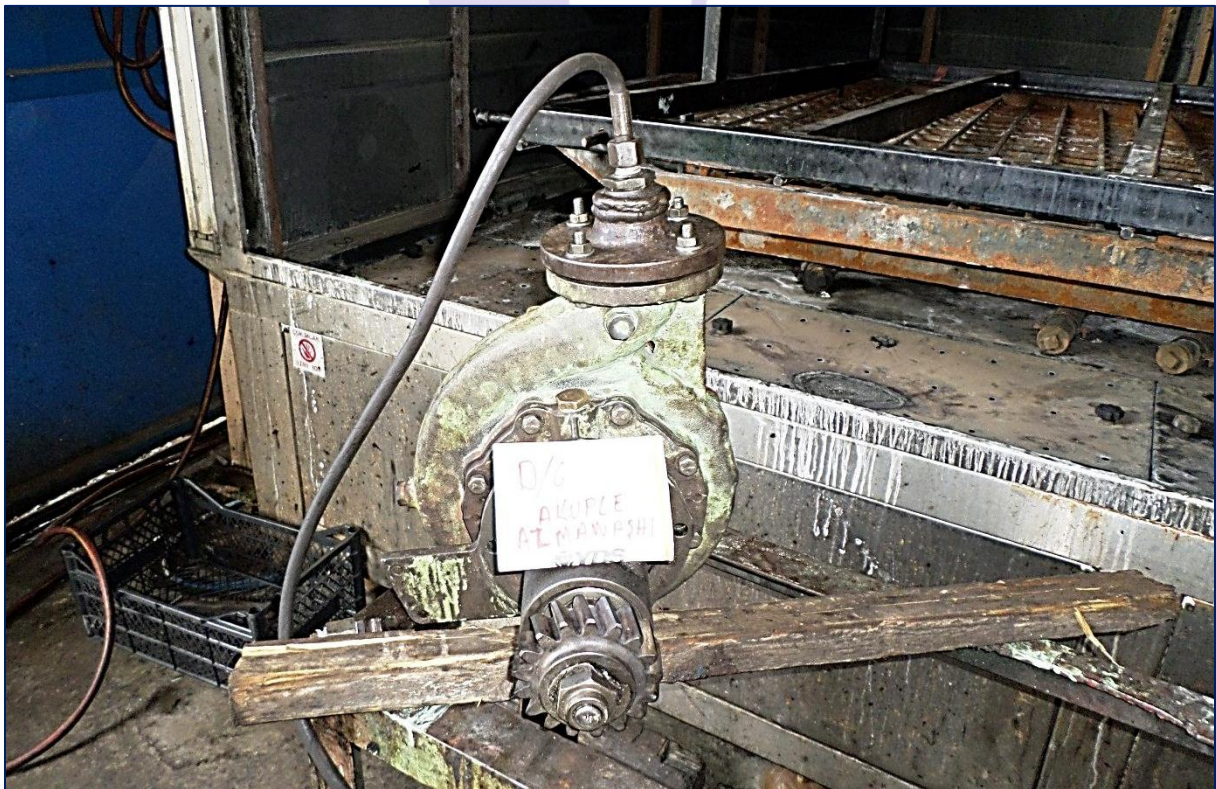
All attached lub.oil pumps of Generator Engine No:1,2,3,4 has dismantled & transferred to the workshop. Disassembled for inspection & reconditioned. Some of the gear type lub.oil pump's gears cleaned, polished & fitted. Also roller bearing has renewed & fitted with engine bearing. After recondition all attached lub.oil pumps assembled & transferred to the vessel and mounted on stu immediately.

Attach fresh water pump of Generator Engine No:4 has dismantled & transferred to the workshop. Disassembled for inspection & recondition. This pump was centrifugal type so all roller bearings has renew.After the fitting of shaft,impeller assembled immediately & transferred to the vessel for mounting on stu.

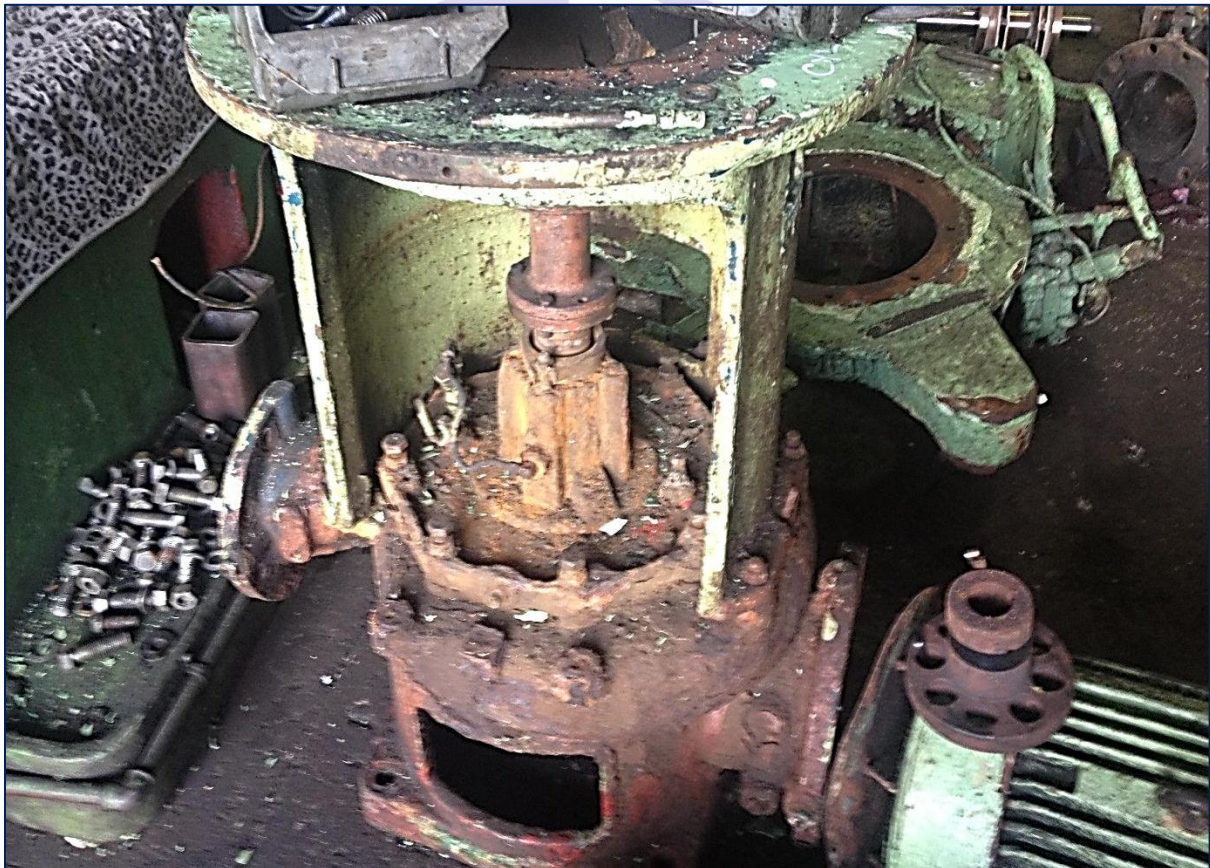
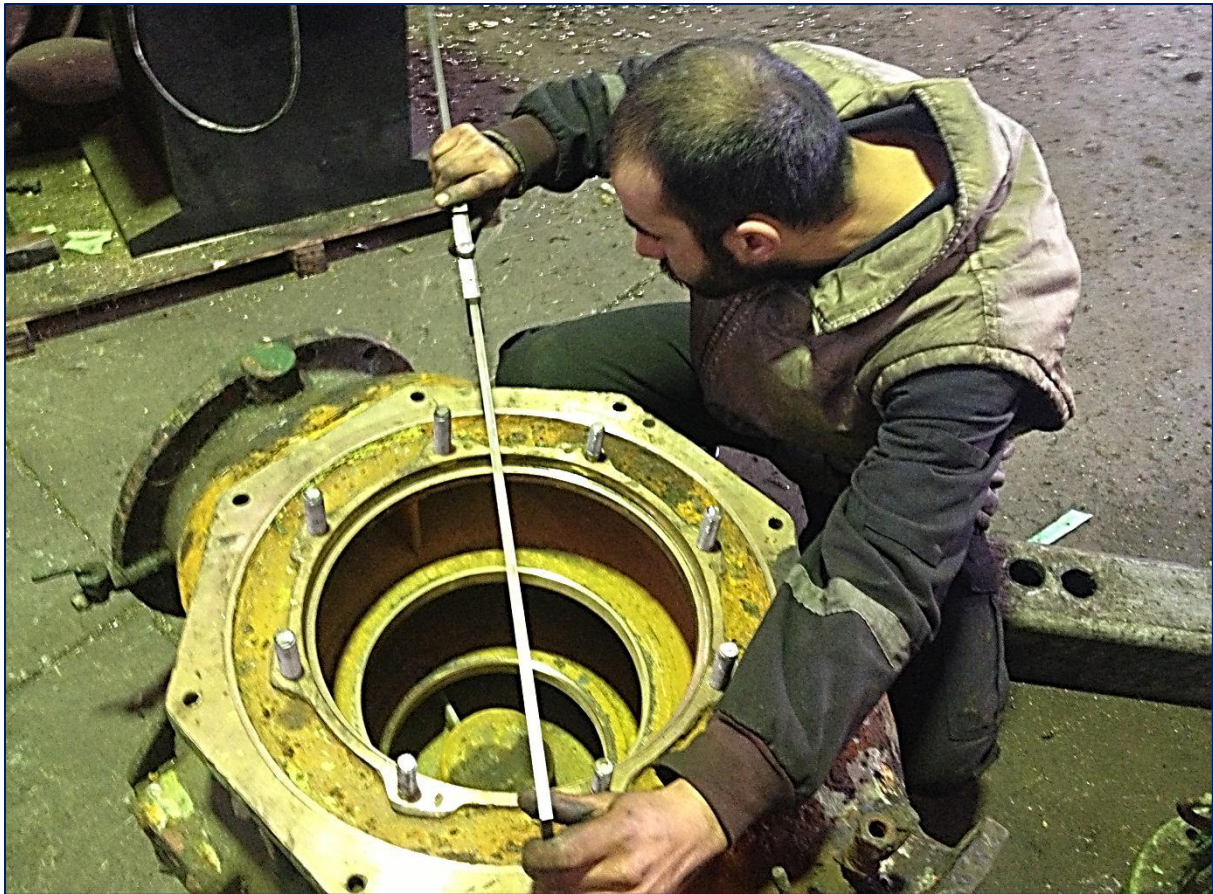
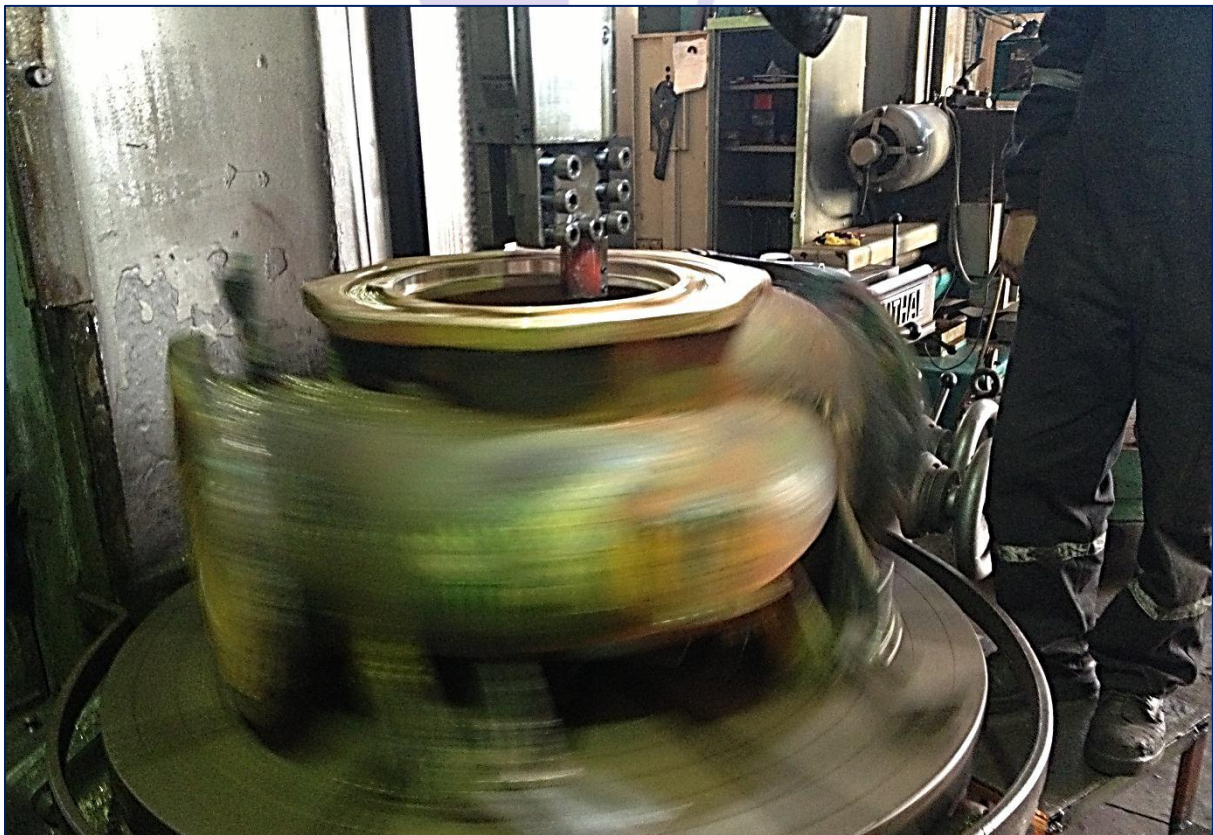
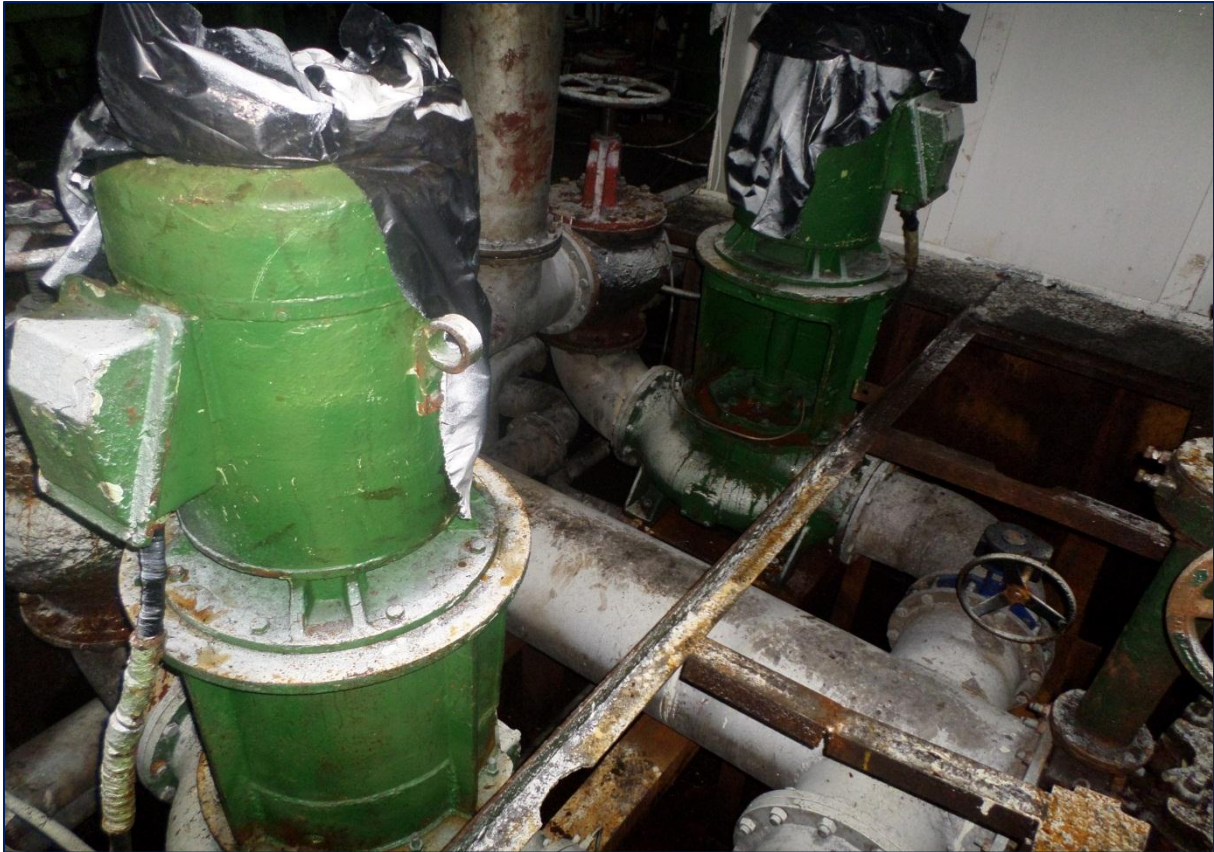
M/E SEA WATER PUMP NO:1 & NO:2 OVERHAUL;

Main Engine Sea Water Pumps has dismantled from foundation. Transferred to the workshop & opened for inspection. According to our inspection, we started to overhaul. Shaft has machined due to corroded surfaces. Backlash has removed. Packing gland bush, wire ring, middle bearing bush, sleeve shaft, fabricated & assembled. Ball bearings has changed by new ones. Case, electrical motor foundation and foundation flange fabricated on the optic laser machine, packing change, case electrical motor foundation seating surface machining for centering the electrical motor, later by centered, meanwhile electrical motor overhaul started already. Electrical motor tested with meger. Ball bearings changed with new ones. Rotor & stator chemically cleaned & heated for drying. Vernished by 2 coats. Ball bearing housing measurements taken for ball bearing clearance, noticed. Case painted, damaged ventilation case repaired. Transferred to the vessel , mounted on stu.

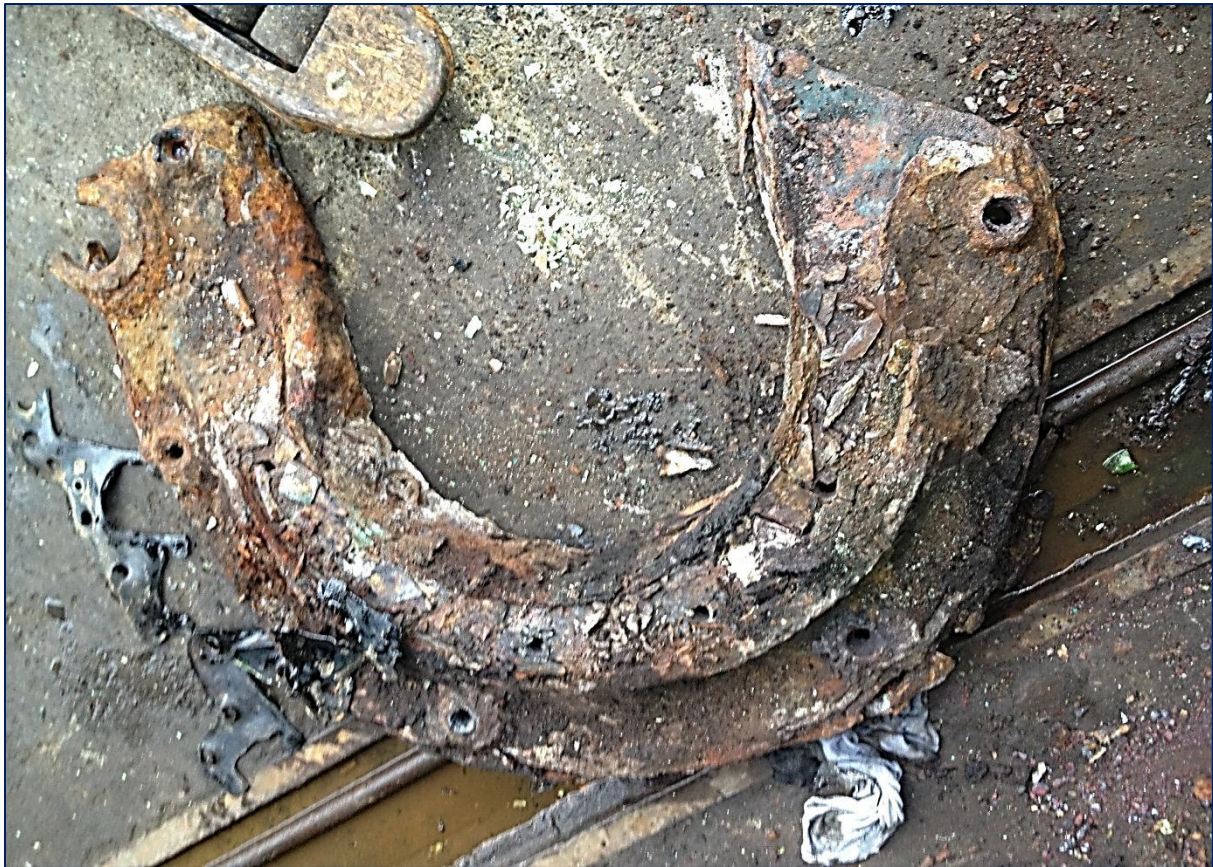
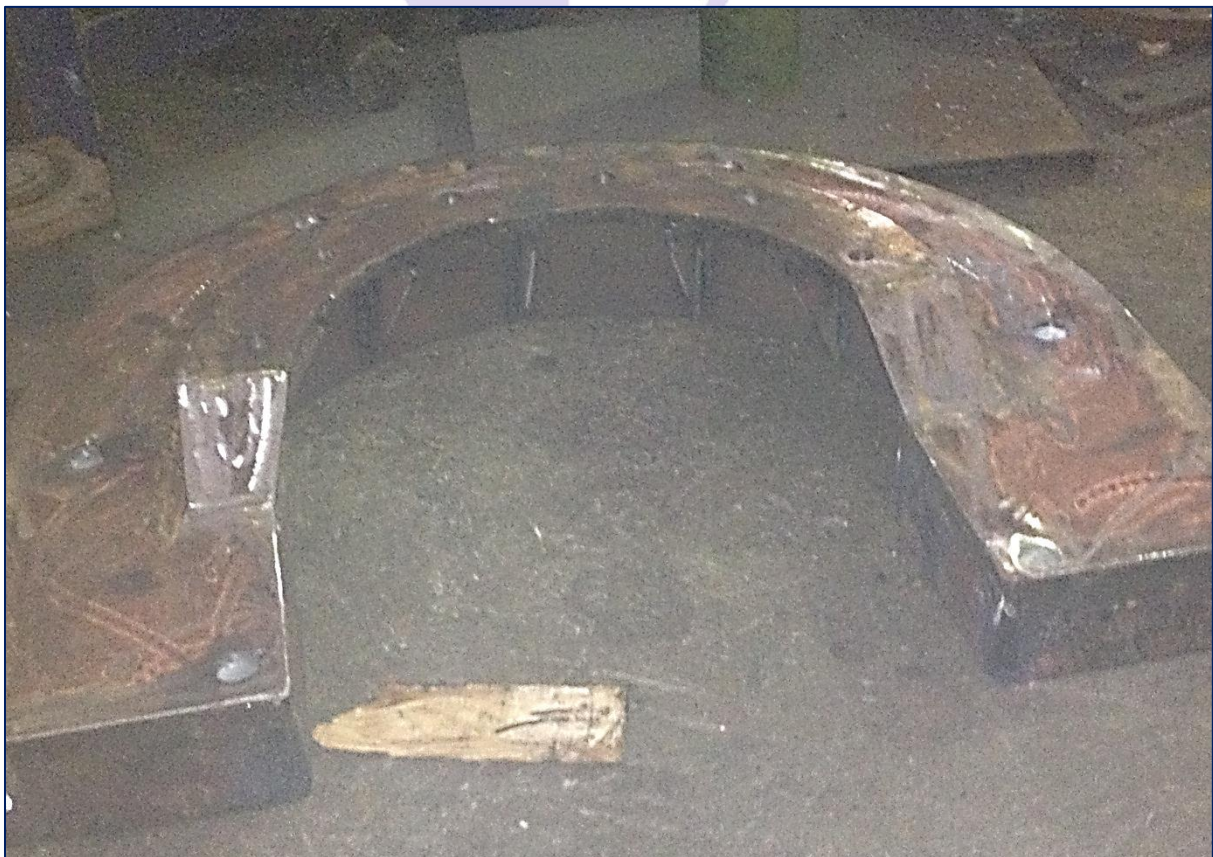
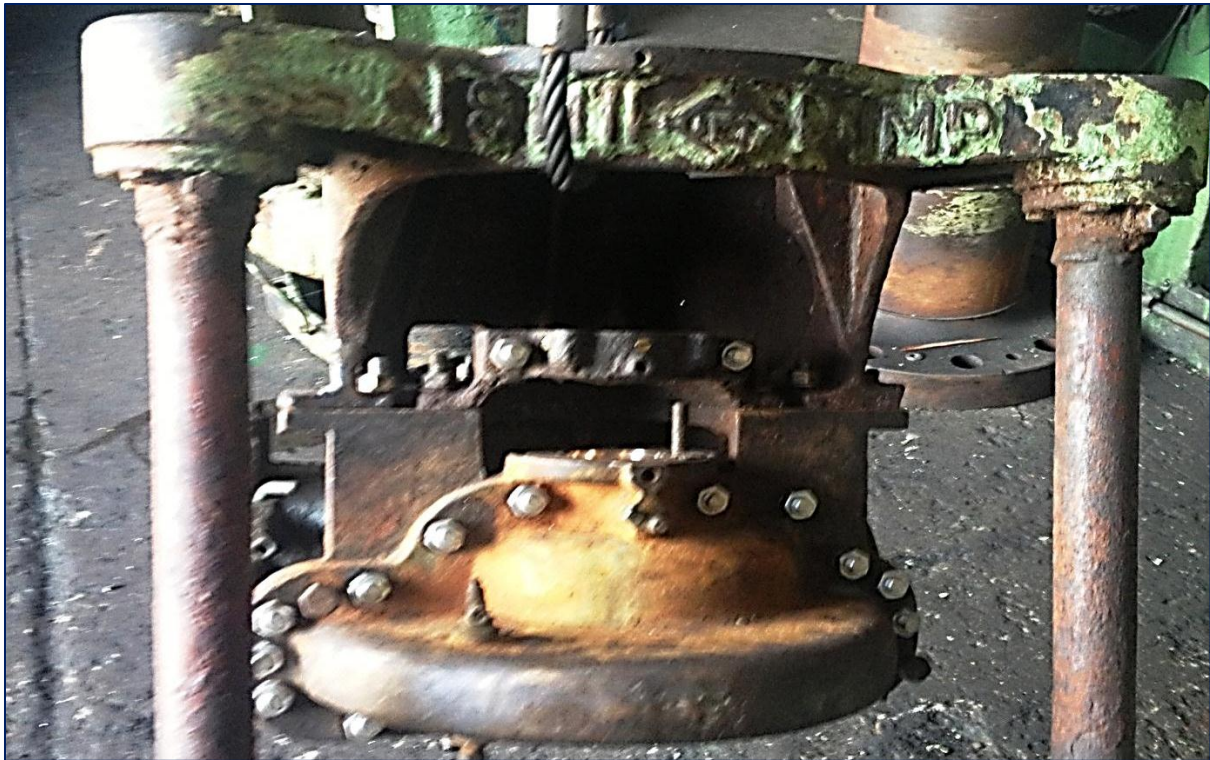
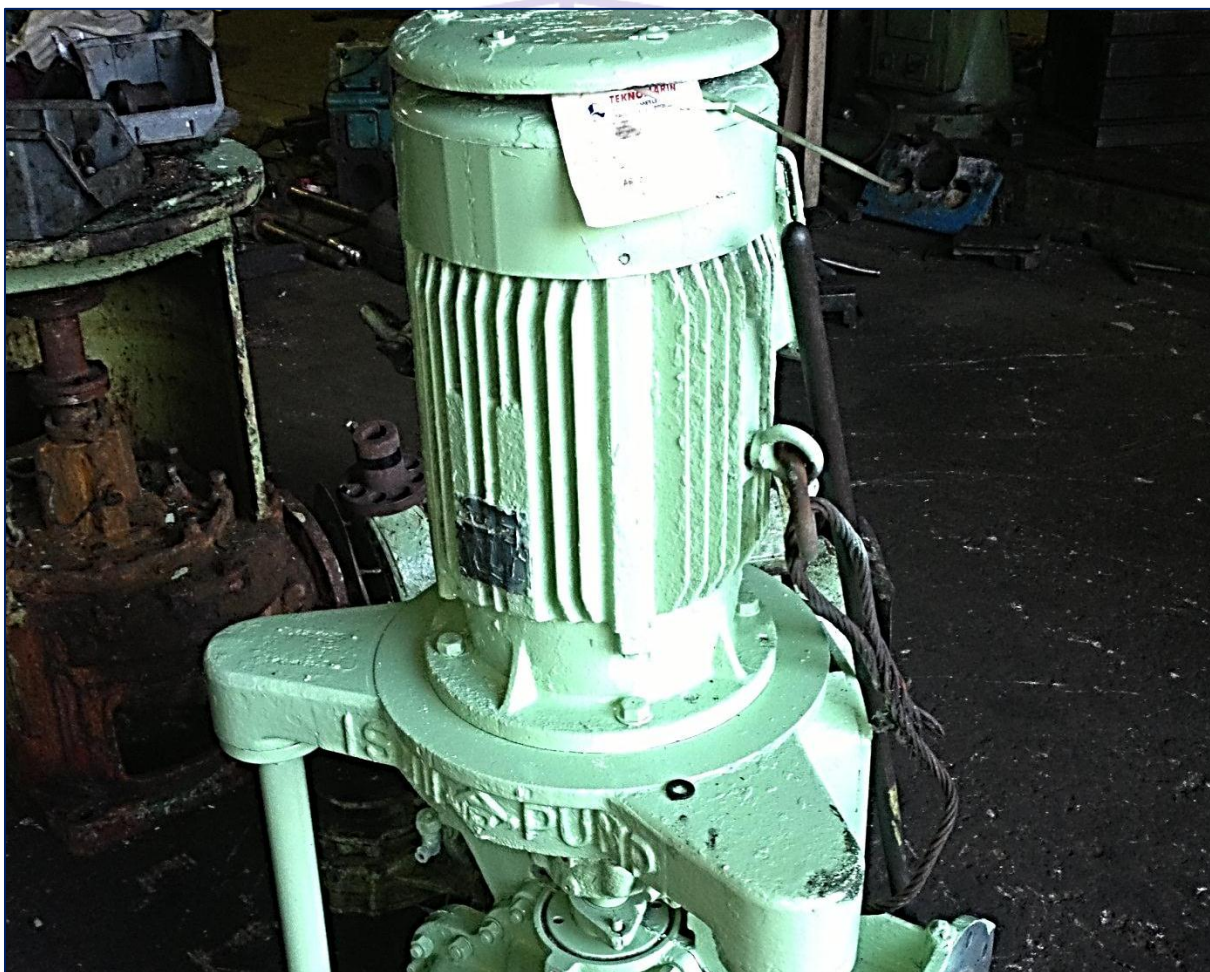
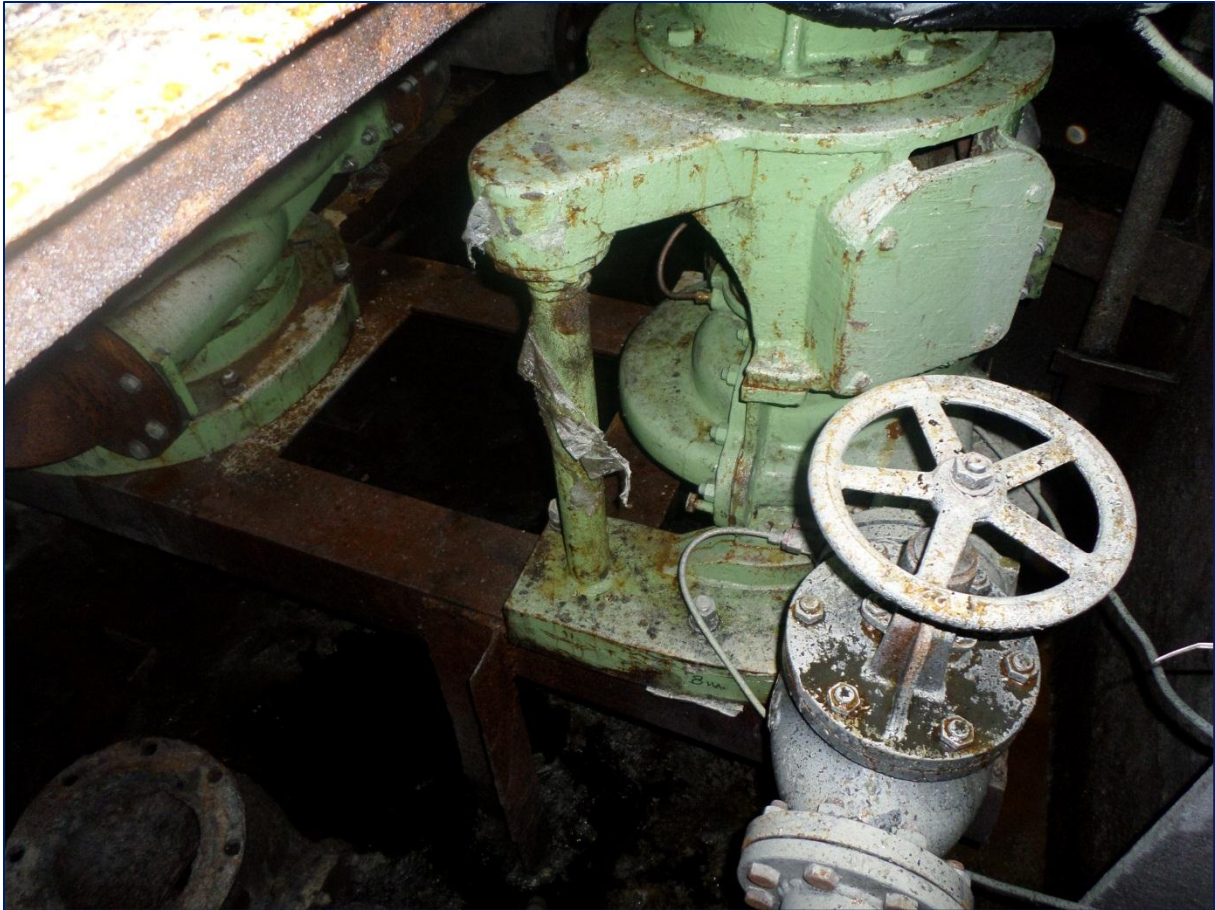
AUXILIARY ENGINE SEA WATER PUMP NO:1 & NO:2 OVERHAUL;

Auxiliary Engine Sea Water Pumps has dismantled from foundation. Transferred to the workshop & opened for inspection. According to our inspection, we started to overhaul. Pump case wear ring seating area rewelded & machined due to deformation. Pump wear ring fabricated. Packing gland sleeve fabricated with bronze material & assembled. Ball bearings has changed by new ones. Foundation welded as per original due to heavily corroded. Case, electrical motor foundation and foundation flange fabricated on the optic laser machine, packing change, case electrical motor foundation seating surface machining for centering the electrical motor, later by bored for alignment & fitted with electrical motor bottom bearing, meanwhile electrical motor overhaul started already. Electrical motor tested with meger. Ball bearings changed with new ones. Rotor & stator chemically cleaned & heated for drying. Vernished by 2 coats. Ball bearing housing measurements taken for ball bearing clearance, noticed. Case painted, damaged ventilation case repaired. Transferred to the vessel , mounted on stu.

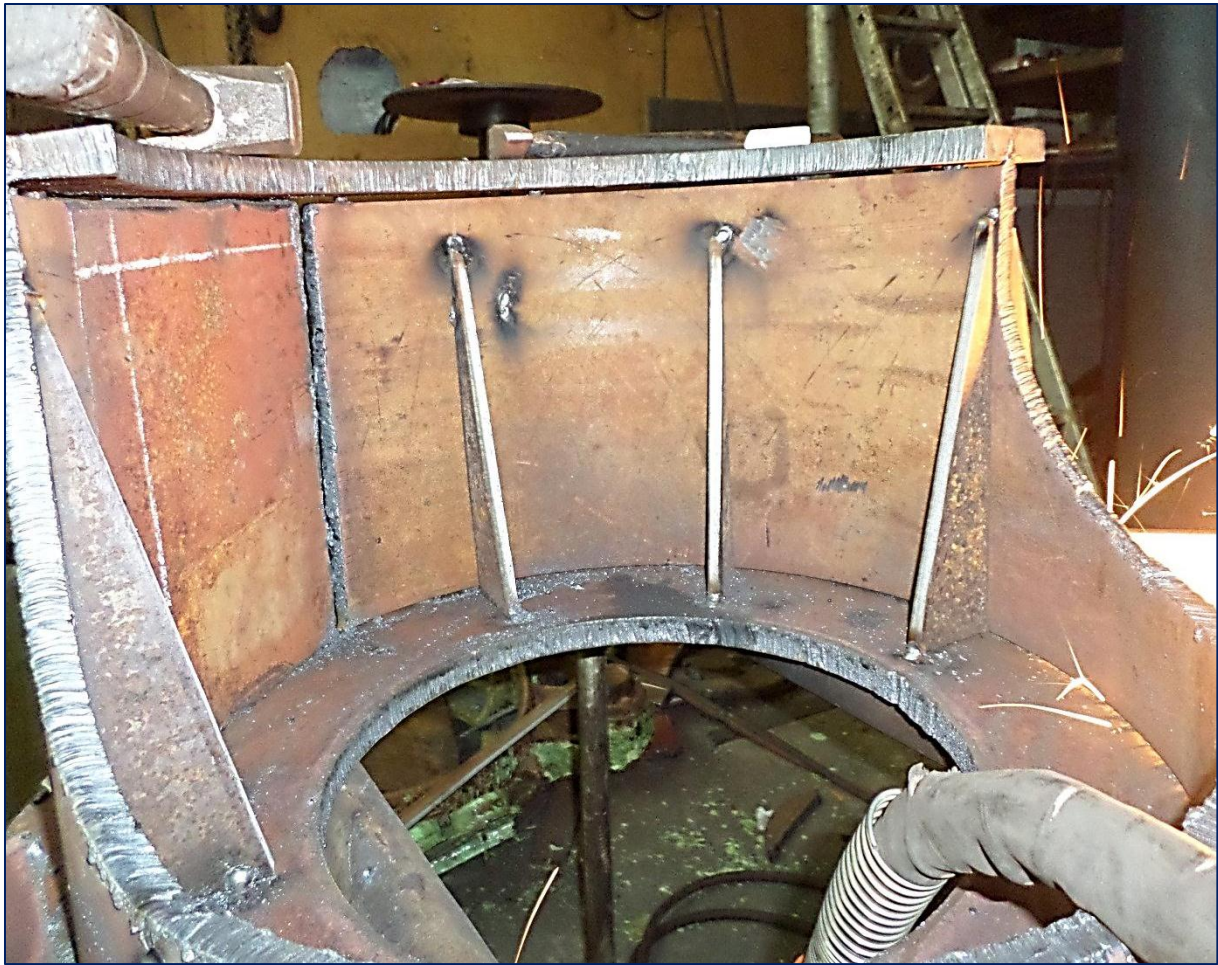
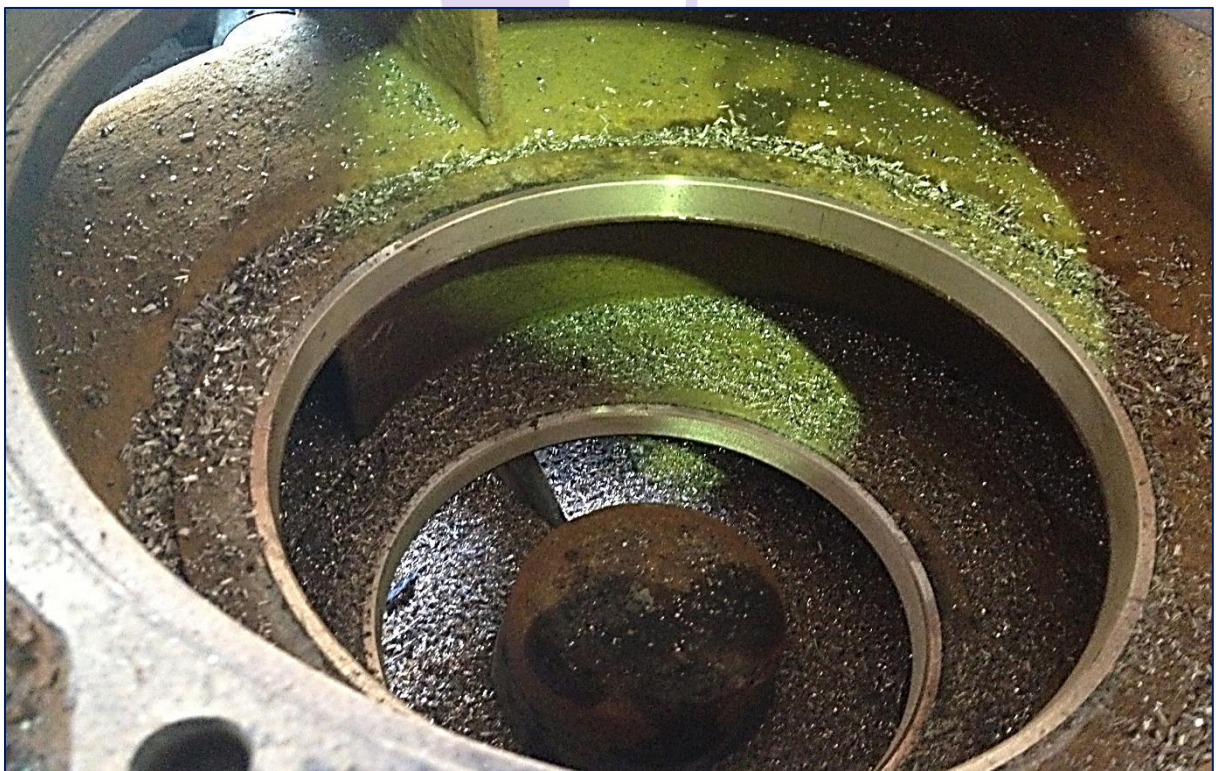
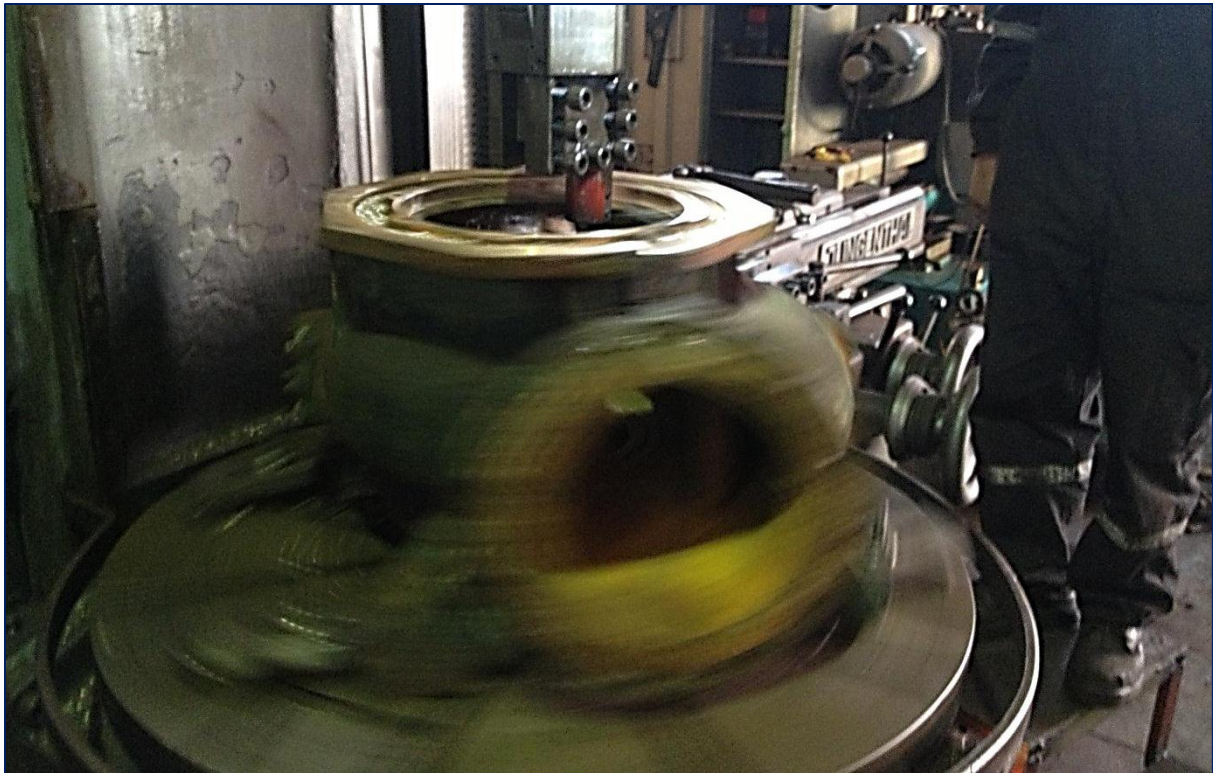
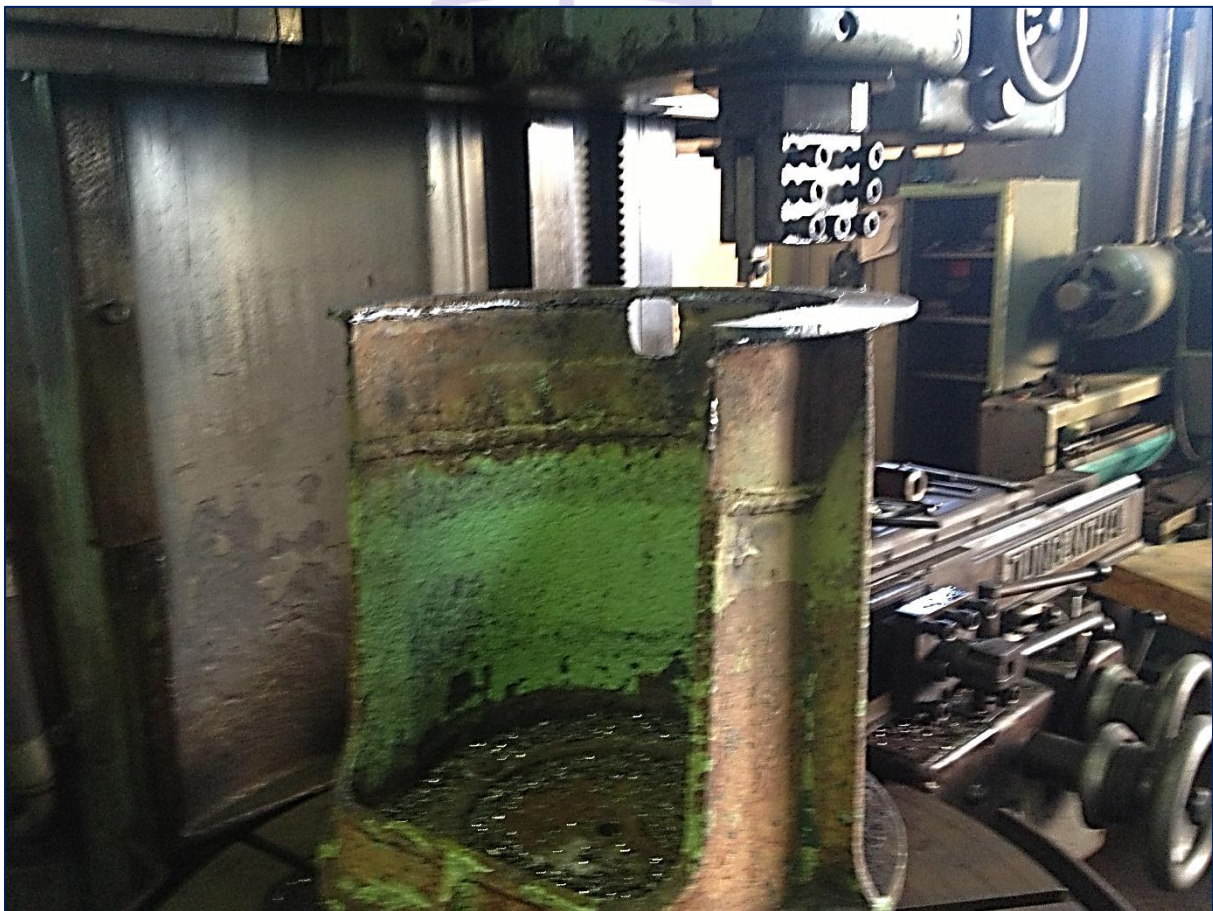
BALLAST PUMP OVERHAUL;

Ballast Pump has dismounted from foundation. Transferred to the workshop & opened for inspection. According to our inspection, we started to overhaul. Shaft has machined due to corroded surfaces. Backlash has removed. Packing gland bush, wire ring, middle bearing bush, sleeve shaft, fabricated & assembled. Ball bearings has changed by new ones. Case, electrical motor foundation and foundation flange fabricated on the optic laser machine, packing change, case electrical motor foundation seating surface machining for centering the electrical motor, later by centered, meanwhile electrical motor overhaul started already. Electrical motor tested with meger. Ball bearings changed with new ones. Rotor & stator chemically cleaned & heated for drying. Vernished by 2 coats. Ball bearing housing measurements taken for ball bearing clearance, noticed. Case painted, damaged ventilation case repaired. Transferred to the vessel , mounted on stu.
