INTRODUCTION

Engines need regular interval overhaul. All units of main engine and auxiliary engines needed to be overhauled while the vessel in Tuzla/Anchorage Area, Tuzla/Gemsan Dry Dock & Tuzla/Türkter Shipyard. Regarding to schedule, the added value of Teknomarin's expert diesel repair capabilities were put to the test.

SULZER RND 90 MAIN ENGINE OVERHAUL

Engine Room had some additional works to be done. Alternator rewinding, turbochargers overhauls, governors overhauls, daeration tank fabricating, cooling sea water pump, fuel oil burning pump, hydrophore pump and some other kinds of pumps overhauls, exhaust isolation jobs, inspection & recondition jobs and many others things to be done means that there is an *“engine room complete overhaul”* we can call it. This report includes all jobs to be done in M/V Almawashi.

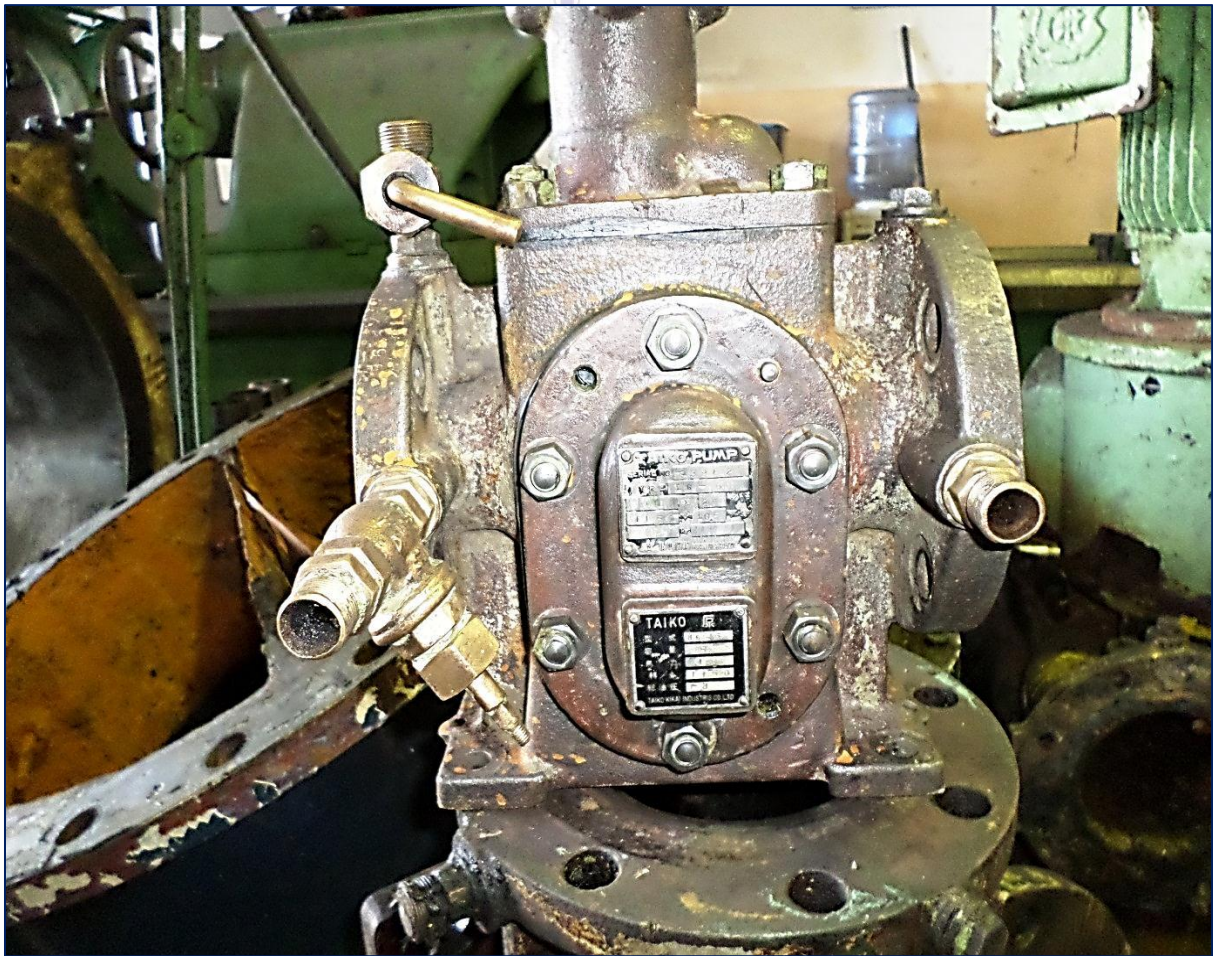
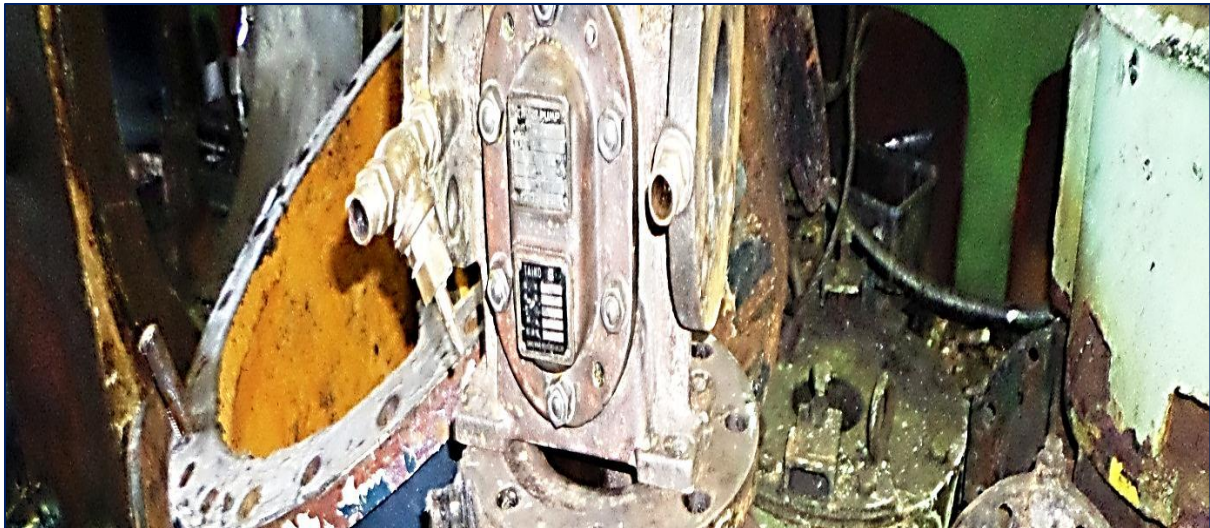
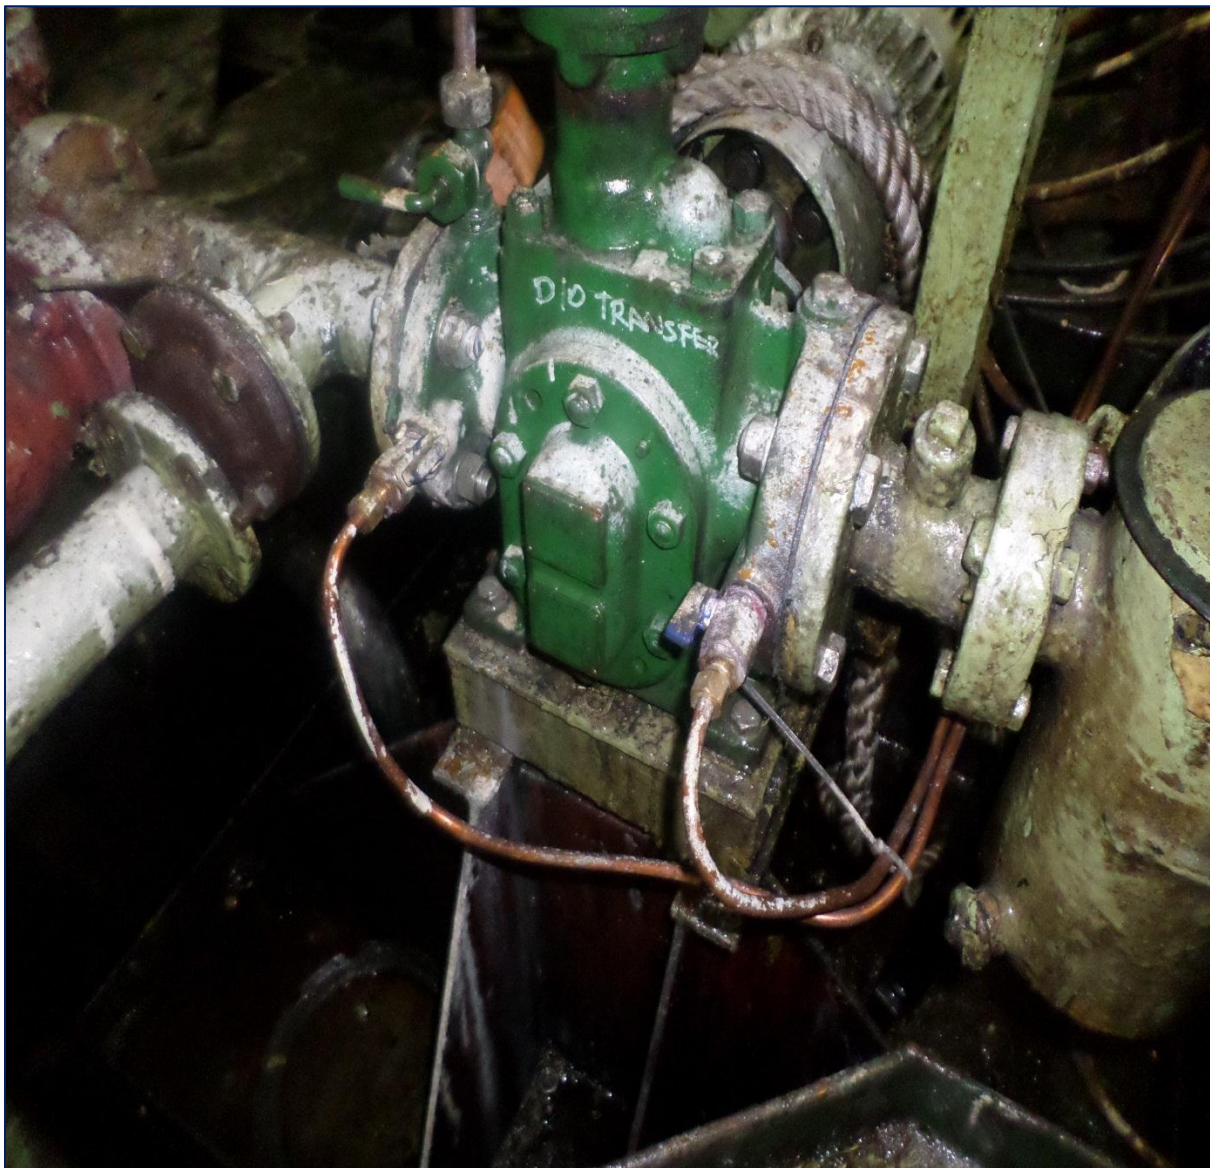
Diesel Oil Transfer Pump has dismantled from foundation. Transferred to the workshop & opened for inspection. According to our inspection, we started to overhaul. Gear & Liner clearance checked. Shaft bending checked, gears crack test made. Bearing bush clearance checked & bearing surface cleaned. Cover case surface machining due to corroded surface. Case connection bolts & nuts changed. Case gasket changed. Case chipping & painting also mechanical seal changed by the new one.

Electrical motor tested with meger. Ball bearings changed with new ones. Rotor & stator chemically cleaned & heated for drying. Vernished by 2 coats. Ball bearing housing measurements taken for ball bearing clearance, noticed. Case painted, damaged ventilation case repaired. Transferred to the vessel , mounted on stu.

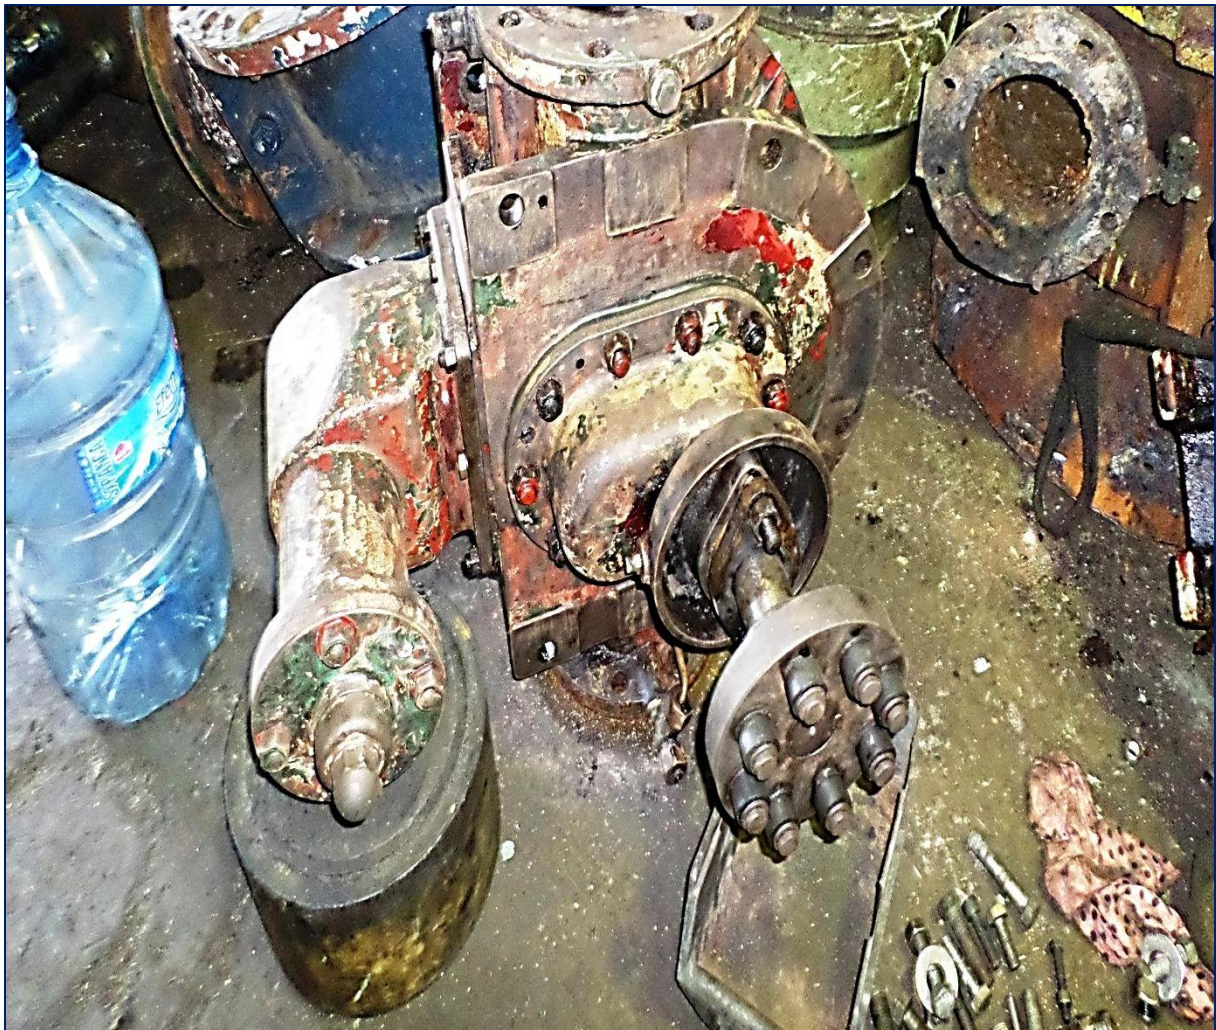
FUEL OIL TRANSFER PUMP OVERHAUL;

Fuel Oil Transfer Pump has dismantled from foundation. Transferred to the workshop & opened for inspection. According to our inspection, we started to overhaul. Gear & Liner clearance checked. Shaft bending checked, gears crack test made. Bearing bush clearance checked & bearing surface cleaned. Cover case surface machining due to corroded surface. Case connection bolts & nuts changed. Case gasket changed. Case chipping & painting also mechanical seal changed by the new one. Electrical motor tested with meger. Ball bearings changed with new ones. Rotor & stator chemically cleaned & heated for drying. Vernished by 2 coats. Ball bearing housing measurements taken for ball bearing clearance, noticed. Case painted, damaged ventilation case repaired. Transferred to the vessel , mounted on stu.

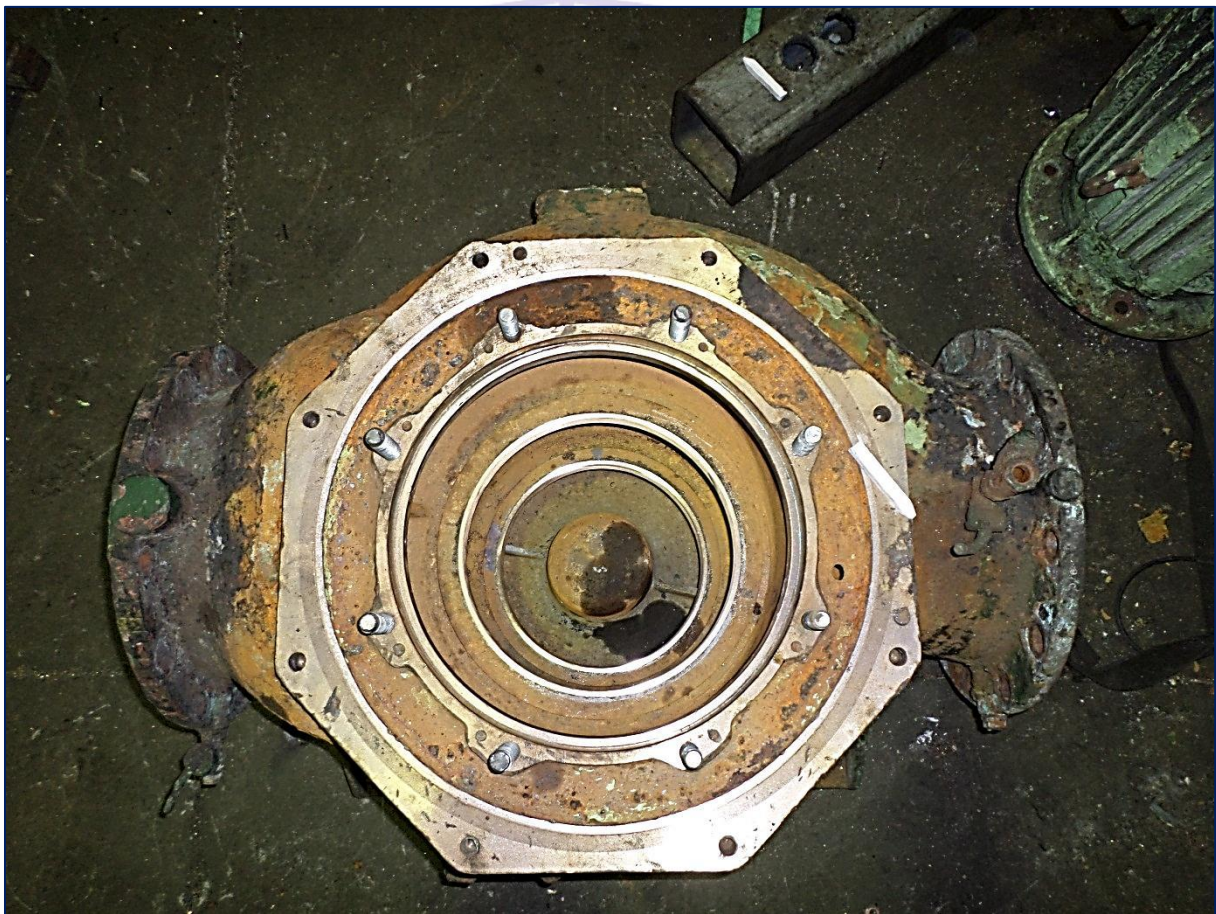
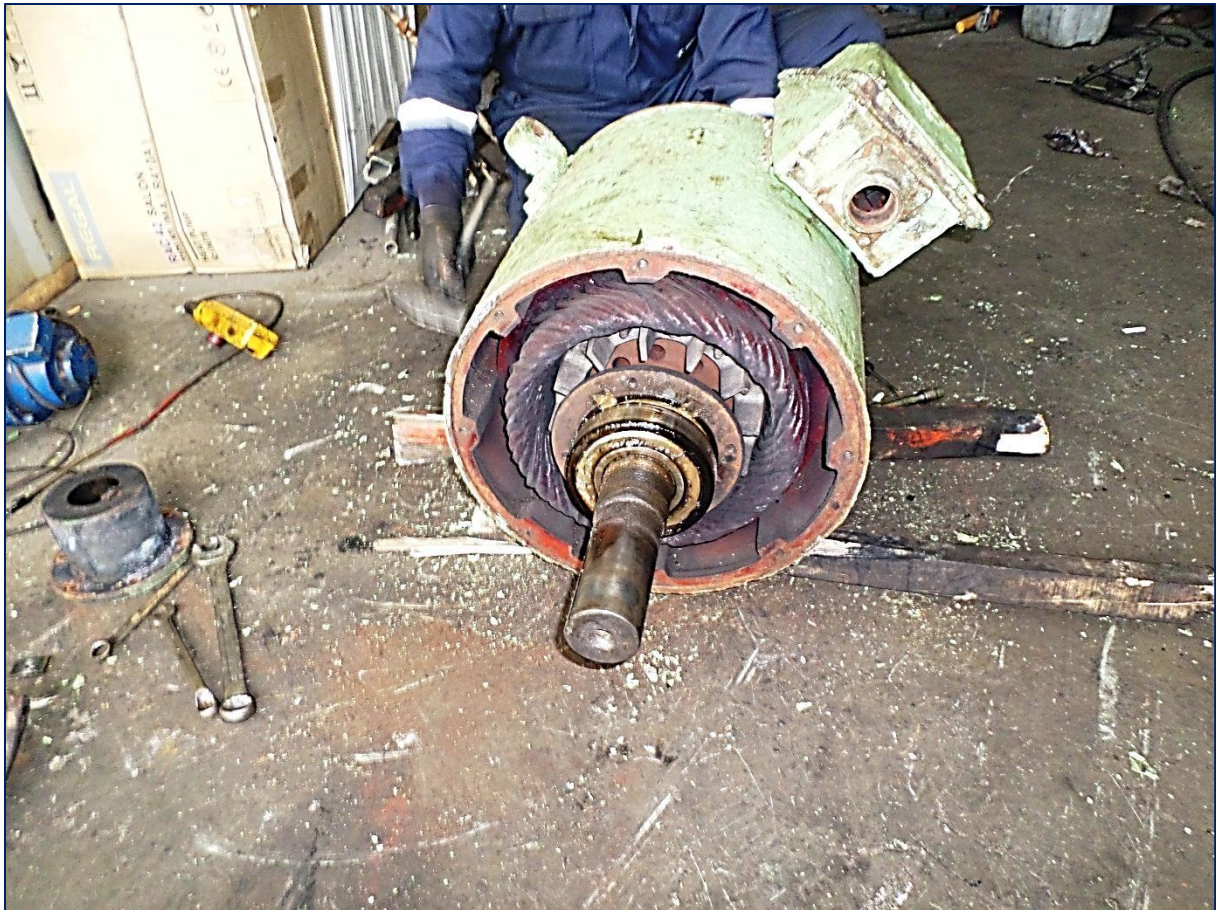
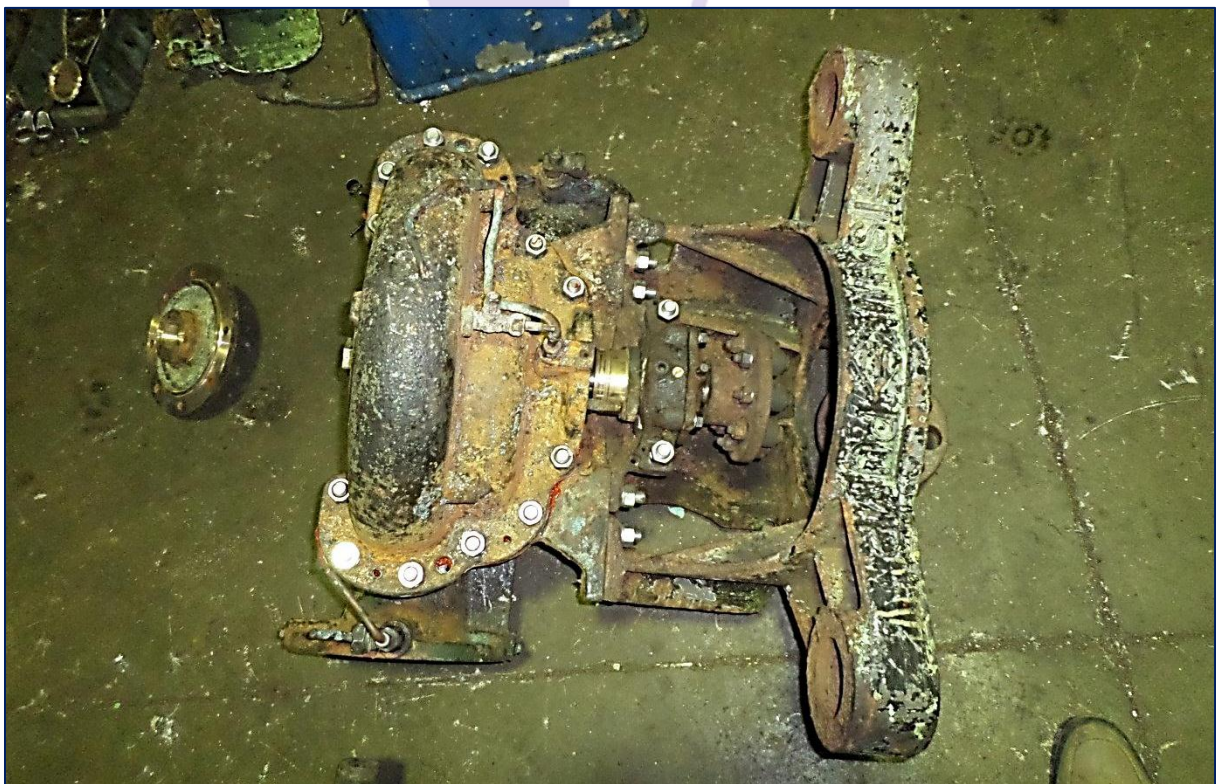
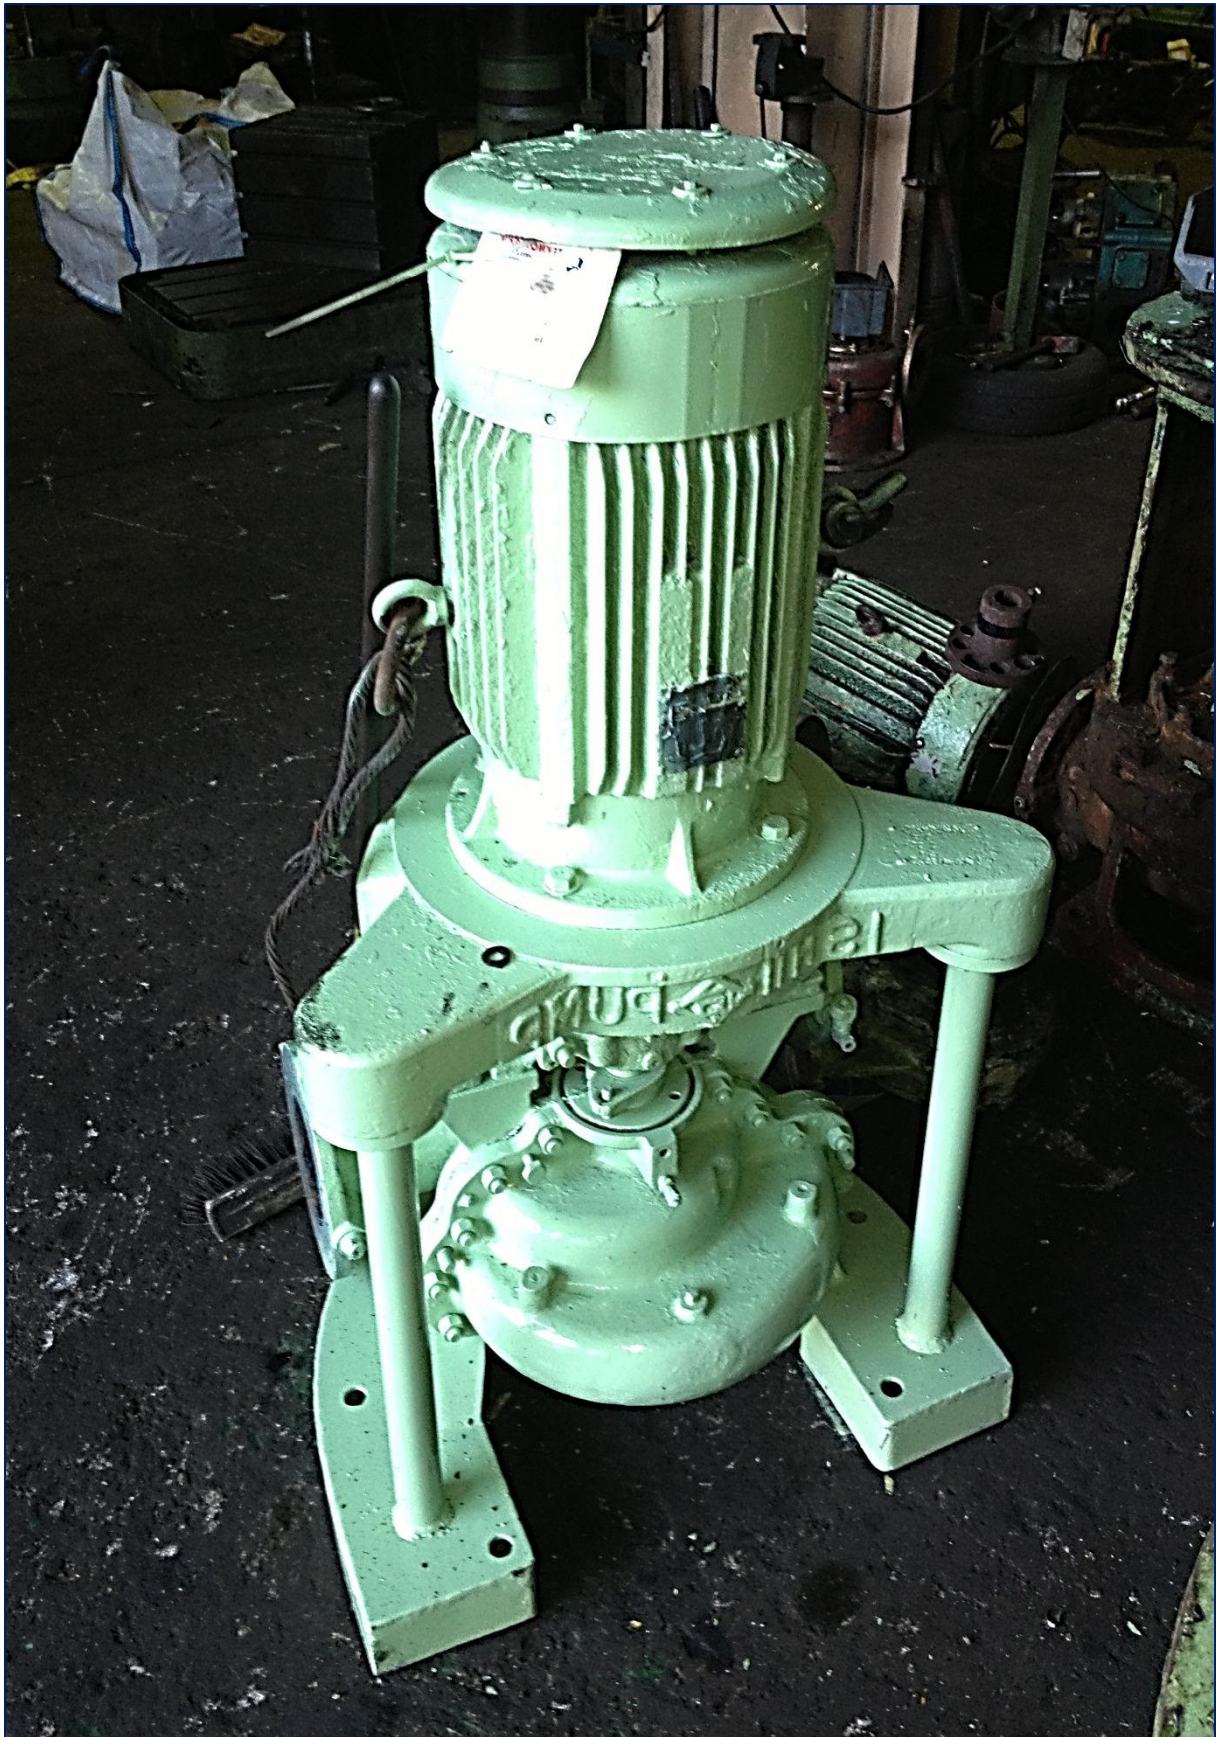
GENERAL SERVICE PUMP OVERHAUL;

General Service Pump has dismantled from foundation. Transferred to the workshop & opened for inspection. According to our inspection, we started to overhaul. Shaft has machined due to corroded surfaces. Backlash has removed. Packing gland bush, wire ring, middle bearing bush, sleeve shaft, fabricated & assembled. Ball bearings has changed by new ones. Case, electrical motor foundation and foundation flange fabricated on the optic laser machine, packing change, case electrical motor foundation seating surface machining for centering the electrical motor, later by centered, meanwhile electrical motor overhaul started already. Electrical motor tested with meger. Ball bearings changed with new ones. Rotor & stator chemically cleaned & heated for drying. Vernished by 2 coats. Ball bearing housing measurements taken for ball bearing clearance, noticed. Case painted, damaged ventilation case repaired. Transferred to the vessel , mounted on stu.

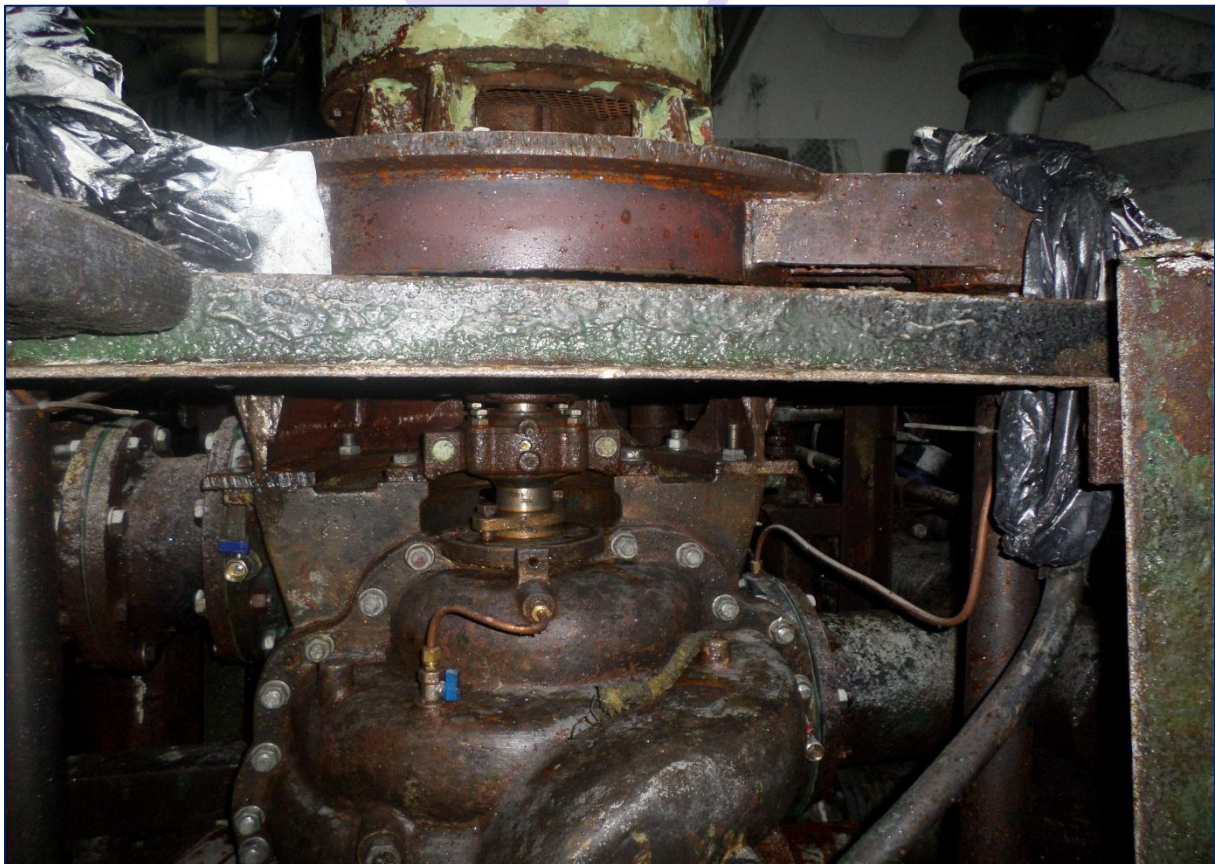
FIRE & BILGE PUMP OVERHAUL;

Fire & Bilge pump has dismounted from foundation. Transferred to the workshop & opened for inspection. According to our inspection, we started to overhaul. Pump case wear ring seating area rewelded & machined due to deformation. Pump wear ring fabricated. Packing gland sleeve fabricated with bronze material & assembled. Ball bearings has changed by new ones. Foundation welded as per original due to heavily corroded. Case, electrical motor foundation and foundation flange fabricated on the optic laser machine, packing change, case electrical motor foundation seating surface machining for centering the electrical motor, later by bored for alignment & fitted with electrical motor bottom bearing, meanwhile electrical motor overhaul started already. Electrical motor tested with meger. Ball bearings changed with new ones. Rotor & stator chemically cleaned & heated for drying. Vernished by 2 coats. Ball bearing housing measurements taken for ball bearing clearance, noticed. Case painted, damaged ventilation case repaired. Transferred to the vessel , mounted on stu.

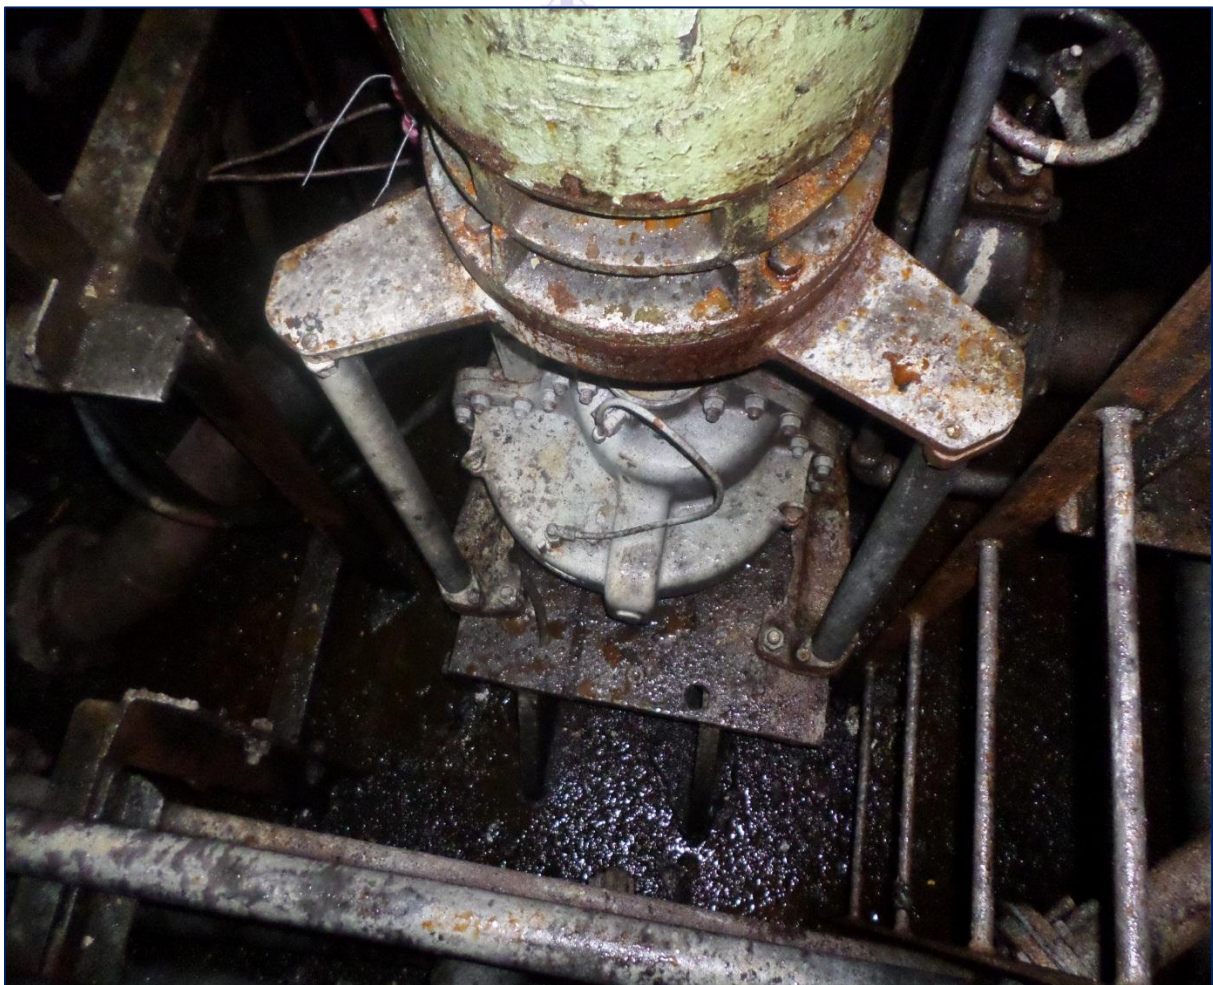
SCRUBBER PUMP OVERHAUL;

Scrubber pump has dismounted from foundation. Transferred to the workshop & opened for inspection. According to our inspection, we started to overhaul. Shaft fabricated with the chrome material. Wire ring fabricated & changed. Also ball bearing changed with the new one. Case, electrical motor foundation and foundation flange fabricated on the optic laser machine, packing change, case electrical motor foundation seating surface machining for centering the electrical motor, later by bored for alignment & fitted with electrical motor bottom bearing, meanwhile electrical motor overhaul started already. Electrical motor tested with meger. Ball bearings changed with new ones. Rotor & stator chemically cleaned & heated for drying. Vernished by 2 coats. Ball bearing housing measurements taken for ball bearing clearance, noticed. Case painted, damaged ventilation case repaired. Transferred to the vessel , mounted on stu.

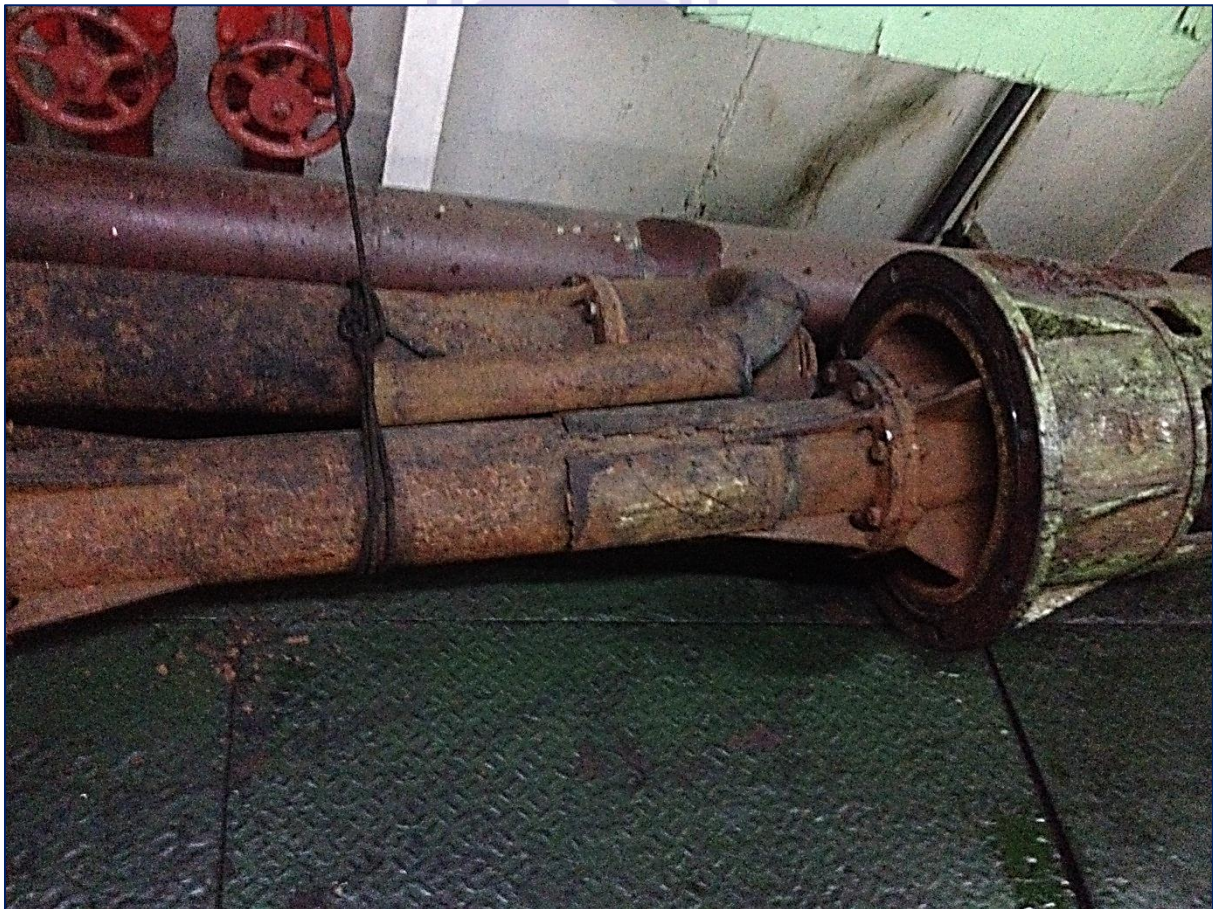
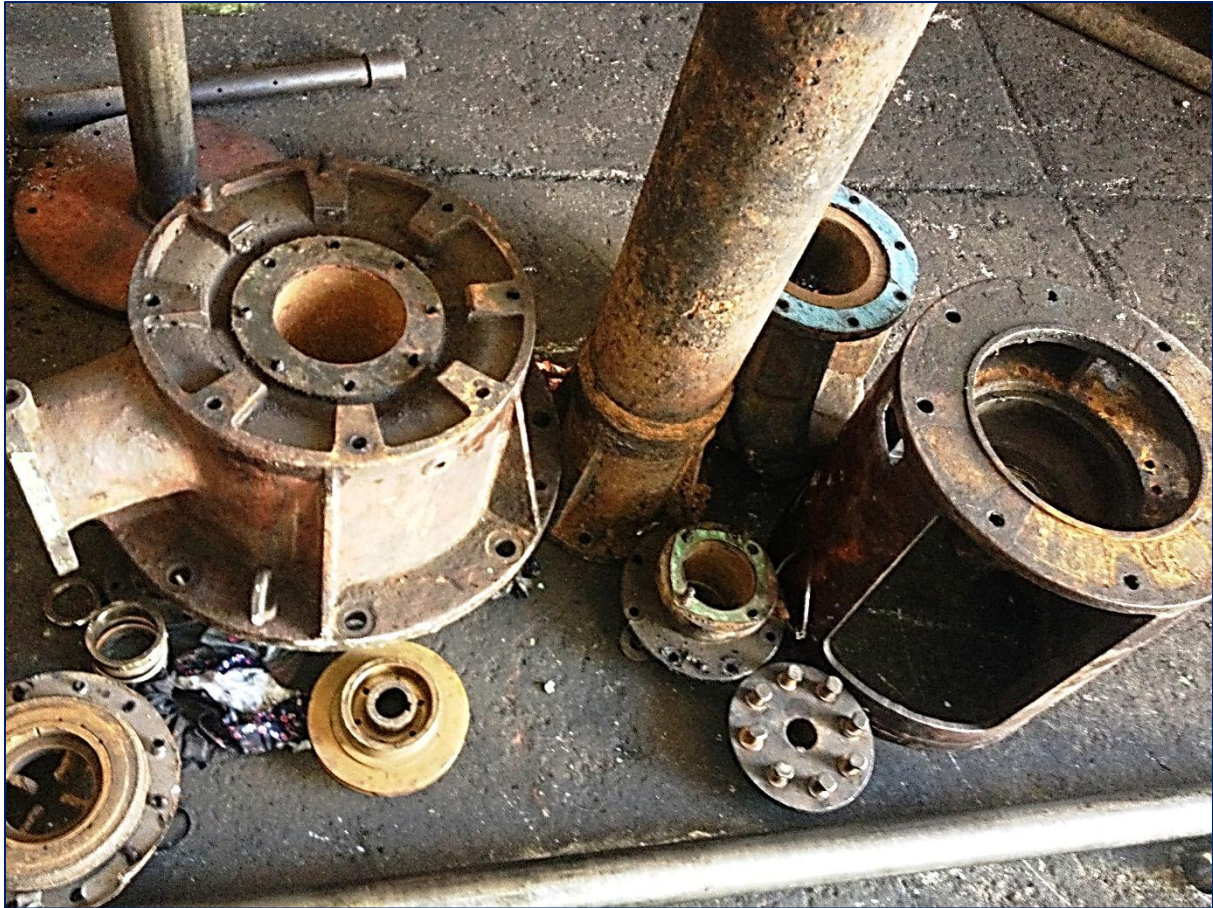
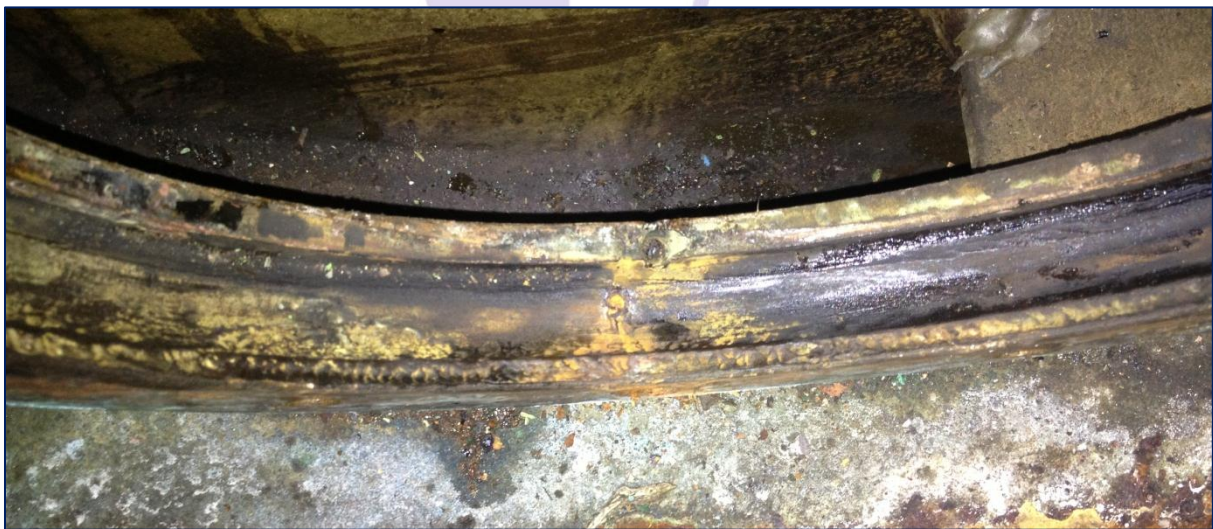
PISTON COOLING PUMP NO:1 OVERHAUL;

Piston cooling fresh water pump has dismantled from foundation. Transferred to the workshop & opened for inspection. According to our inspection, we started to overhaul. Bended piston cooling pump new shaft fabricated. Wire ring fabricated with bronze material & changed. Pump lower case has reconditioned. Mechanical seal changed with the new one. Pump shaft protection case fabricated with flange, wire ring seat place welded. Electrical motor foundation and foundation flange fabricated on the optic laser machine, packing change, case electrical motor foundation seating surface machining for centering the electrical motor, later by bored for alignment & fitted with electrical motor bottom bearing, meanwhile electrical motor overhaul started already. Electrical motor tested with meger. Ball bearings changed with new ones. Rotor & stator chemically cleaned & heated for drying. Vernished by 2 coats. Case painted, damaged ventilation case repaired. Transferred to the vessel , mounted on stu.

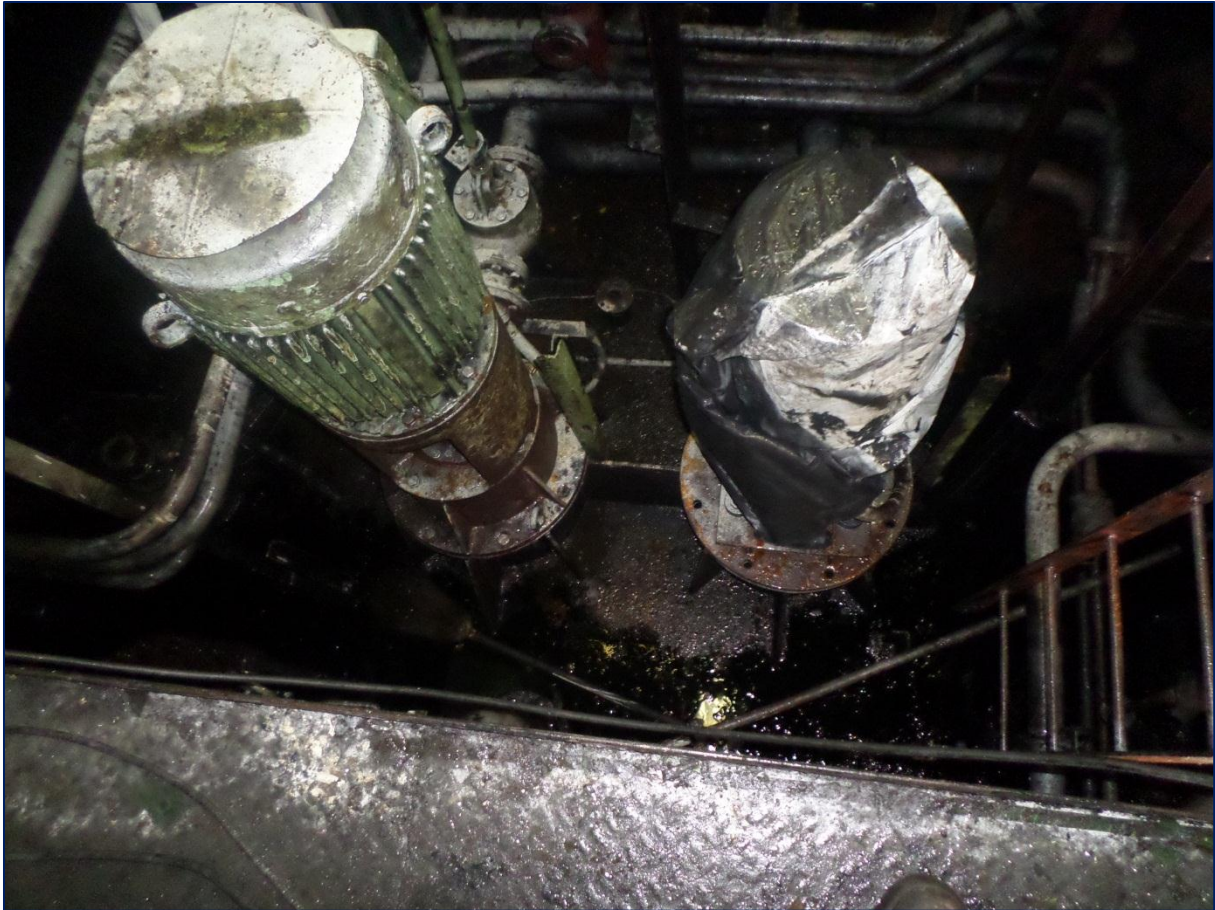
PISTON COOLING FRESH WATER PUMP NO:2 OVERHAUL;

Piston cooling fresh water pump has dismounted from foundation. Transferred to the workshop & opened for inspection. According to our inspection, need to replace with the new pump.

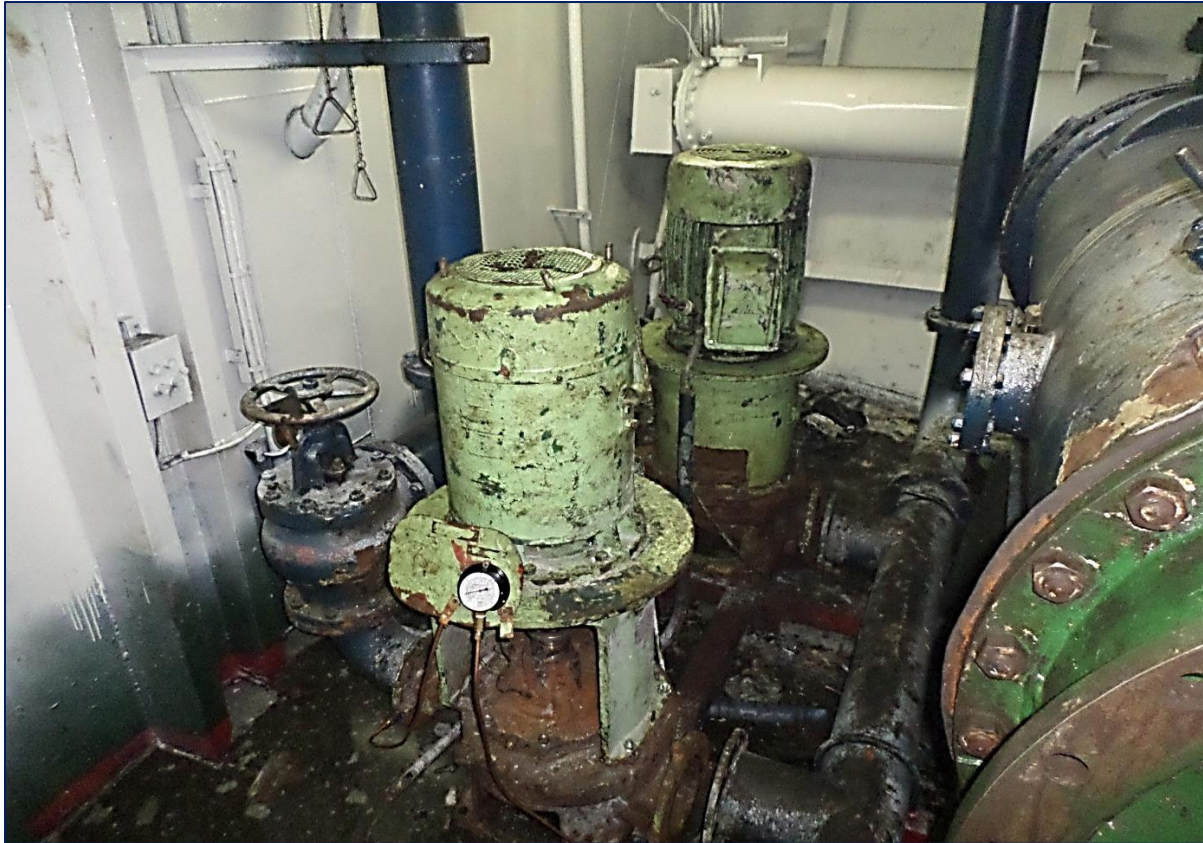
JACKET COOLING FRESH WATER PUMP NO:1 & NO:2 OVERHAUL;

Jacket Cooling Fresh Water Pumps has dismounted from foundation. Transferred to the workshop & opened for inspection. According to our inspection, we started to overhaul. Shaft has machined due to corroded surfaces. Backlash has removed. Packing gland bush, wire ring, middle bearing bush, sleeve shaft, fabricated & assembled. Ball bearings has changed by new ones. Case, electrical motor foundation and foundation flange fabricated on the optic laser machine, packing change, case electrical motor foundation seating surface machining for centering the electrical motor, later by centered, meanwhile electrical motor overhaul started already. Electrical motor tested with meger. Ball bearings changed with new ones. Rotor & stator chemically cleaned & heated for drying. Vernished by 2 coats. Ball bearing housing measurements taken for ball bearing clearance, noticed. Case painted, damaged ventilation case repaired. Transferred to the vessel , mounted on stu.

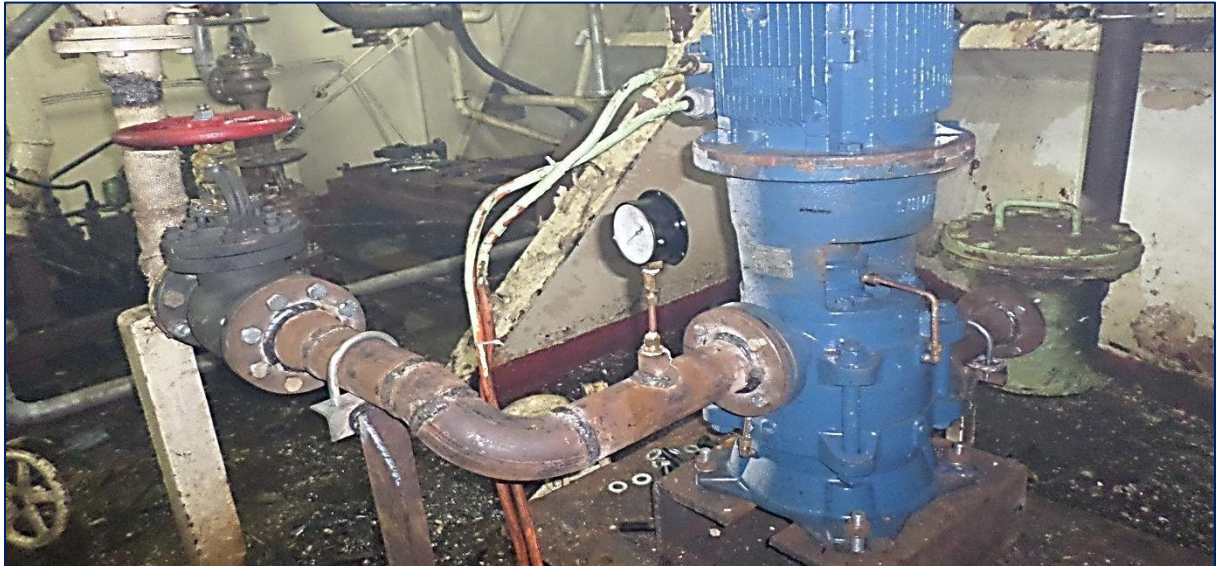
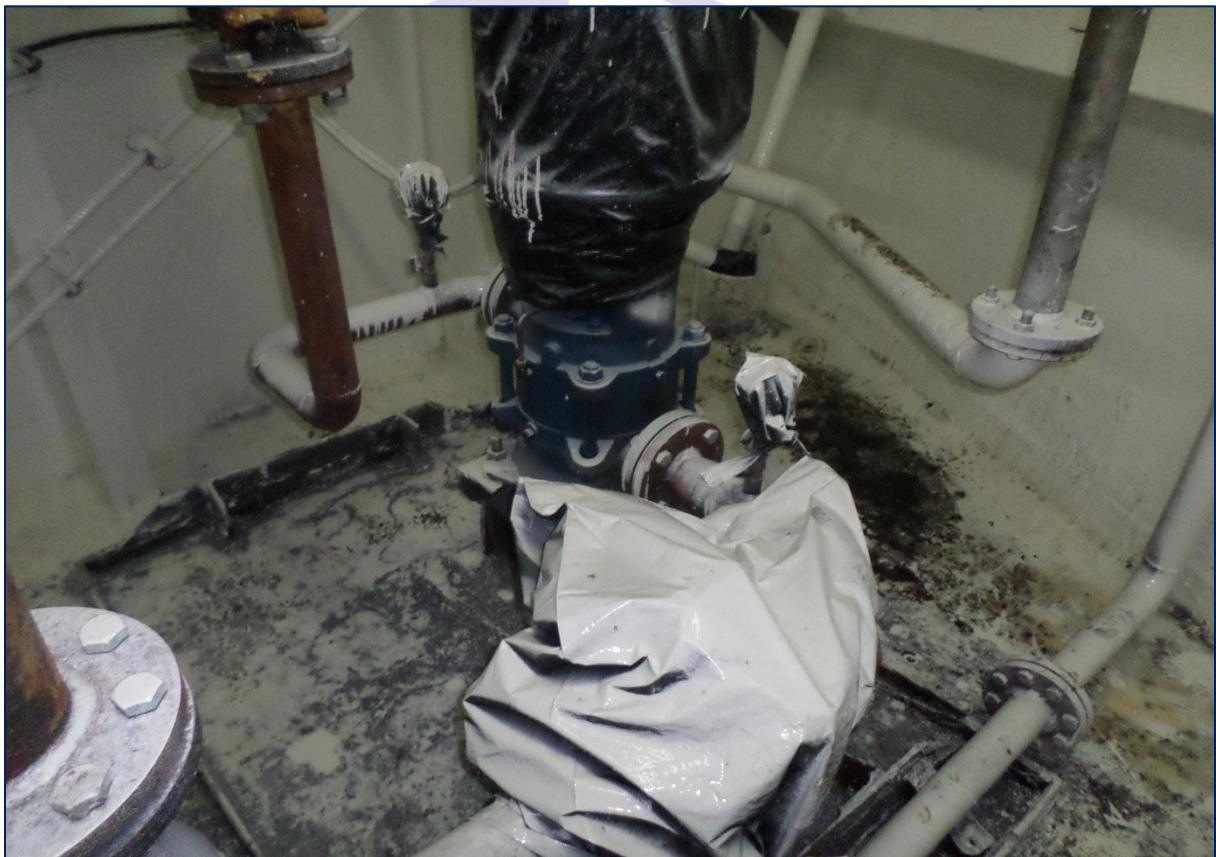
BOILER FEED WATER PUMP NO:1 & NO:2 OVERHAUL;

Both boiler feed water pumps has dismantled from foundation. Transferred to the workshop & opened for inspection. According to our inspection, need to replace with the new pumps. Pipes & foundation fitted.

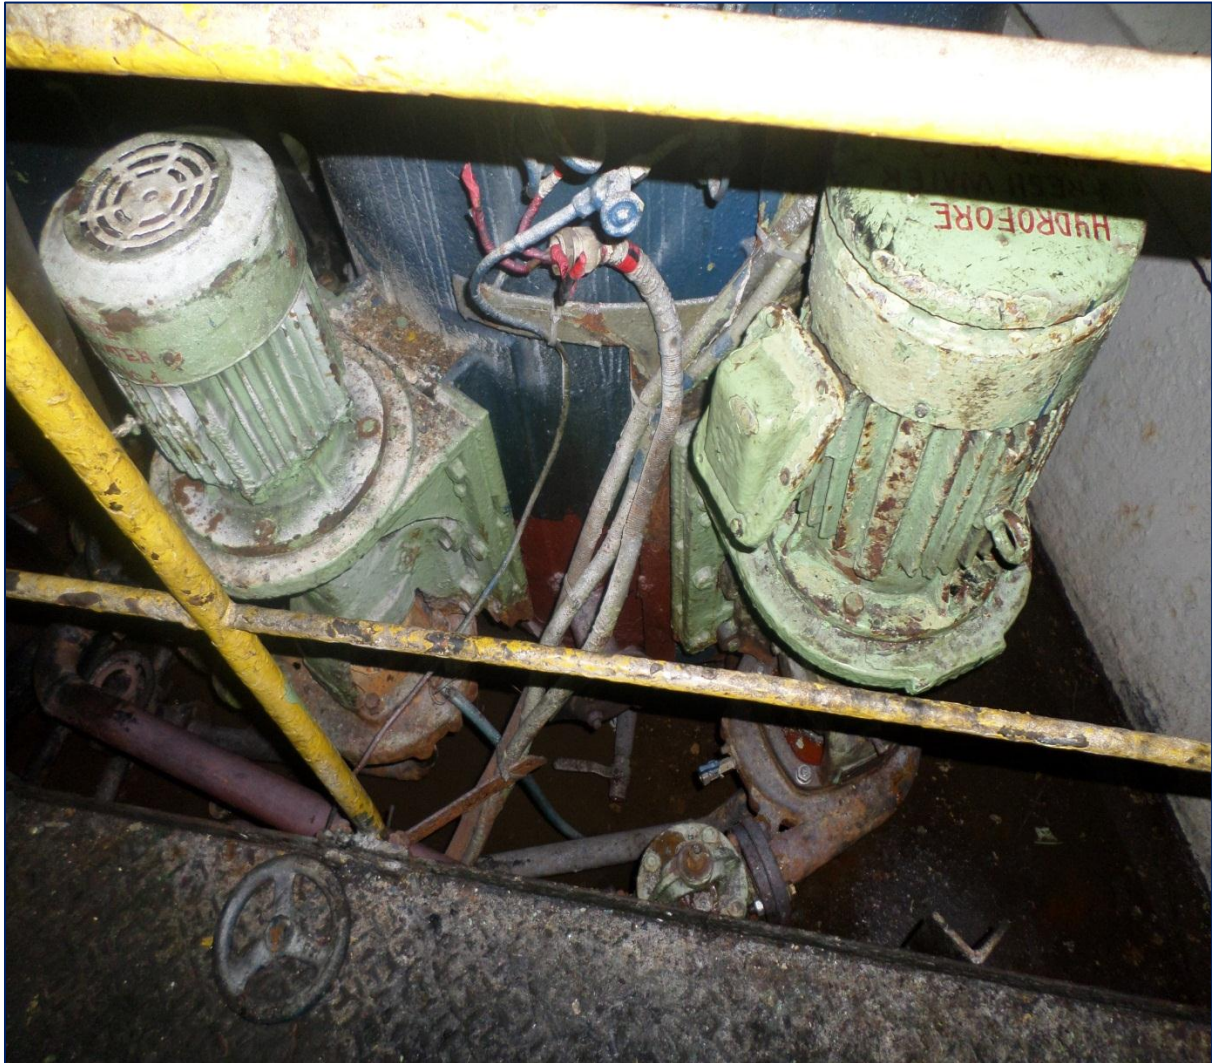
HYDROPHORE PUMP NO:1 OVERHAUL;

Hydrophore pump has dismantled from foundation. Transferred to the workshop & opened for inspection. According to our inspection, need to replace with the new pump. Pipes & foundation fitted.
