INTRODUCTION

Engines need regular interval overhaul. All units of main engine and auxiliary engines needed to be overhauled while the vessel in Tuzla/Anchorage Area, Tuzla/Gemsan Dry Dock & Tuzla/Türkter Shipyard. Regarding to schedule, the added value of Teknomarin's expert diesel repair capabilities were put to the test.

SULZER RND 90 MAIN ENGINE OVERHAUL

Engine Room had some additional works to be done. Alternator rewinding, turbochargers overhauls, governors overhauls, daeration tank fabricating, cooling sea water pump, fuel oil burning pump, hydrophore pump and some other kinds of pumps overhauls, exhaust isolation jobs, inspection & recondition jobs and many others things to be done means that there is an *“engine room complete overhaul”* we can call it. This report includes all jobs to be done in M/V Almawashi.

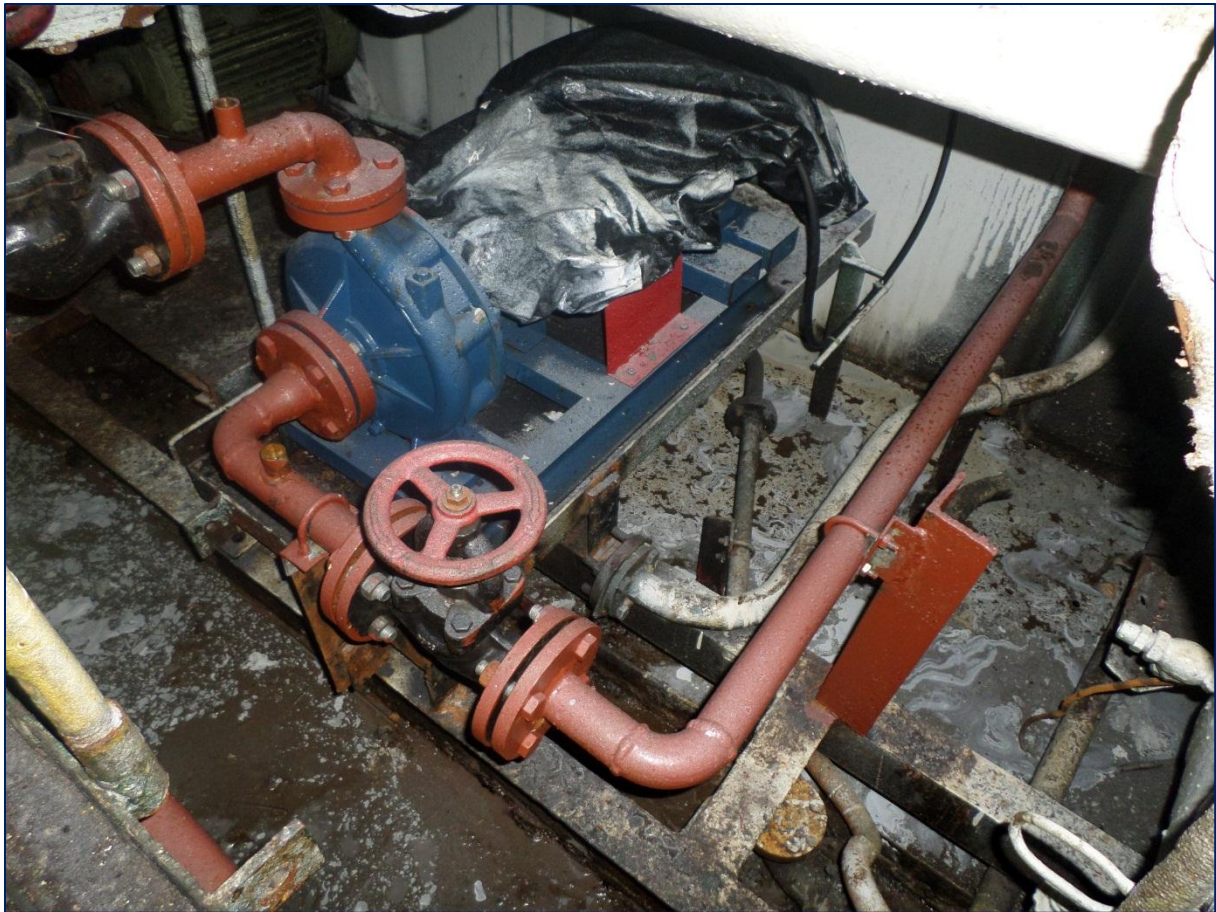
Hydrophore Pump No:2 Electrical motor tested with meger. Ball bearings changed with new ones. Rotor & stator chemically cleaned & heated for drying. Vernished by 2 coats. Ball bearing housing measurements taken for ball bearing clearance, noticed. Case painted, damaged ventilation case repaired. Transferred to the vessel , mounted on stu.

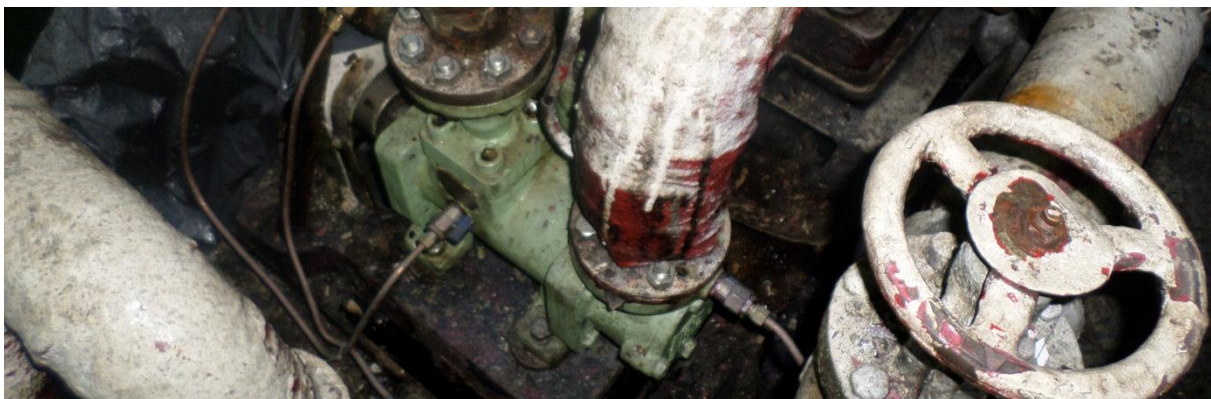
FUEL OIL BURNING PUMP NO:1 & NO:2 OVERHAUL;

Fuel Oil Burning Pumps has dismantled from foundation. Transferred to the workshop & opened for inspection. According to our inspection, pump case liner honned for surface bending, ball bearings changed, gear clearance controlled, mechanical seal changed by the new one, oil seal changed, case's bolts, nuts & gaskets changed. Later by the recondition, pumps transferred to the vessel, mounted on stu.

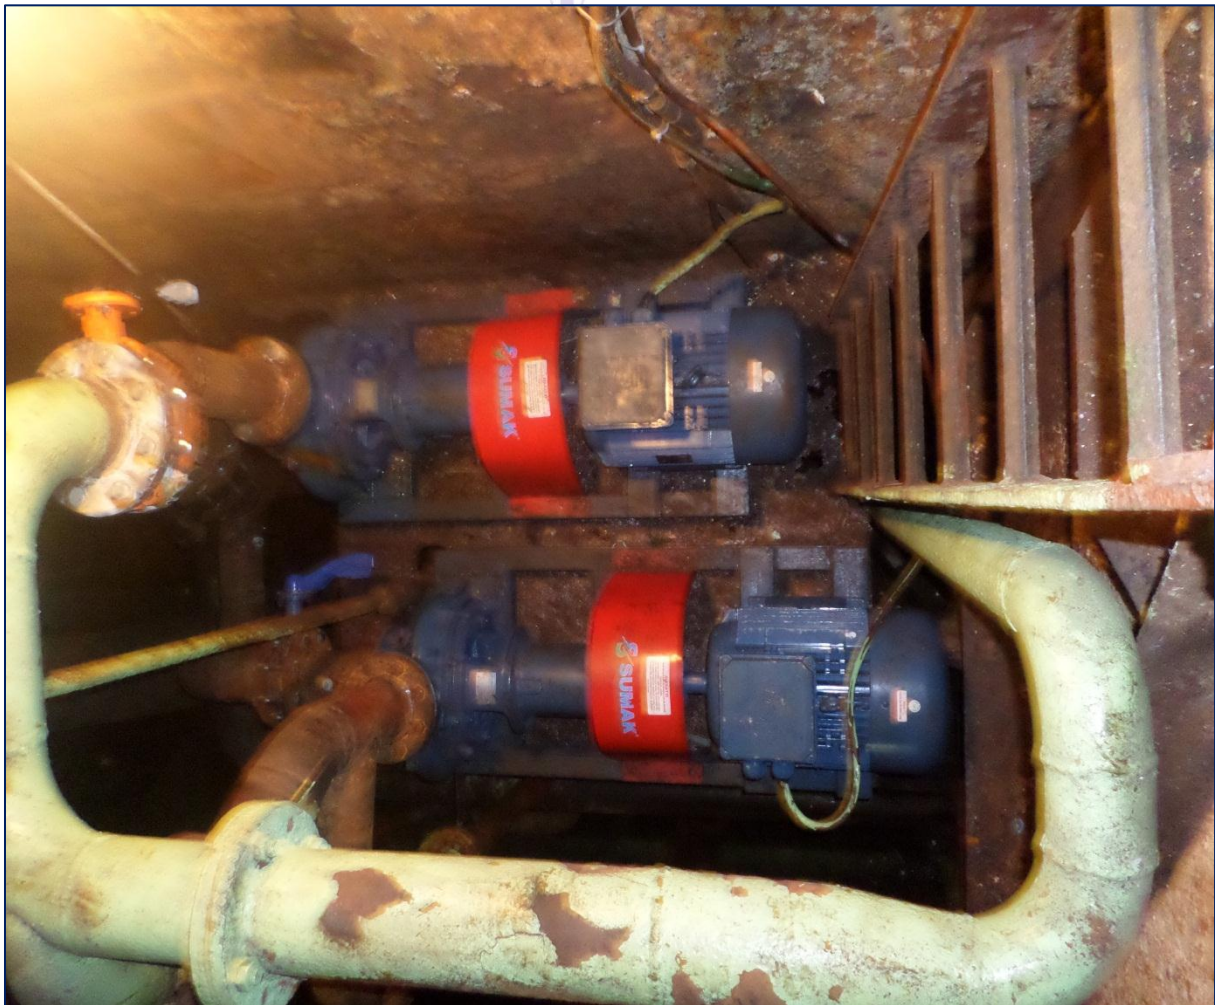
GENERATOR ENGINE NO:5 SEA WATER PUMP NO:1 & NO:2 OVERHAUL;

Generator Engine Sea Water pumps has dismantled from foundation. Transferred to the workshop & opened for inspection. According to our inspection, need to replace with the new pump. Pipes & foundation fitted.

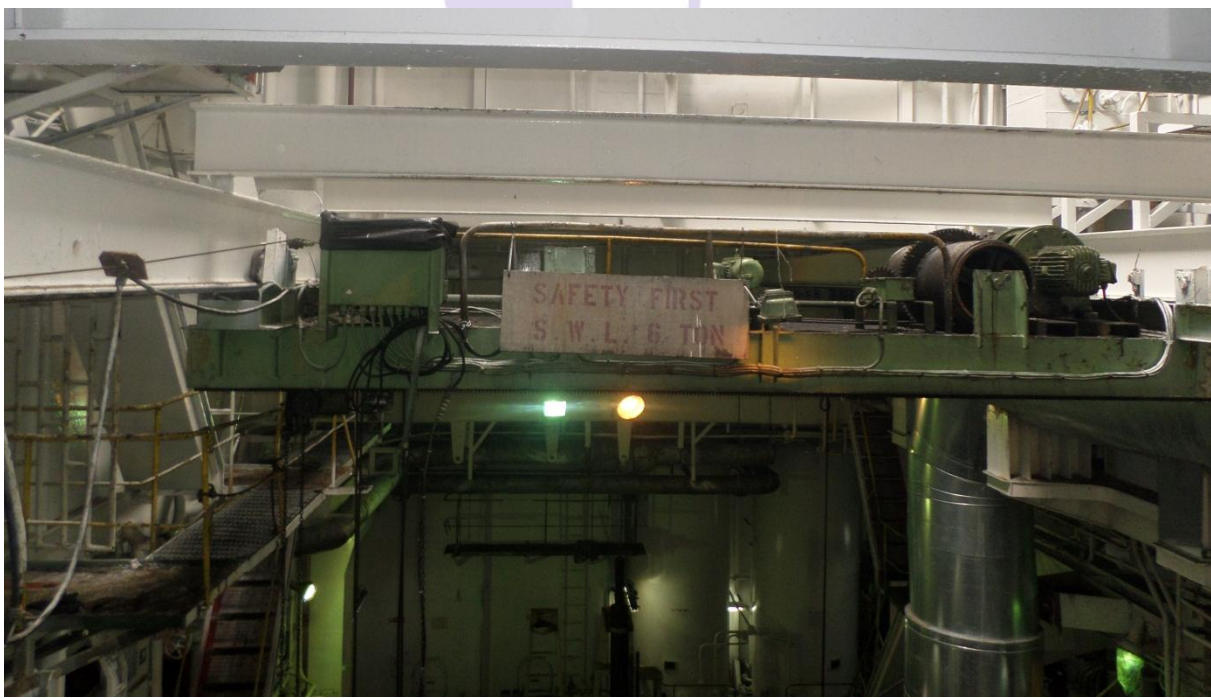
We chose appropriate loads for the test based on the manufacturer's load ratings for the condition of use. A 25% minimum partial load, the rated load, and a proof load as close as possible but not exceeding 125% of rated load shall be used. We checked manufacturer's limitations and or specific instructions on testing. The crane operated without a load through its full range of operation and all safety devices and limit switches checked. The 25% partial load be applied and required adjustments made for appropriate function. Lift the rated load a sufficient height to ensure that each tooth of the lifting gear train has subjected to the rated load. We lowered the load to a height of 4-8 inches above the ground. After the tests are completed, conduct a thorough examination to ensure that the crane has satisfactorily withstood the tests. We parked the crane at the proper location for service access and relax all rigging and reeving to allow for inspection of the wire rope and reeving components. Opened the main disconnect and install a safety lock—out device before mounting the crane.

*Engine Room Crane / Tested / **Operative.***

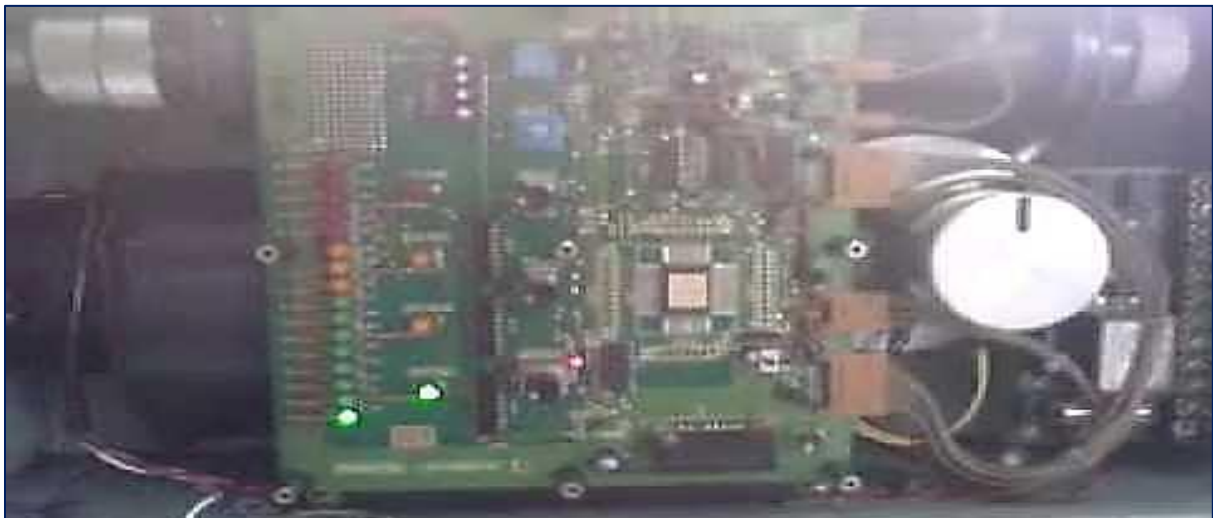
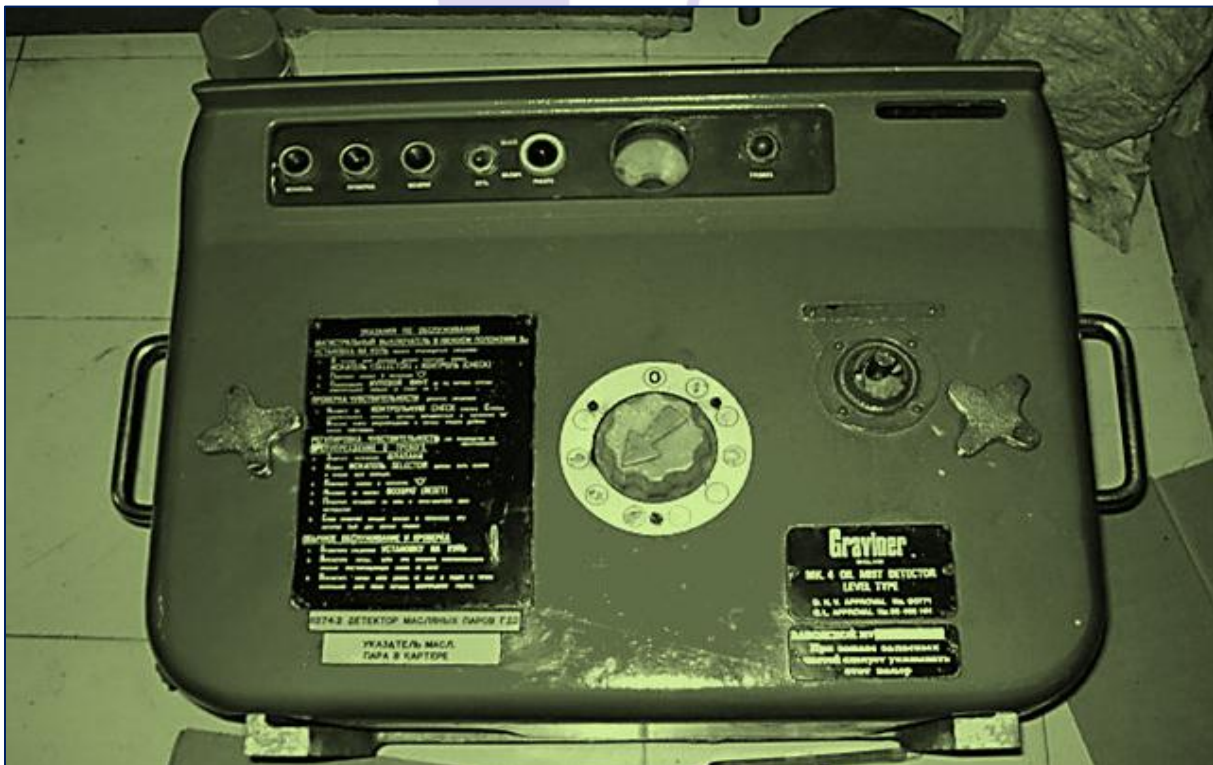
OIL MIST DETECTOR OVERHAUL;

Oil Mist Detector has dismantled & transferred to the workshop. OMD has disassembled & cleaned firstly. Some of the cable connections were heavily damaged & need to renew. Also main socket was stuck with dust. After the synchronizing the detector, tested with paper on mirror side. OMD activated for all cylinders and setted operative for all. After the recondition, transferred to the vessel & mounted on stu. *Oil Mist Detector / Tested / **Operative**.*

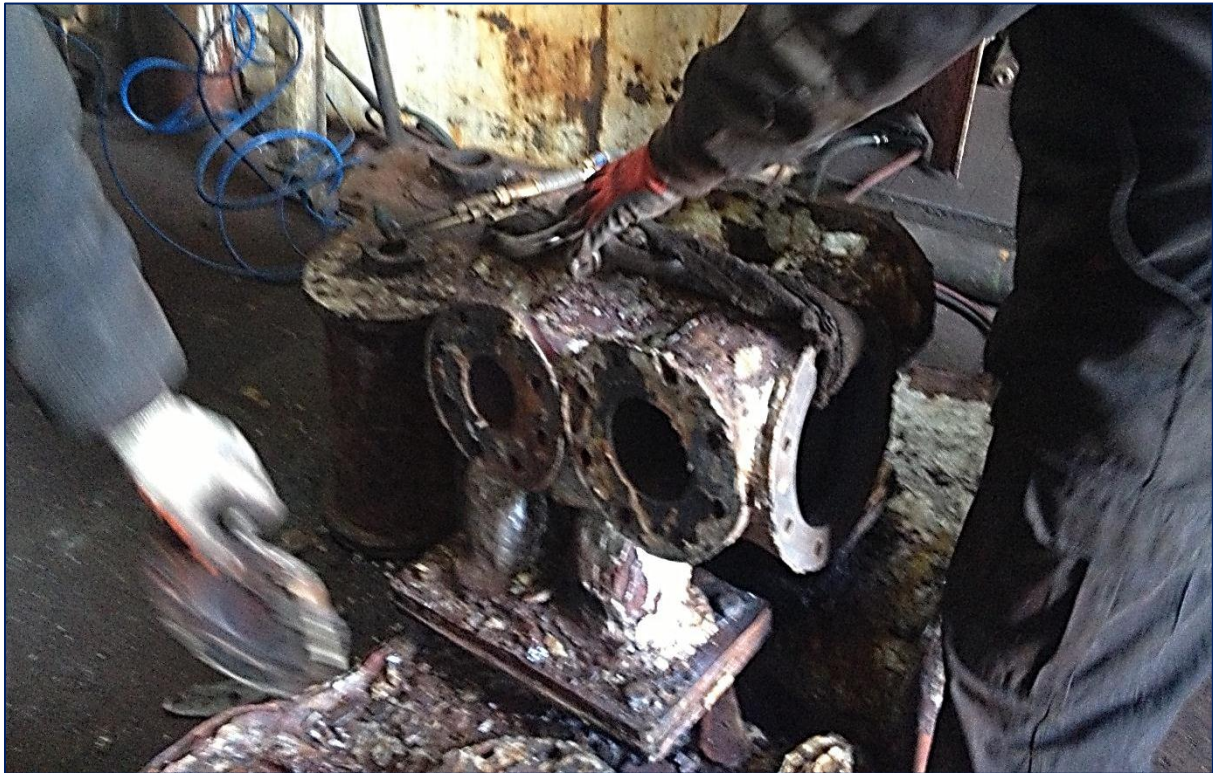
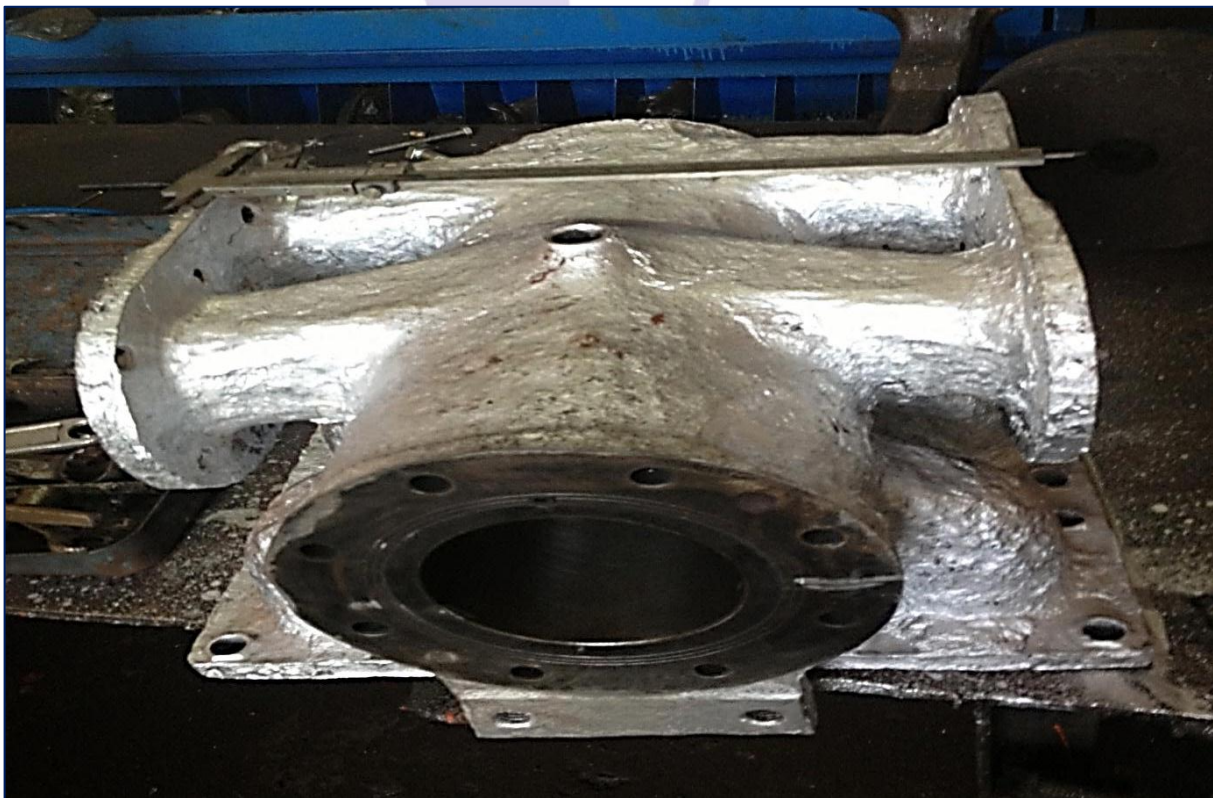
Port, Starboard & Center / Windlass & Capstain Steam Engines has dismantled & transferred to the workshop. Due to inspection, chromaged shaft renewed, liners honned & pistons fabricated due to sizes of honned liners. Piston rings also fabricated & replaced. Sphero slide fabricated & fitted. Keys, nuts, bolts & gasket fabricated & renewed. Also packing gland fabricated & installed. Later

by scrapped, rubbered & painted. Assembled & transferred to the vessel, mounted on stu & made ready for test.

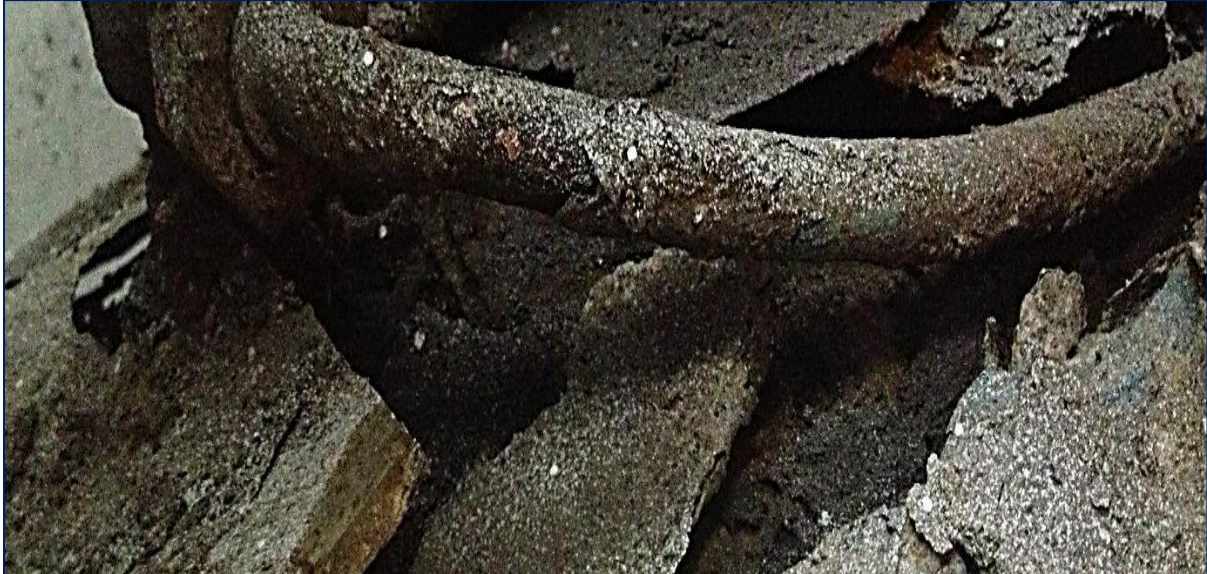
STEAM TANK ISOLATION;

Due to our inspection, steam tank isolation has corroded & damaged.
Regarding to our taken measures, isolation plates has renewed & replaced.

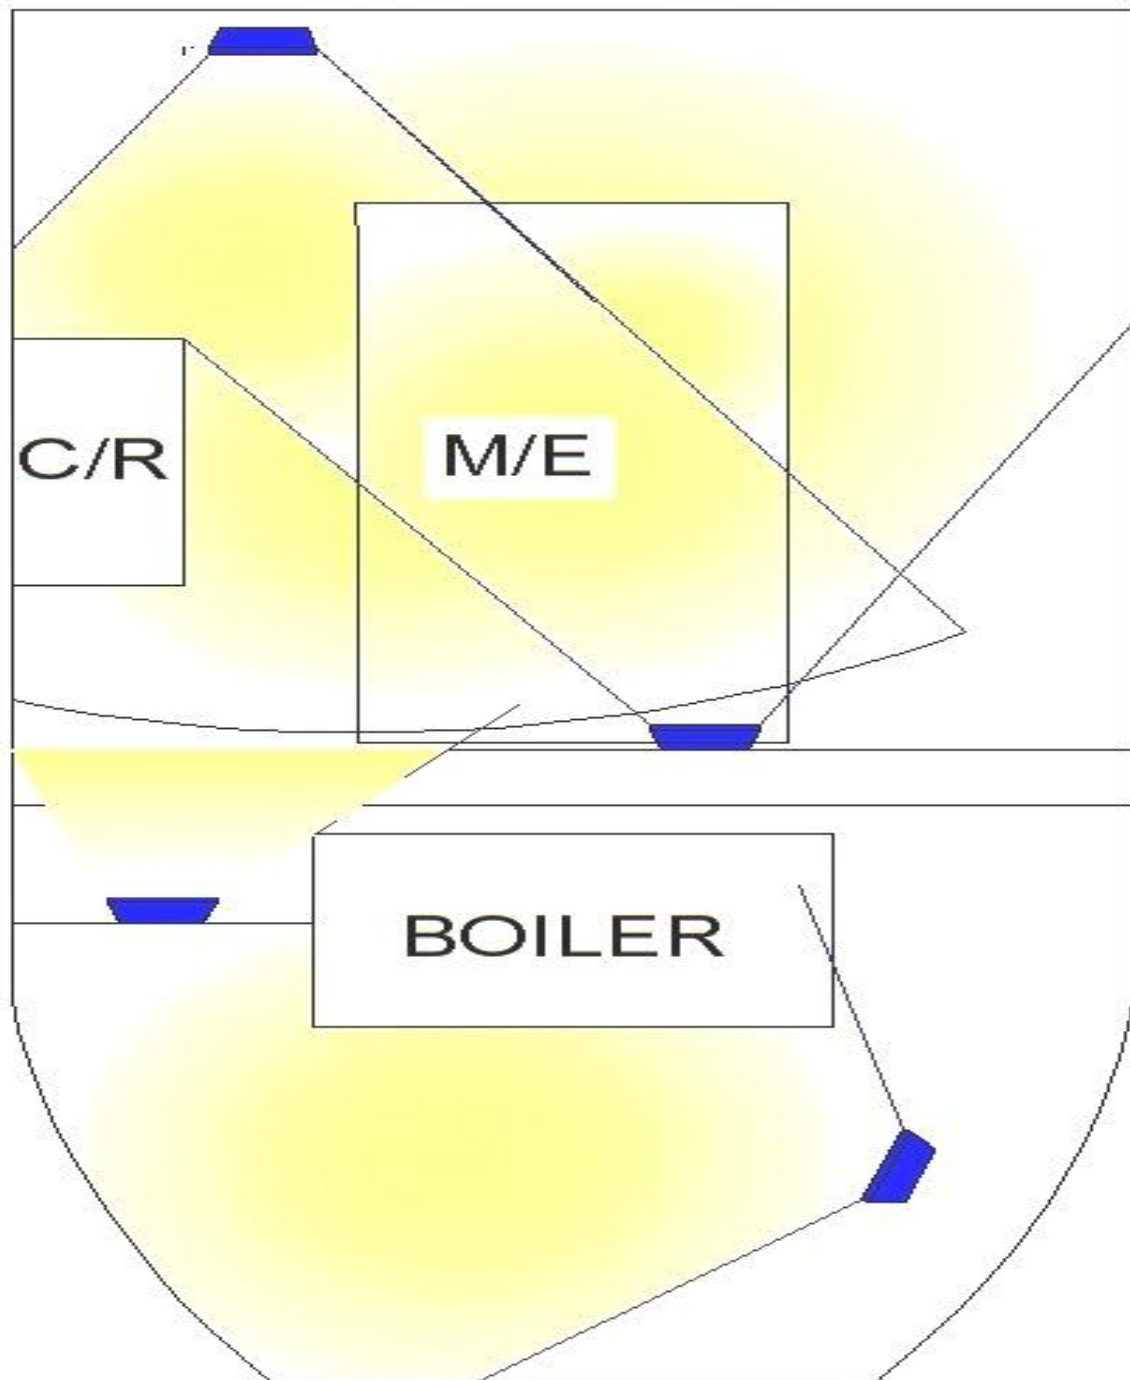
FORWARD

4 units of projectors installed to the engine room for improving the lighting.

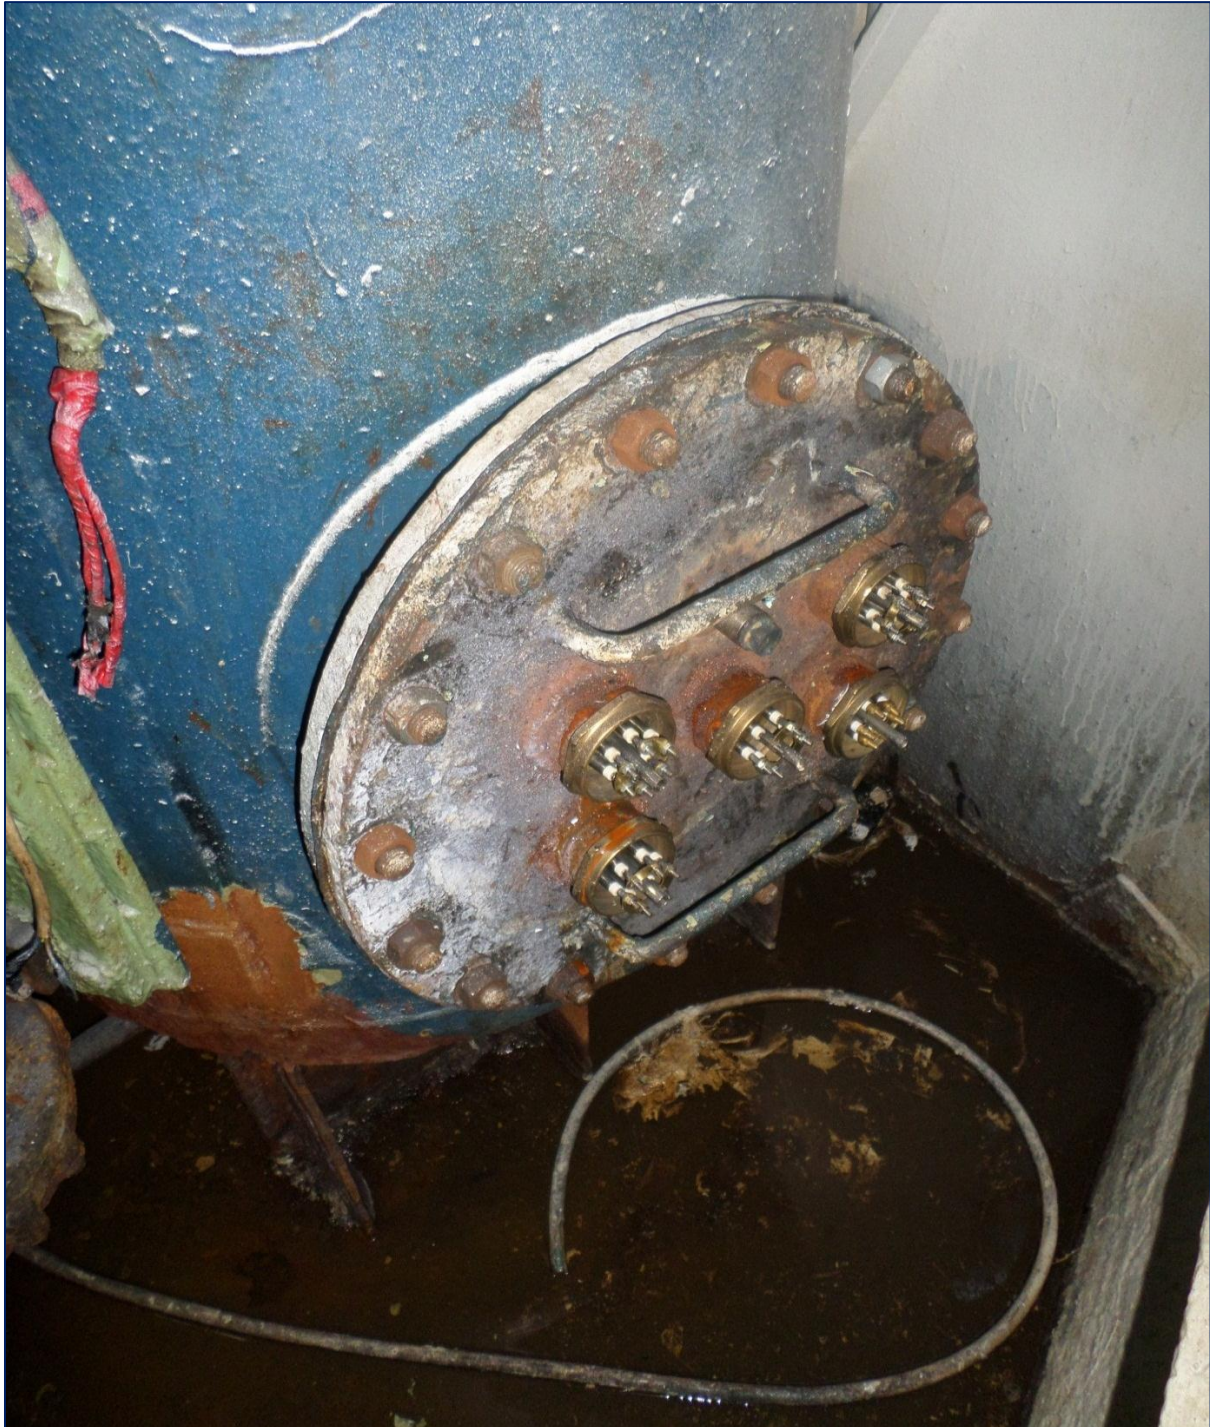
HOT WATER HEATER FOR ACCOMODATION REVISING;

Regarding to our inspection, one of the hydrophore tanks, needs to be revised, equipped with the 5 pcs of 5 KW Heater with thermostat.

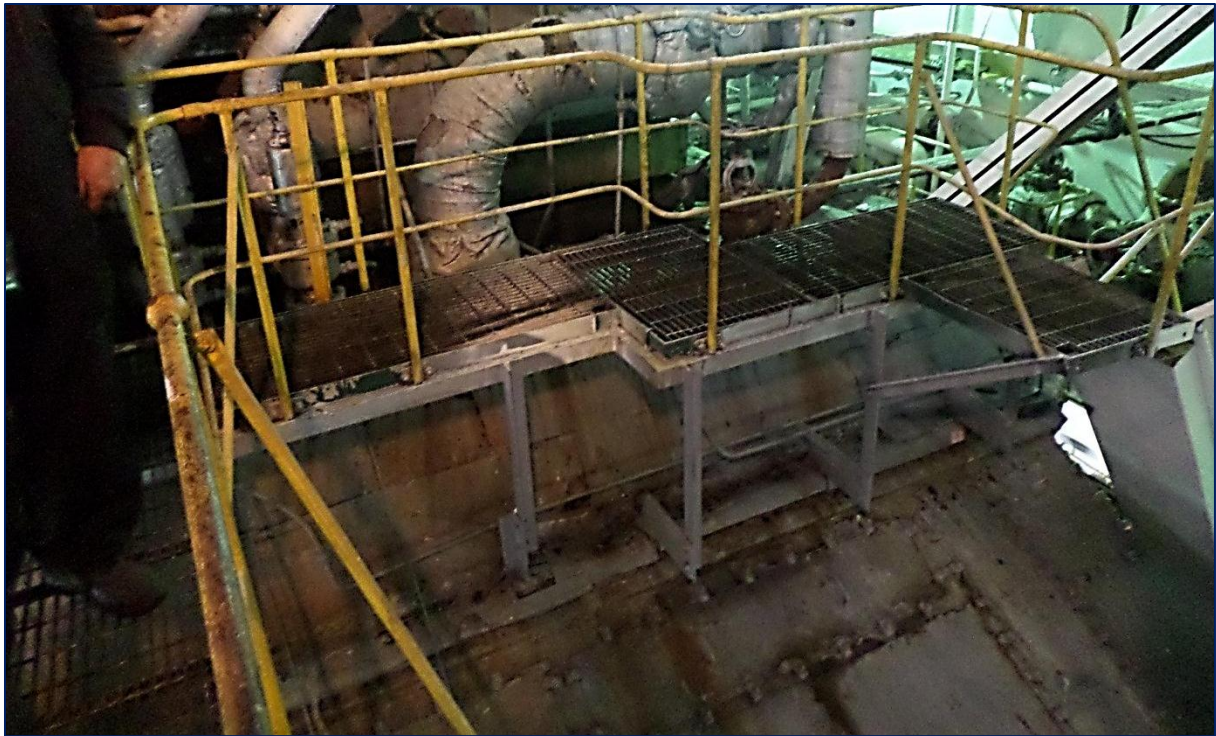
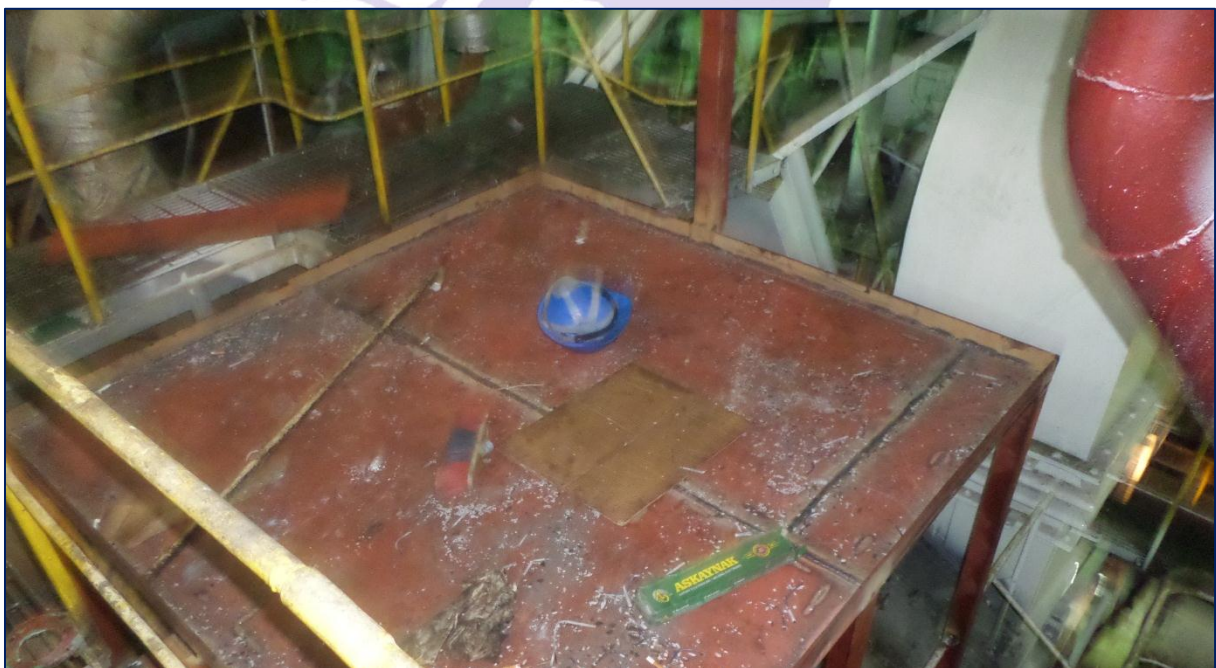
STEAM GENERATOR INSTALLED & FITTED;

According to the present steam boiler & system condition, new steam generator must be installed for system of heating fuel oil, steam for accomodation etc. In the lights of these informations, a new steam generator supplied to the vessel & fitted to the place that showed by ship staff.

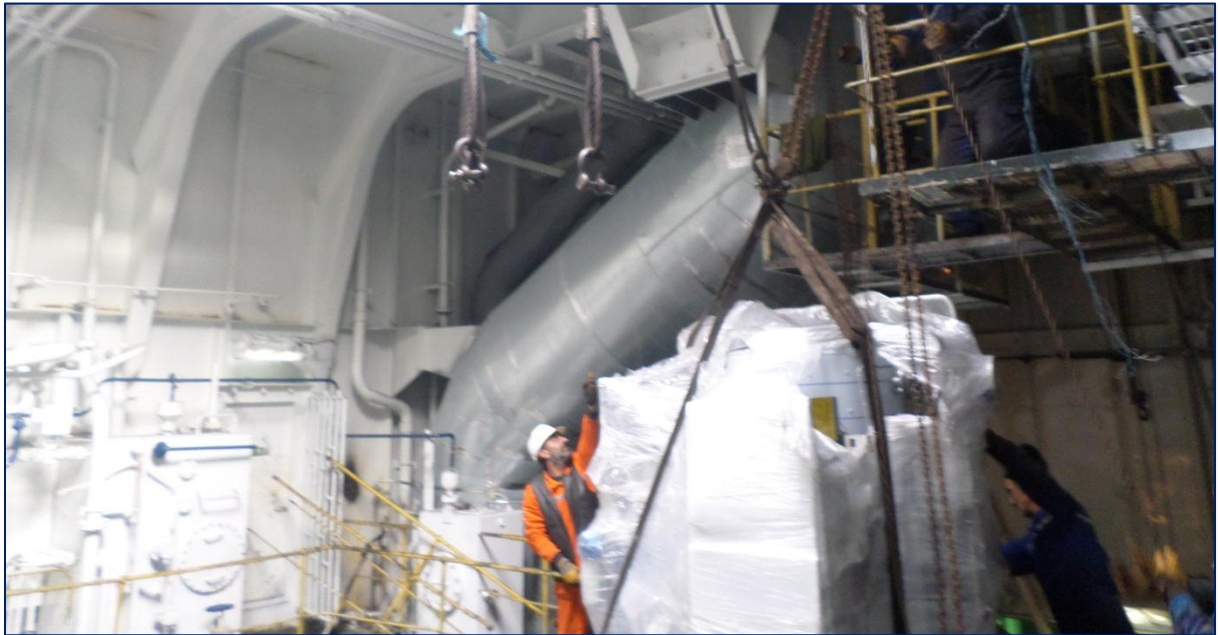
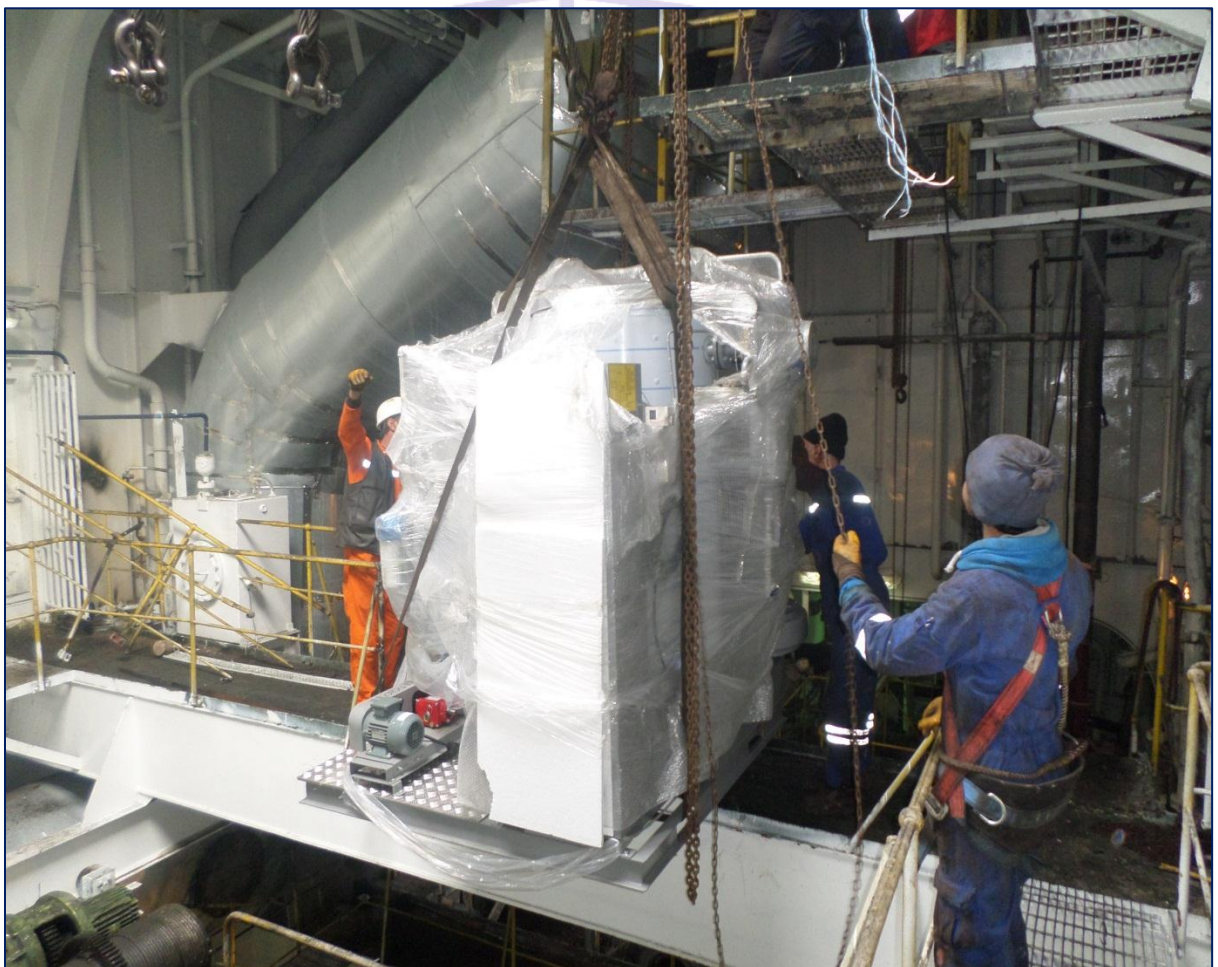
After the fitting & welding of foundation, steam generator was ready for the transfer to engine room & for setting up.

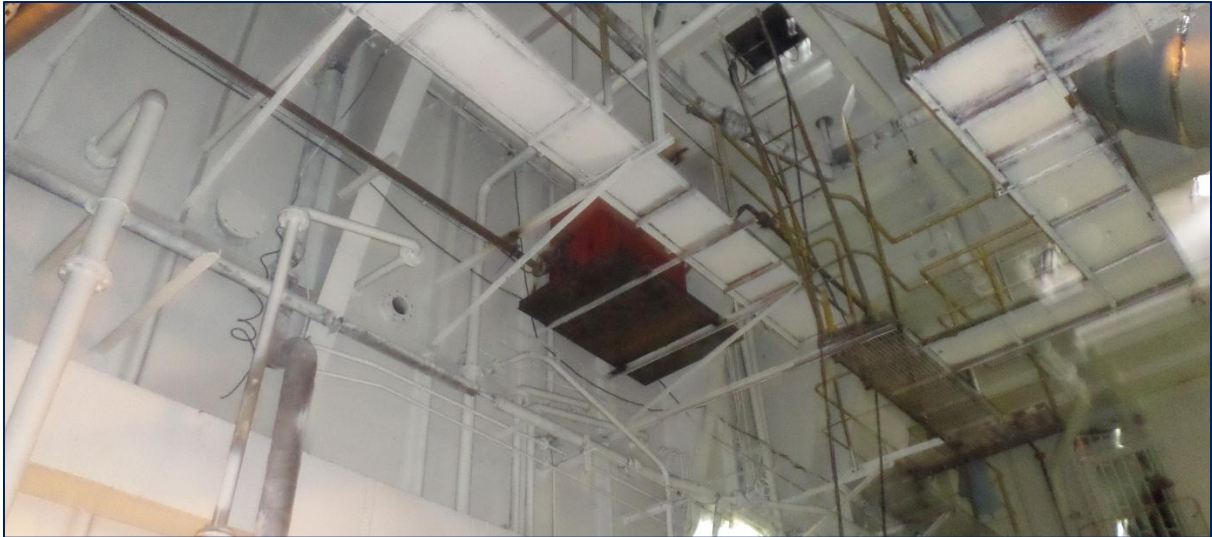
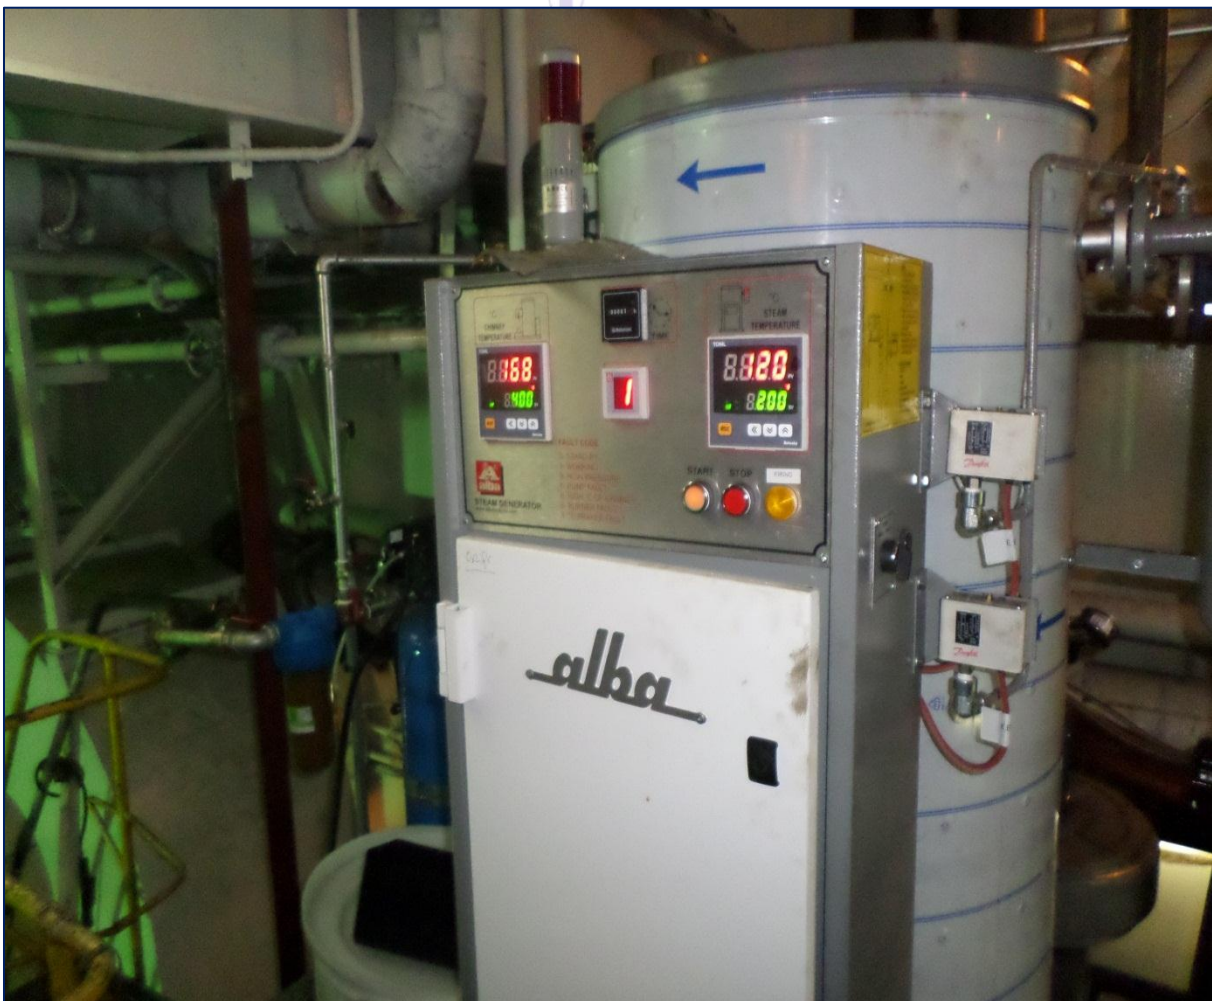
Meanwhile we fitted a diesel oil tank to high level of the steam generator blower for the gravity drop. Quick closing valve for the diesel oil line has mounted. And the controller has been putted to the chimney.

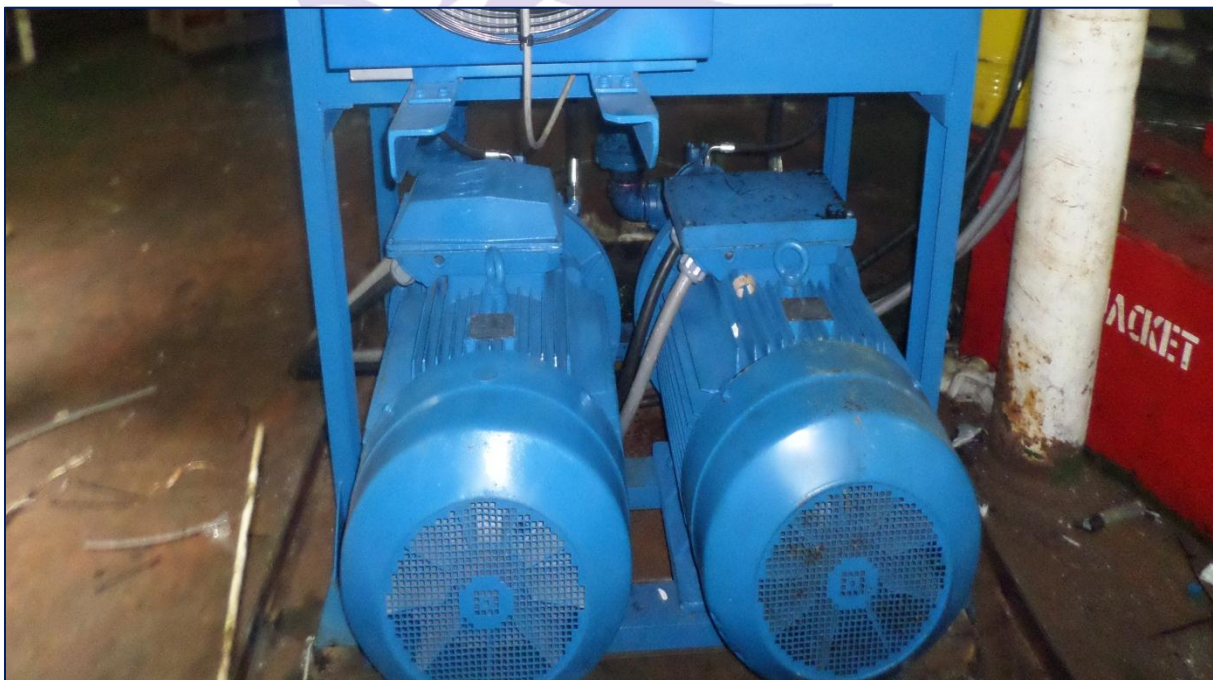
90x2 KW 160X2 CC POWER UNIT FOR WINDLASS

Regarding to our inspection, windlass & capstain winches must be replaced & renewed by hydraulic system. We cancelled all steam inlines & we made ready a new hydraulic system for windlass & capstain.

- *Oil tank
- *Oil filling cover
- *Level contactor (500mm)
- *Inlet Valve
- *90 KW 380V ABB Elc. Motor
- *A7V160 DR1RPFMO Piston Pump
- *1/4" 315 Check Valve
- *100x250 Bar manometer
- *DB 30 315 BAR Pressure secure valve
- *4-DWVG-25 G5*/F Armed way valve
- *MRH-3150 SWN-2 Radial Piston pump motor
- *4050 230V Cooler with fan
- *1/2" 25 MC Return filter

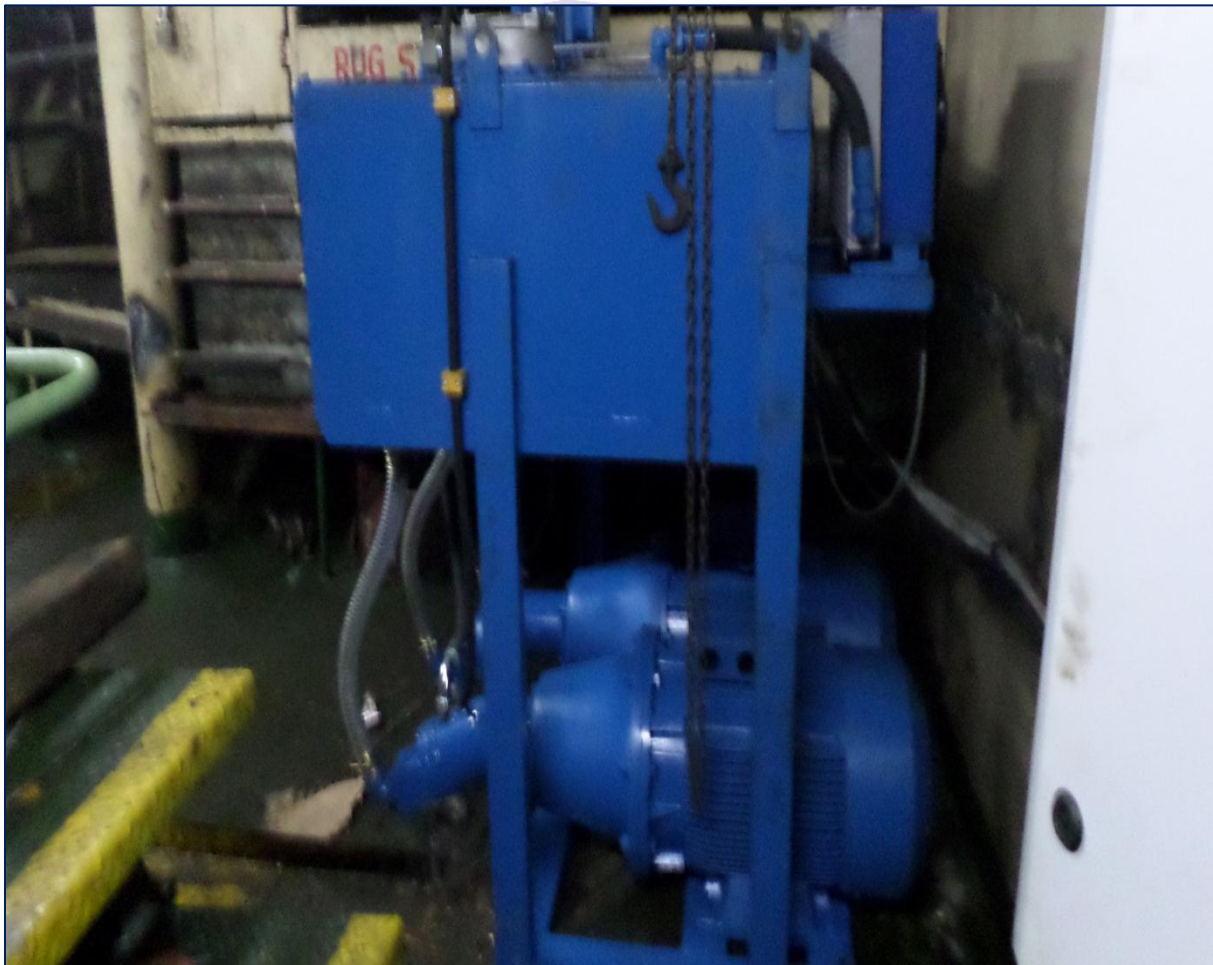
45x2 KW 160X2 CC POWER UNIT FOR CAPSTAIN

- *Oil tank
- *Oil filling cover
- *Level contactor (500mm)
- *Inlet Valve
- *45 KW 380V Gamak Elc. Motor
- *A2F80R293Piston Pump
- *1" Check Valve
- *100x250 Bar manometer
- *DB 30 315 BAR Pressure secure valve
- *4-DWMG-16 G5*/F Armed way valve
- *MRH-3150 SWNX-2 Radial Piston pump motor
- *4040M 230V Cooler with fan
- *1/2" 25 MC Return filter
