MH3D NEWS

Software release

New TESA-REFLEX software versions are now available for MH3D, MH3D Recorder and MH3D DUAL systems.

A Firmware version is also available for the TESA-REFLEX DUAL panel.

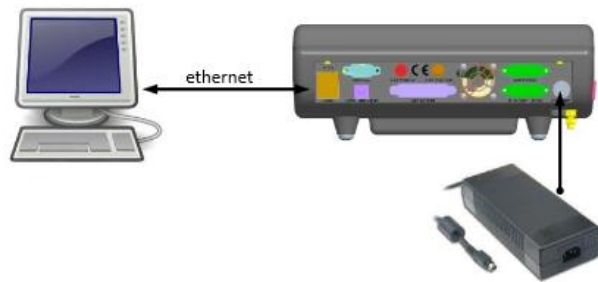
Step n°	Description
1	<p>Power supply your TESA-REFLEX panel and connect it to your computer through an Ethernet (RJ45) cable.</p>

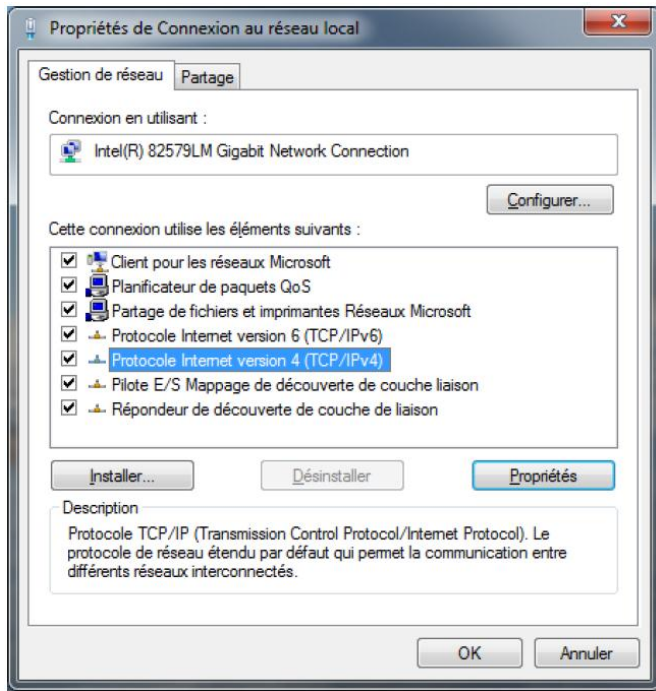
2	<p>Configure your computer to access the panel.</p> <p>Start → Control Panel → Network and Sharing Center → Change Adapter Settings → Right Click on appropriate card → properties → TCP/IP Version 4</p>

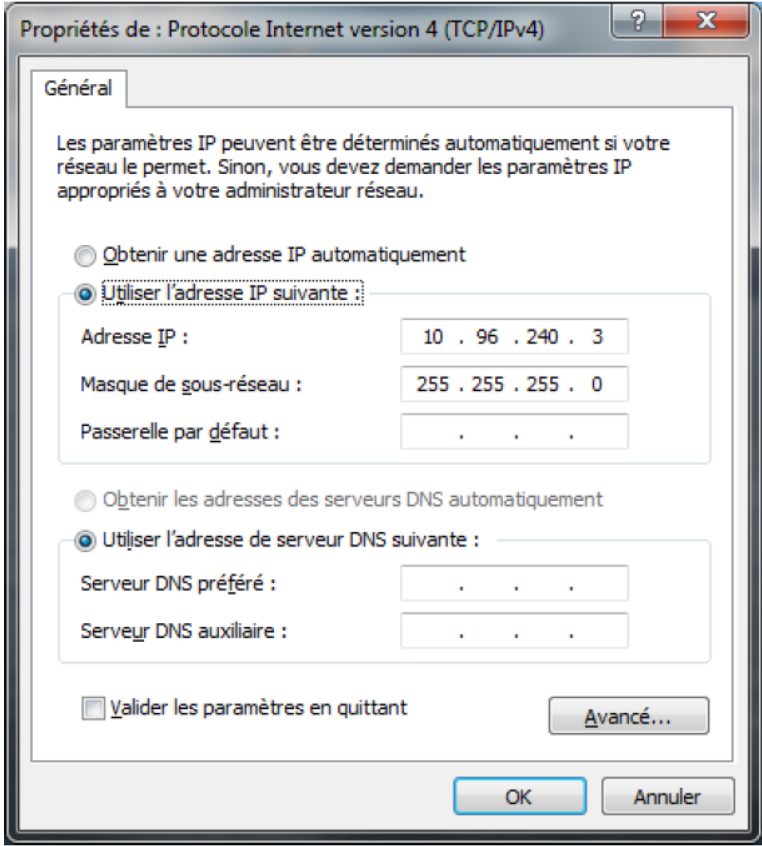
3	<p>Select “use following IP adresse” and enter the following info:</p>

<p>IP address = 10.96.240.3</p> <p>Subnet mask = 255.255.255.0</p>
