europhysicsnews

47/4

2016

15 YEARS LATER: ON THE PHYSICS OF HIGH-RISE BUILDING COLLAPSES

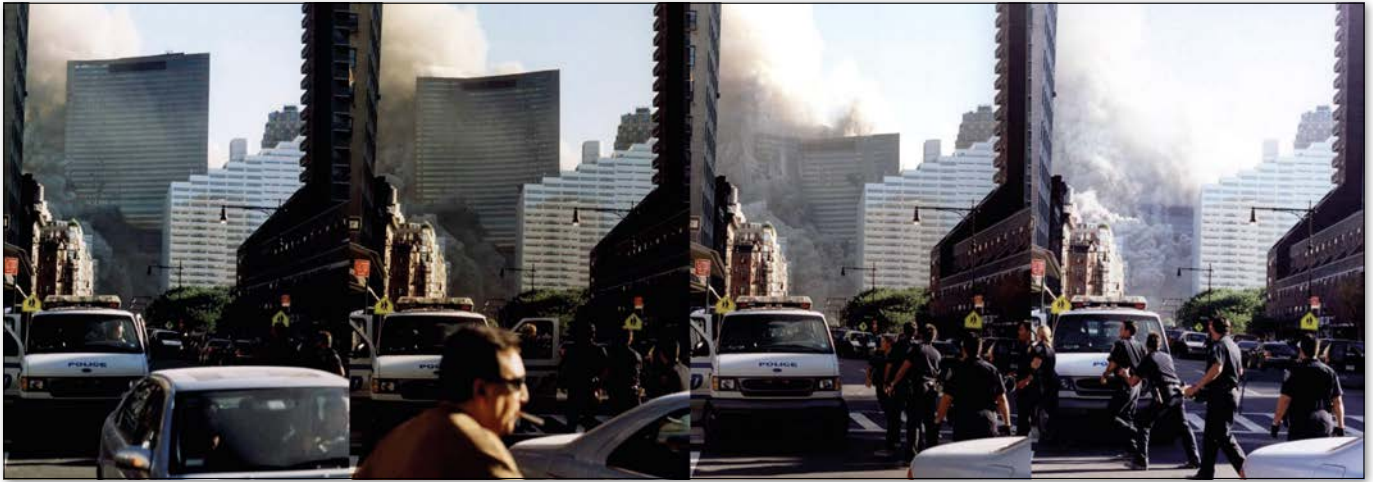
▼ FIG. 1: WTC 5 is an example of how steel-framed high-rises typically perform in large fires. It burned for over eight hours on September 11, 2001, and did not suffer a total collapse (Source: FEMA).

Throughout history, three steel-framed high-rises are known to have suffered partial collapses due to fires; none of those led to a total collapse. Countless other steel-framed high-rises have experienced large, long-lasting fires without suffering either partial or total collapse (see, for example, Fig. 1a and 1b) [1].

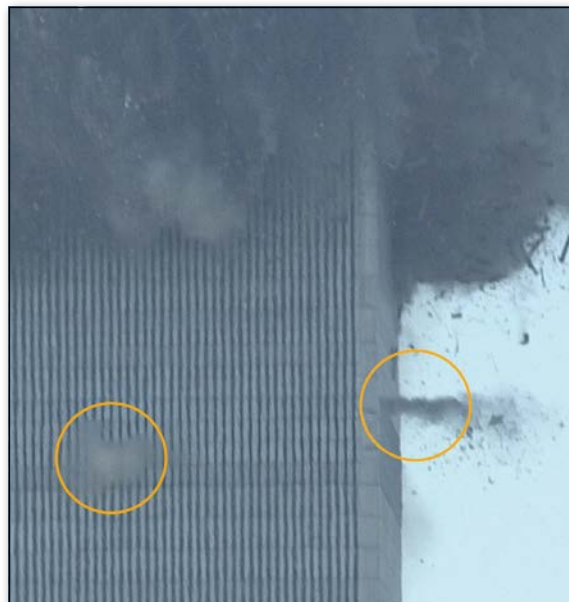
◀ FIG. 5: High-velocity bursts of debris, or “squibs,” were ejected from point-like sources in WTC 1 and WTC 2, as many as 20 to 30 stories below the collapse front (Source: Noah K. Murray).

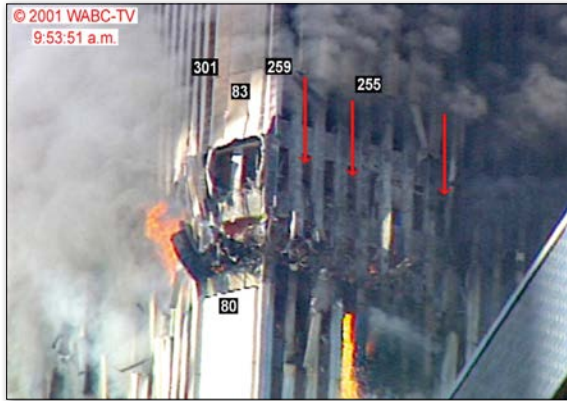
► **FIG. 6:** Molten metal was seen pouring out of WTC 2 continuously for the seven minutes leading up to its collapse (Sources: WABC-TV, NIST).

NIST sidesteps the well-documented presence of molten metal throughout the debris field and asserts that the orange molten metal seen pouring out of WTC 2 for the seven minutes before its collapse was aluminum from the aircraft combined with organic materials (see Fig. 6) [6]. Yet experiments have shown that molten aluminum, even when mixed with organic materials, has a silvery appearance—thus suggesting that the orange molten metal was instead emanating from a thermite reaction being used to weaken the structure [12]. Meanwhile, unreacted nano-thermitic material has since been discovered in multiple independent WTC dust samples [13].
