Sicherheitsmitteilung
SM161102

Betroffene Muster:
alle UPT Gurtzeuge – Trenngriffe
(Sport / Sigma / Military TS/MM)

To: **Whom it may concern**
Re: **Break away cable lengths – UPT Vector sport containers**

Cutaway Cable Trim Instructions – All Systems

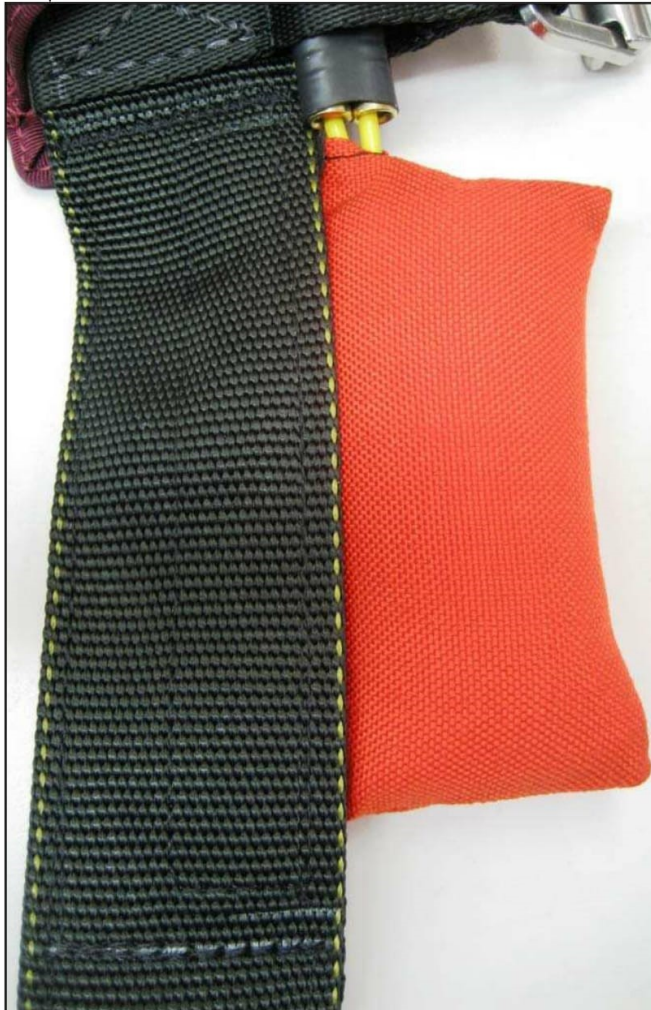
Step 1

Insure the cutaway handle Velcro is squarely mated to the main lift web Velcro.

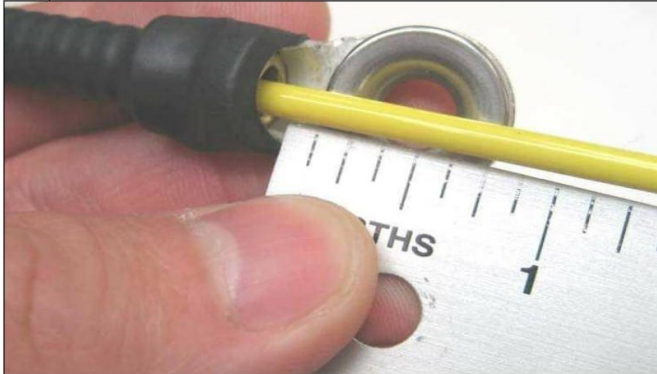
Step 3a

Begin measuring where the cable comes out of the end fitting.

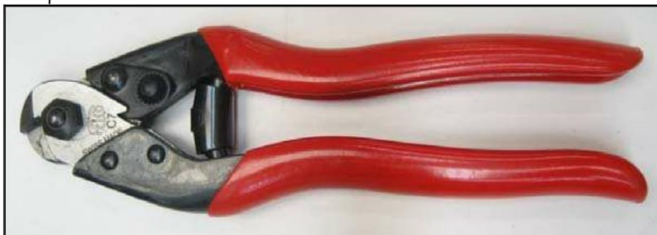
Step 4a

With appropriate cable cutters, snip to the correct length,

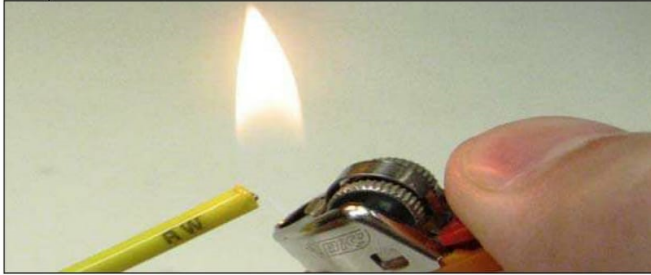
Step 5

To smooth out the cut ends, heat **ONLY THE TIPS** with a lighter or butane torch till it just begins to mushroom.

1. Proceed very quickly through steps 5-6.
2. Steps 5-6 should be practiced before attempting on the handle.

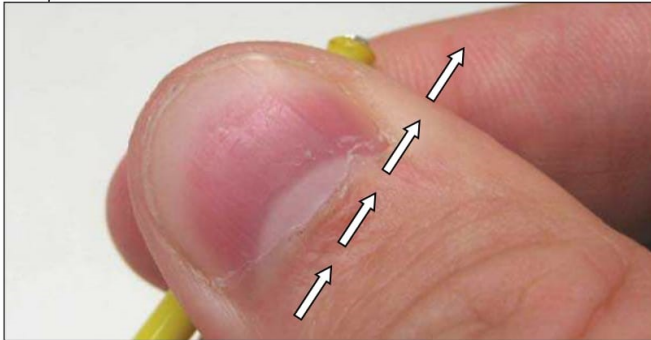
Step 6b

In one smooth and fluent motion, quickly and repeatedly pull the firmly gripped cable completely out rotating it 90° each time.

Reheating up to 3 times may be necessary.

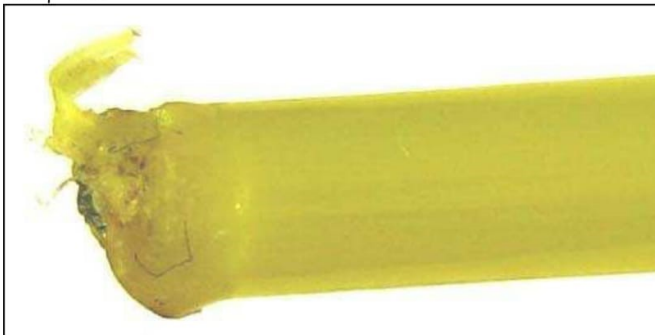
Step 6e

Examples of poorly burned cable ends.

Poorly burned ends may snag on and damage the Type 2a locking loop on main risers.
